**TESTING AND ASSESSMENT OF
CG-7 PRESSURE RELIEF VALVE AND
PROPANE CYLINDER PERFORMANCE**

VOLUME 1: RESULTS AND EVALUATION

January 31, 2003

BATTELLE
505 King Avenue
Columbus, Ohio 43201-2693

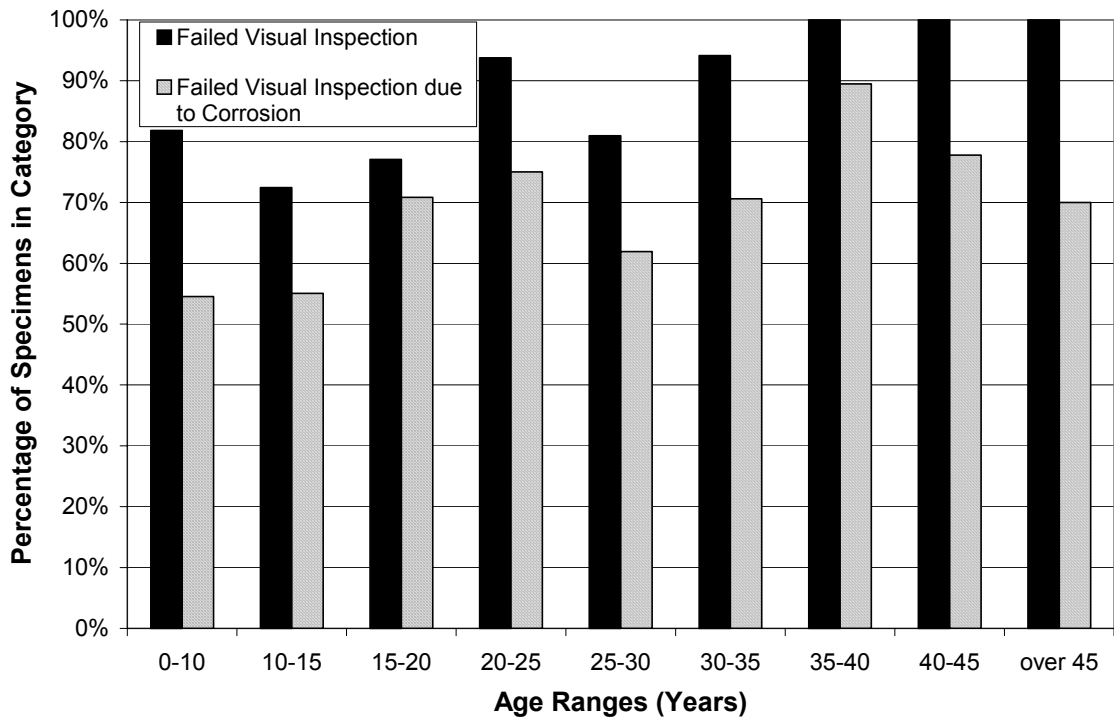
The visual inspection results of all collected cylinders are summarized in Table 1. Of the nearly 400 cylinders collected from across the United States, 51 passed visual inspection. Of the 343 cylinders that failed visual inspection, 256 failed solely due to corrosion. The remaining cylinders failed due to denting, improper float valve, fire damage, or other reasons.

Figure 10. Comparison of the percentage of cylinders collected in each age bracket which failed visual inspection for all causes and which failed inspection due to corrosion.

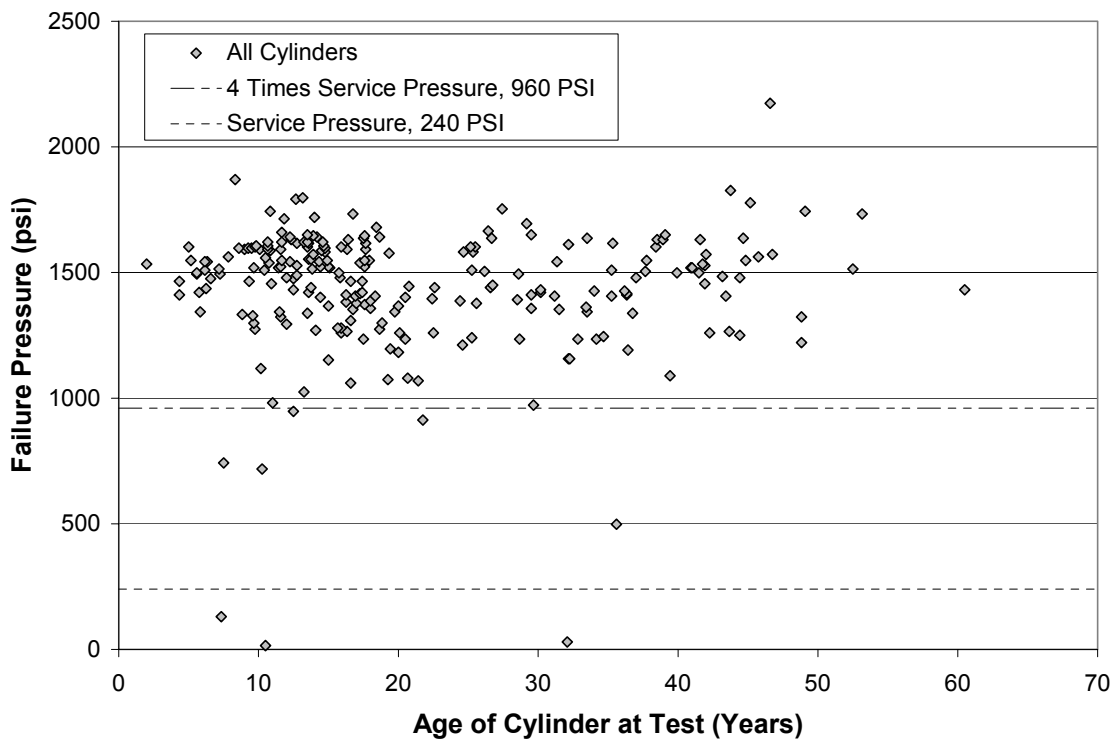
Figure 13. Failure pressure of all cylinders tested as a function of age.

cylinders tested, (3.4 percent) actually failed at pressures below 960 psi. The oldest cylinder tested, 60 years old, failed at 1400 psi. Visual inspection was successful in rejecting each of the 8 cylinders which failed below 960 psi. In fact, the lowest failure pressure of a cylinder that passed visual inspection was 1235 psi, more than five times the service pressure. The test results indicate that these cylinders are durable and robust and that the current visual inspection method is an effective and very conservative criterion for identifying damaged or weakened cylinders.

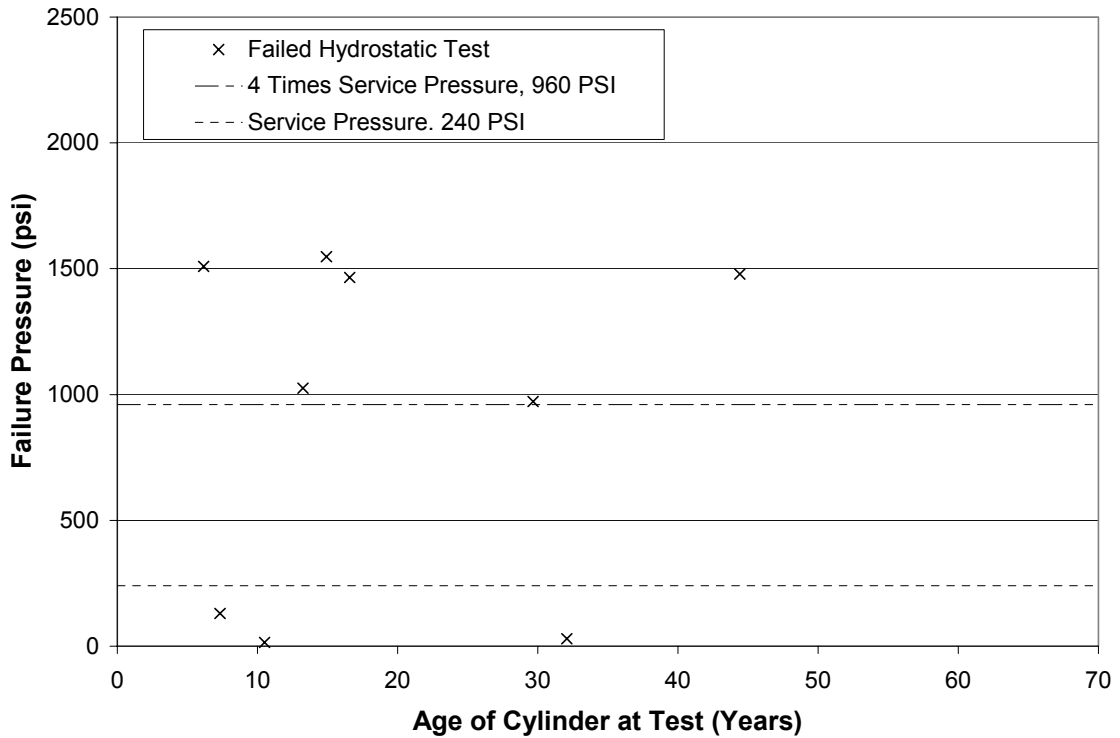
Figure 20. Failure pressure of cylinders that failed hydrostatic expansion test.

These test results indicate that hydrostatic expansion testing was not effective at identifying weakened cylinders tested in this program. Further examination is warranted. Hydrostatic expansion depends upon steel properties and upon wall thickness. It should be expected to discern the integrity of cylinders that fail by general corrosion over the entire surface. However, the failures observed in this investigation occurred primarily because of localized corrosion or other local phenomena. Hydrostatic expansion with a 10 percent expansion criterion did not appear capable of detecting this type of failure. Figure 21 compares the burst pressure of the tested cylinders to the permanent expansion that was measured. These results suggest that a criterion of 2 or 3 percent maximum permanent expansion might be better able to discern the integrity of cylinders. However, there are other issues that need to be considered before modifying the expansion criterion. The results suggest that this test method should be reviewed to reevaluate its suitability for this class of cylinder.

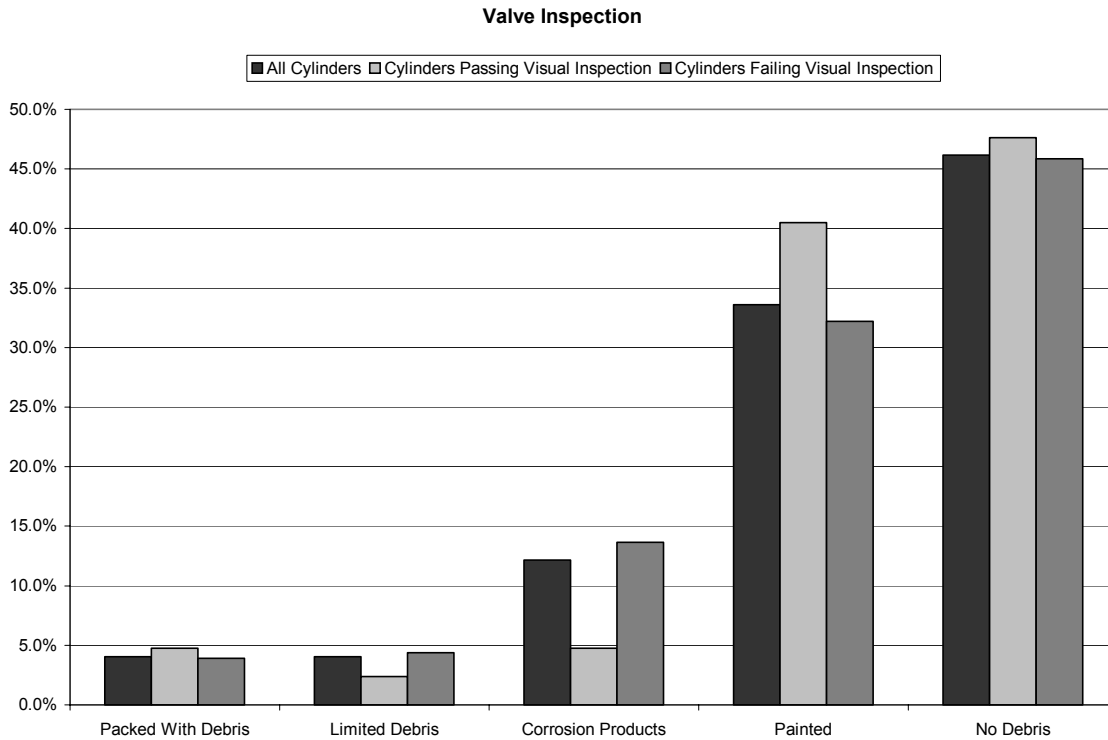
Figure 22. Summary and comparison of results of visual inspection of valves from cylinders which passed and failed cylinder visual inspection procedures.

Figure 22 shows the results of the visual inspection of relief valves and compares those from cylinders passing visual inspection to those failing cylinder visual inspection.

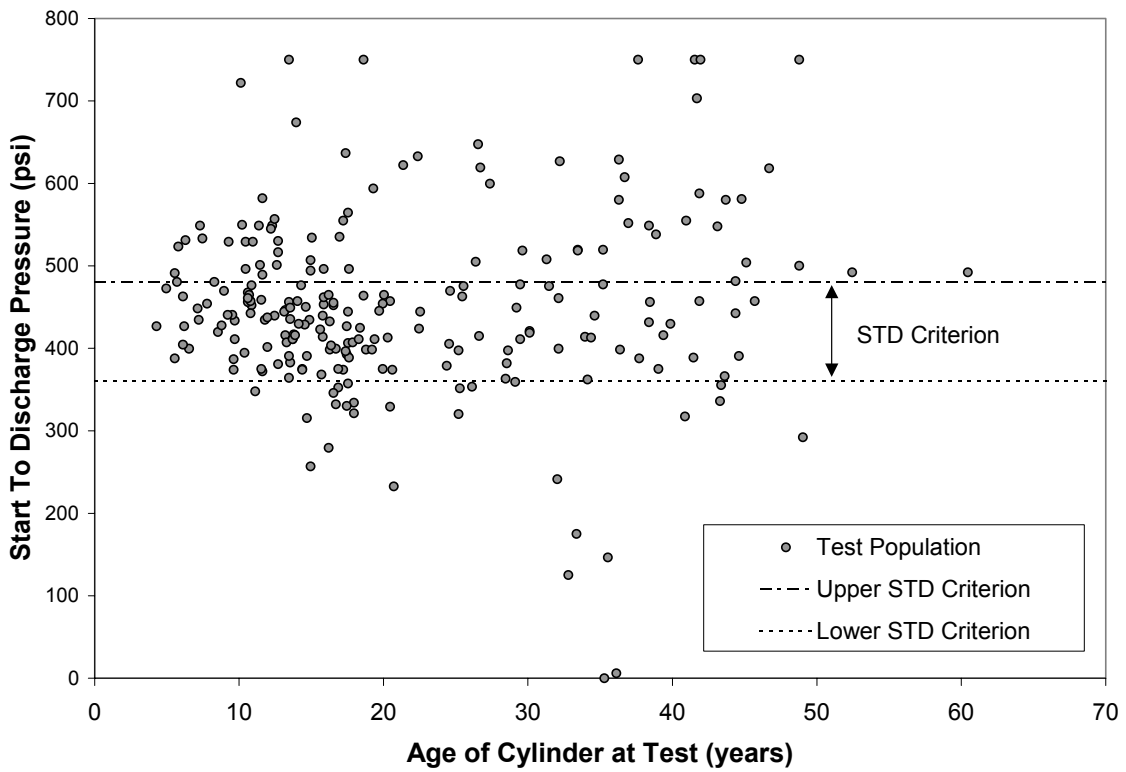
Relief valves for 20-pound cylinders are expected to fully open by 480 psi, the minimum test pressure of the cylinder. Of the 229 valves tested, 11 failed to fully open when pressured up to 750 psi. Inspection of these valves showed that debris present in the outlet of the majority of these valves was likely the primary reason they failed to completely open. None of the valves examined in this program had protective caps. Furthermore, although debris may be detectable by detailed visual inspection, CGA Pamphlet C-6 *Standards for Visual Inspection of Compressed Gas Cylinders* does not require inspection of relief valve outlets. Industry experience suggests that the use of protective caps and/or visual inspection of the relief valve outlet may reduce the potential for debris to impede the operation of the relief valve.

Figure 23. First sequence (A) start-to-discharge pressure of all relief valves tested.
