ADDENDUM TO THE FINAL REPORT ON:

TESTING AND ANALYSIS OF THE PERFORMANCE OF PRESSURE RELIEF VALVES FOR CUSTOMER TANKS

Battelle Project N007245
PERC Docket 15203

April 2011

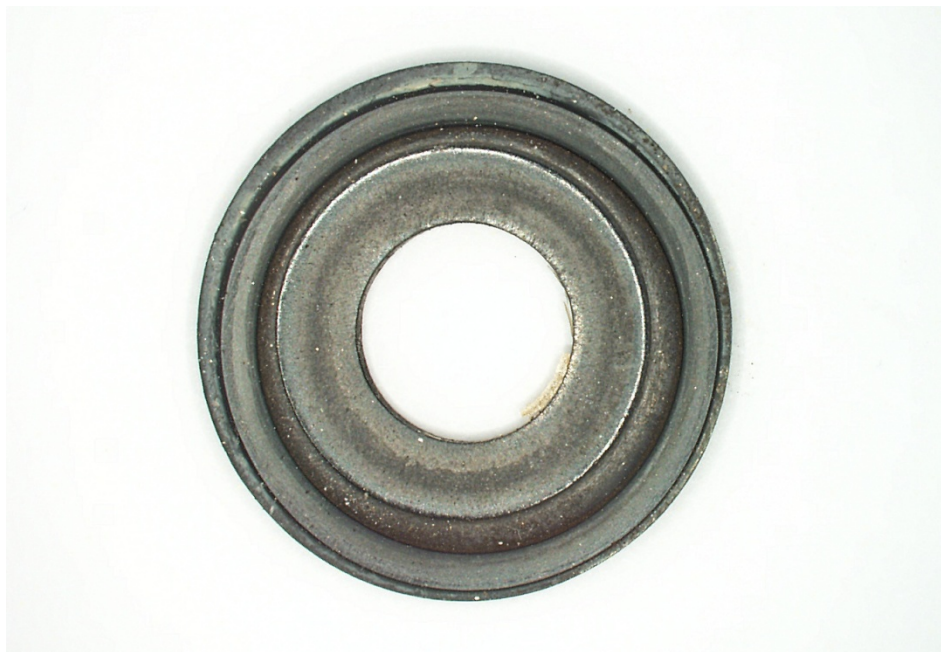
exhibited a high start-to-discharge pressure. It is possible that this condition indicates possible misalignment of the valve stem/poppet in the PRV which could have contributed to their performance issues during testing. As will be illustrated subsequently, misalignment of the valve stem could result in a strong interaction between the valve stem surface and the guide spacer inner surface which could increase the load required to open the valve. Also moisture condensation in those regions could promote crevice corrosion which again could contribute to higher valve opening loads.

Figure 9 - Compression Set Rings on the Active/Sealing Surface of the Gasket From PRV 7
Note that the compression set rings are somewhat off center.

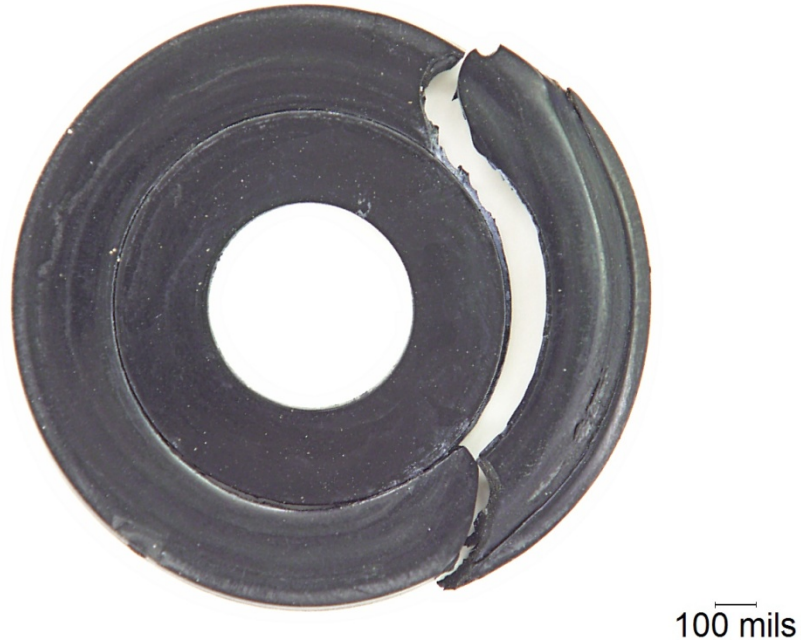
The only condition identified during the examination of the gasket material that conclusively resulted in the recorded PRV performance was the broken gasket in PRV 211 (discharged immediately when tested). That condition also was identified in the original PRV performance testing report [19]. It should be noted that the data sheet that accompanied PRV 211 did not indicate that the valve was removed because it was leaking.

Figure 10 - Broken Gasket from PRV 211
The gasket was in two pieces when the PRV was disassembled.

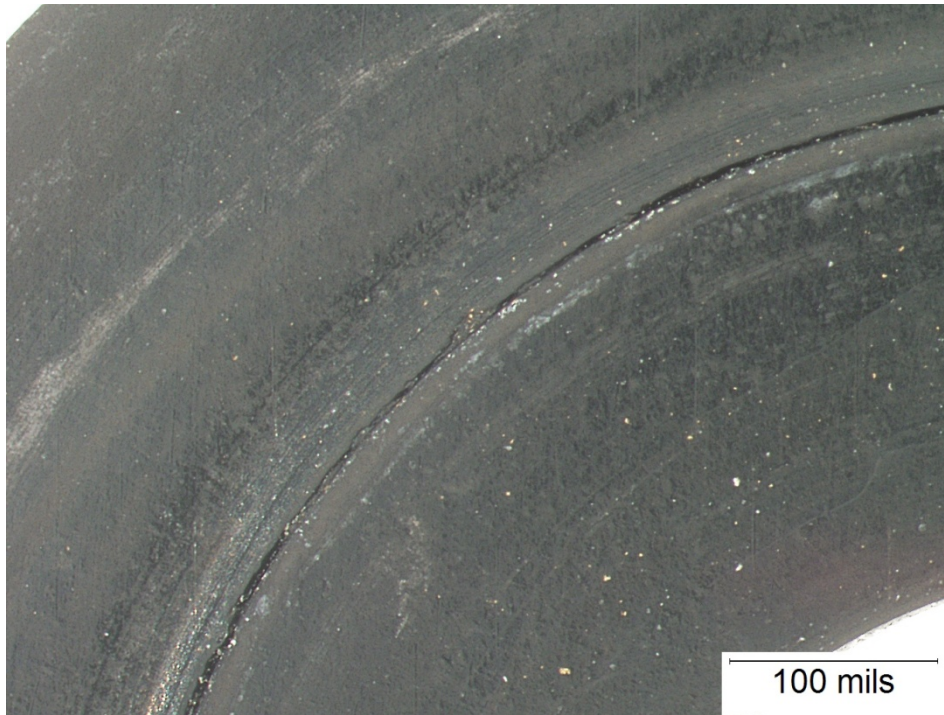
Figure 11 - Circumferential Crack Extending along the Compression Set Ring in the Gasket from PRV 211

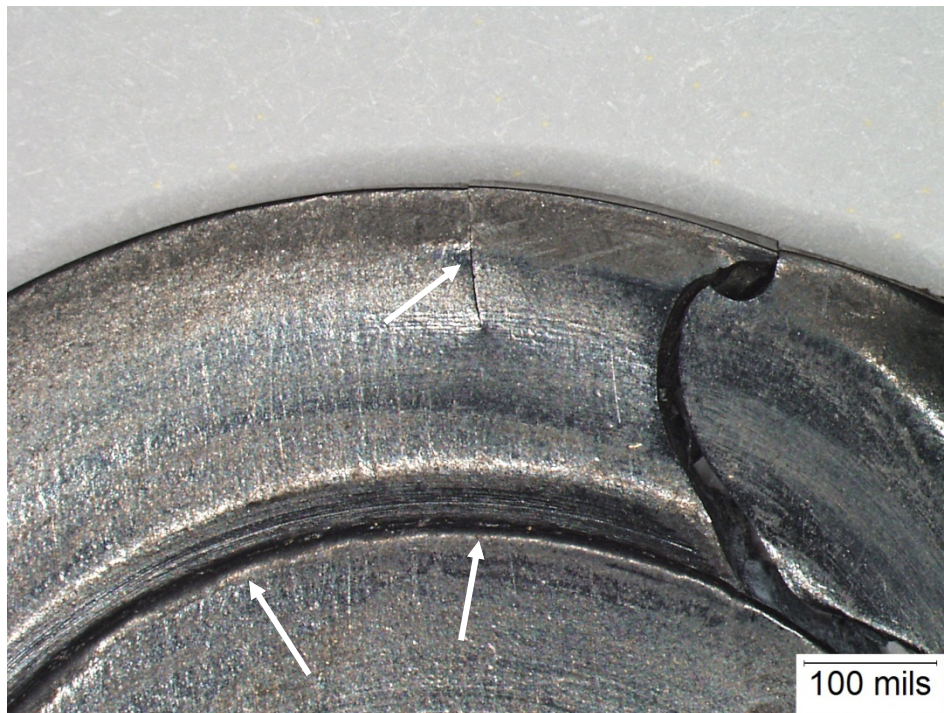
Figure 12 - Circumferential and Radial Cracks in the Gasket from PRV 211

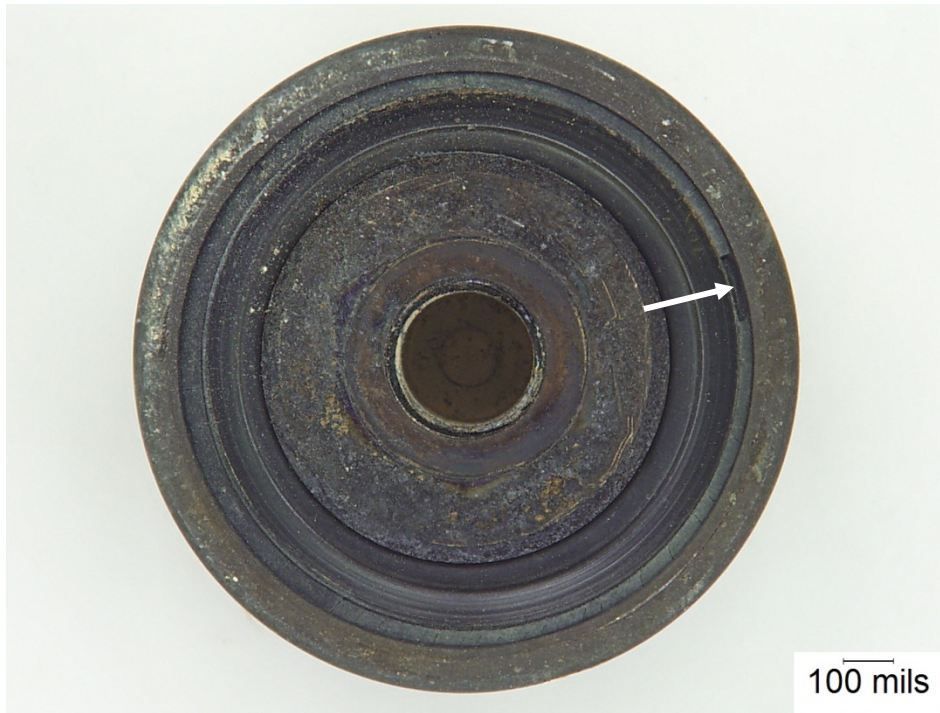
Figure 13 - Sealing Surface of the Gasket from PRV 270
Note the smaller region where material had broken out (arrow). The gasket is still in the holder.

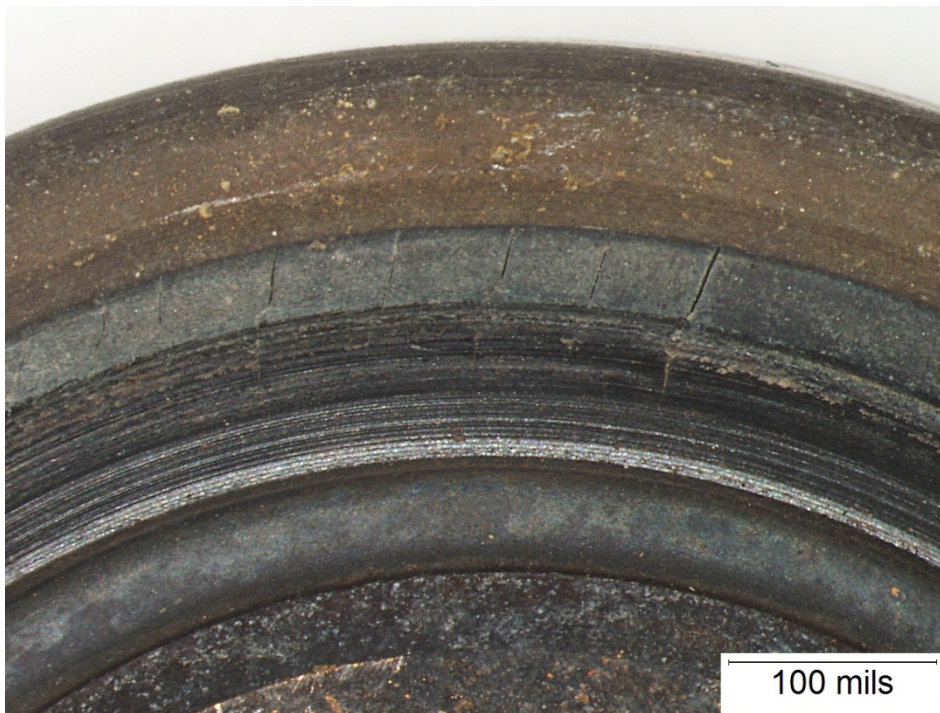
Figure 14 - Radial cracks in the Outer Circumferential Ring (Beyond the Seal Ring Surface) in the Gasket from PRV 270

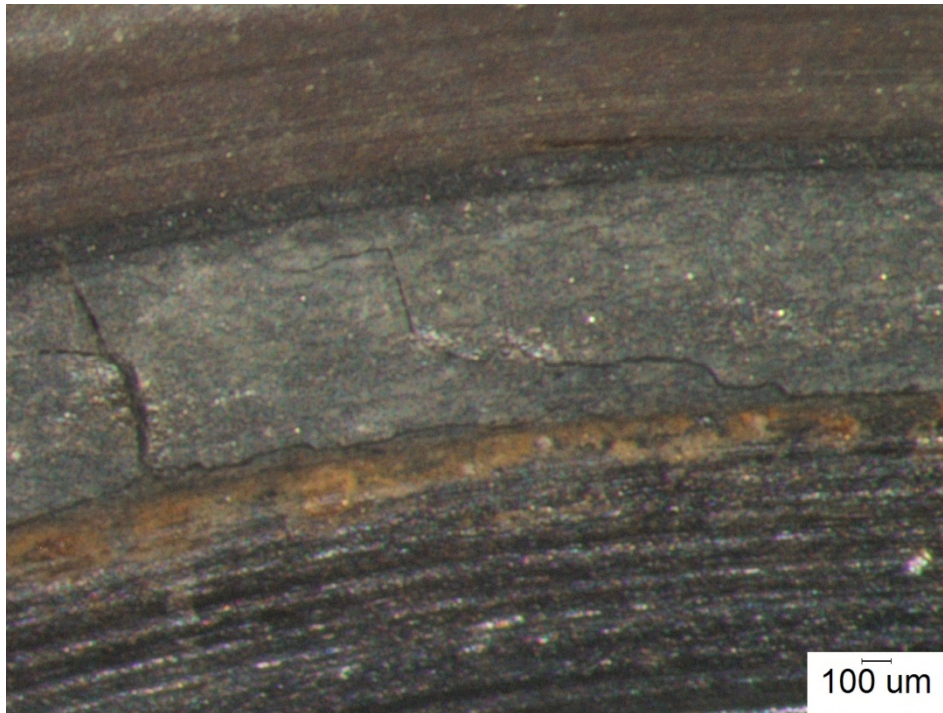
Figure 15 – Higher Magnification View of Radial and Circumferential Cracks in the Surface of the Outer Circumferential Ring in PRV 270

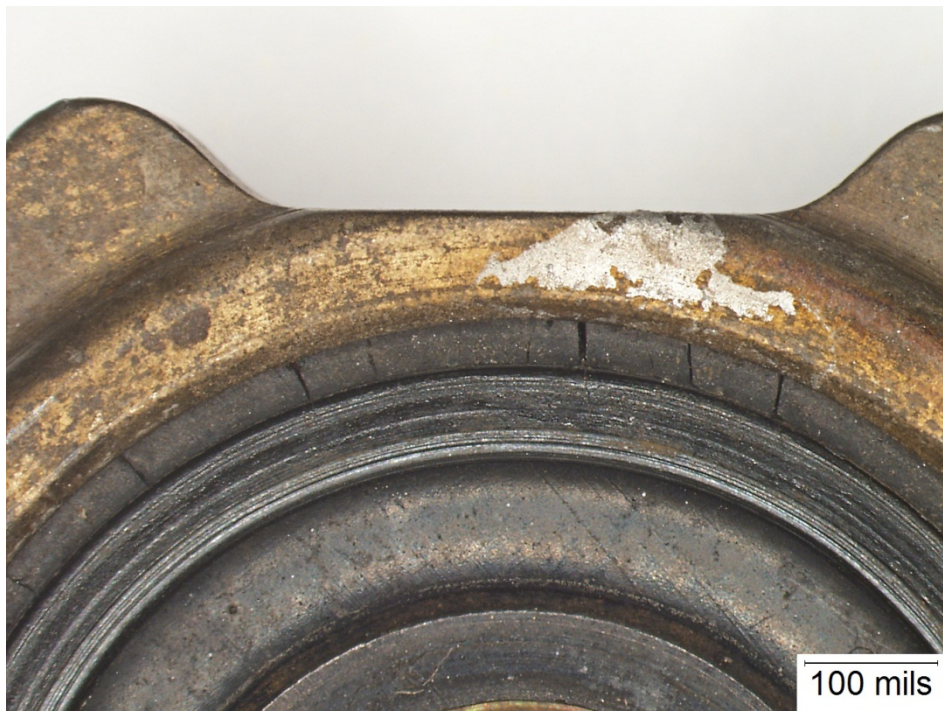
Figure 16 - Radial Cracks in the Outer Circumferential Ring on the Sealing surface of the Gasket from PRV 329
The gasket is still in the holder

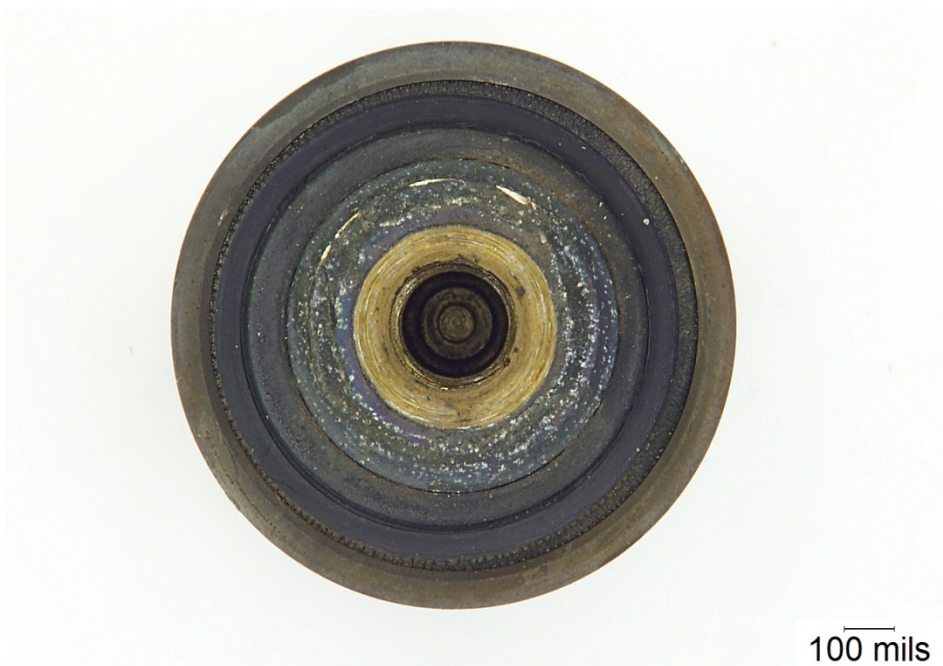
Figure 17 - Sealing Surface of the Gasket from PRV 343
Note the roughened surface in the outer circumferential ring and the compression set rings are somewhat off center; the latter condition perhaps indicating misalignment.

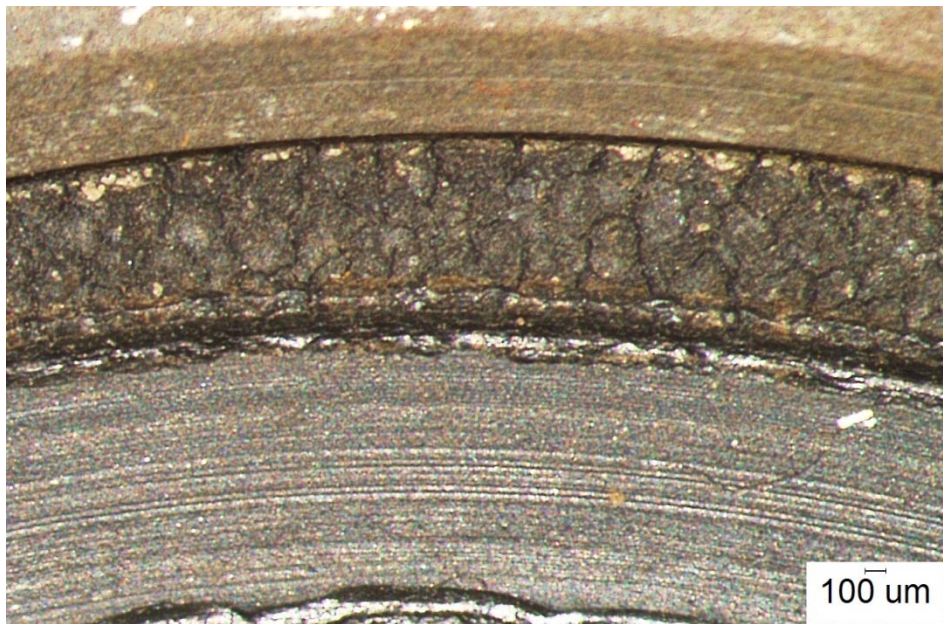
Figure 18 - Higher Magnification View of the Gasket Surface in the Outer Ring showing "Alligator Skin" Appearance of the Roughened Surface Region from PRV 343

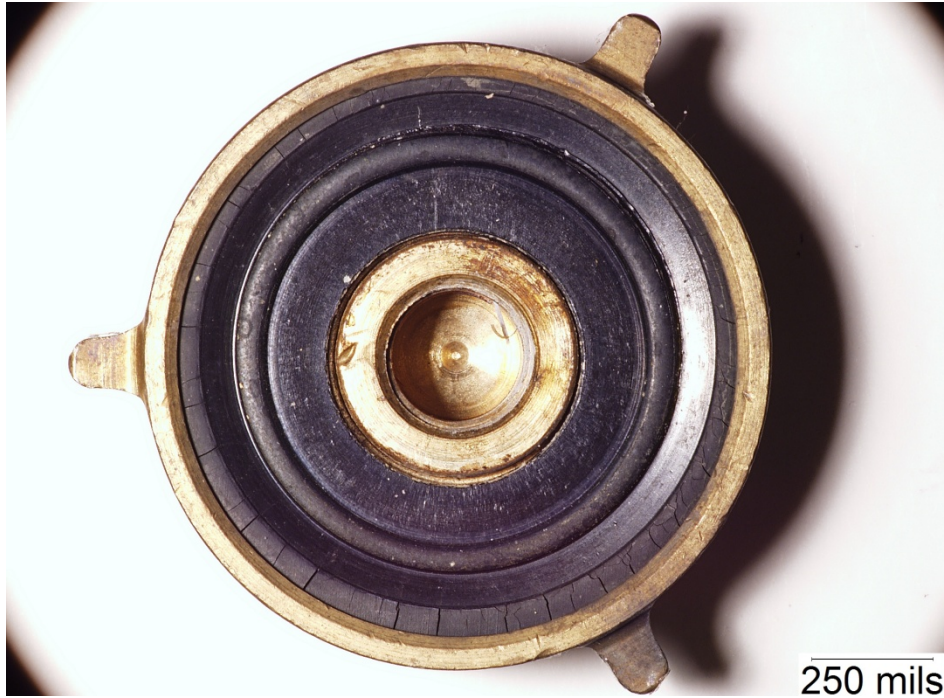
Figure 23 - Radial Cracks in the Outer Circumferential Ring (Beyond the Seal Region) in the Gasket from PRV 407

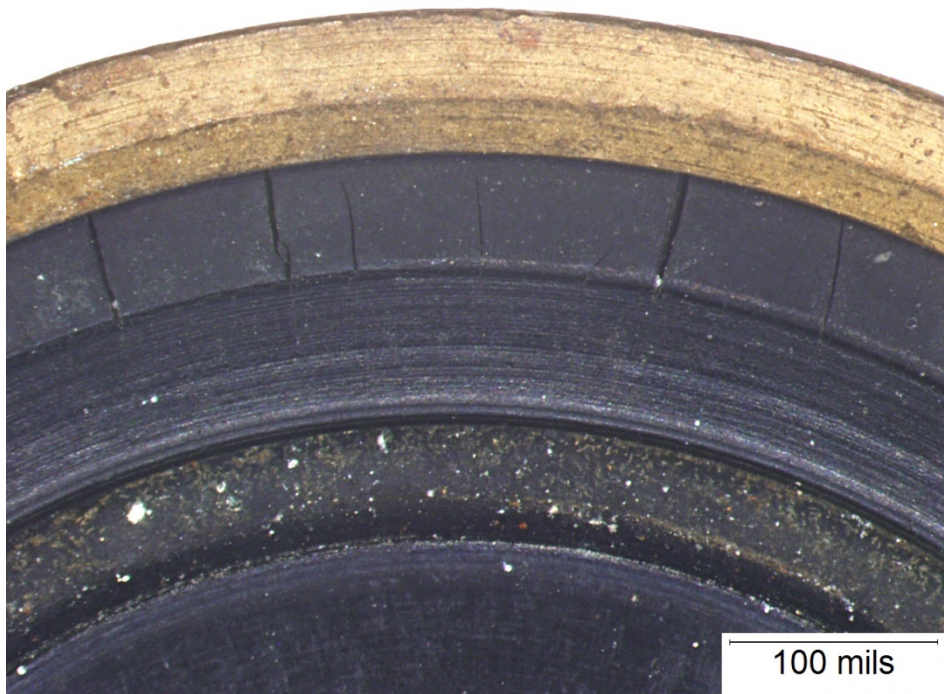
Figure 24 - Higher Magnification View of the Radial Cracks in the Gasket from PRV 407

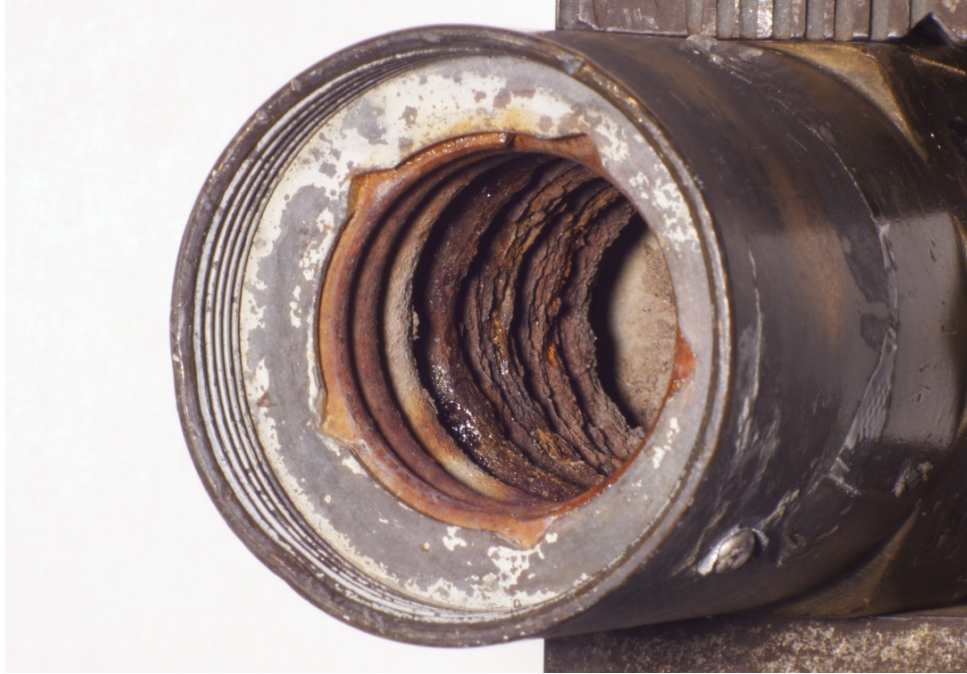
The examination of PRV 62 has conclusively shown that the internal components were so severely corroded that they were locked in place.

Figure A-1. Severe Corrosion of the Spring in PRV 62

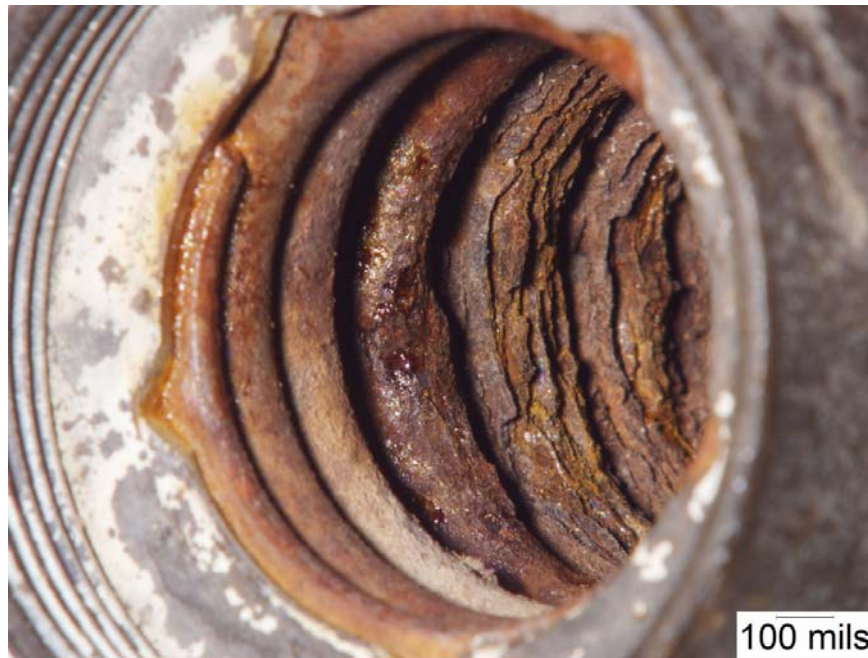
Figure A-2. Higher Magnification View of the Corrosion of the Coils in Spring in PRV 62

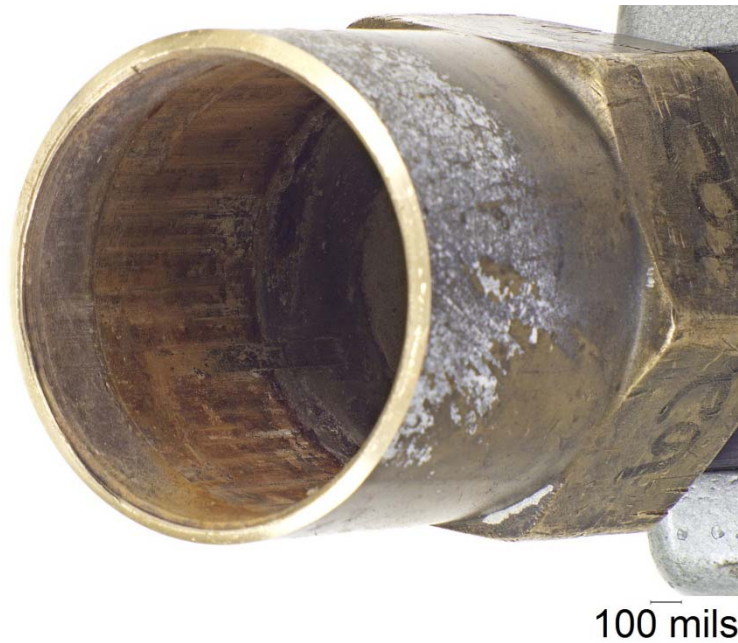
Figure A-3. Internal Surface of the Valve Body from PRV 62 after the Spring was Removed

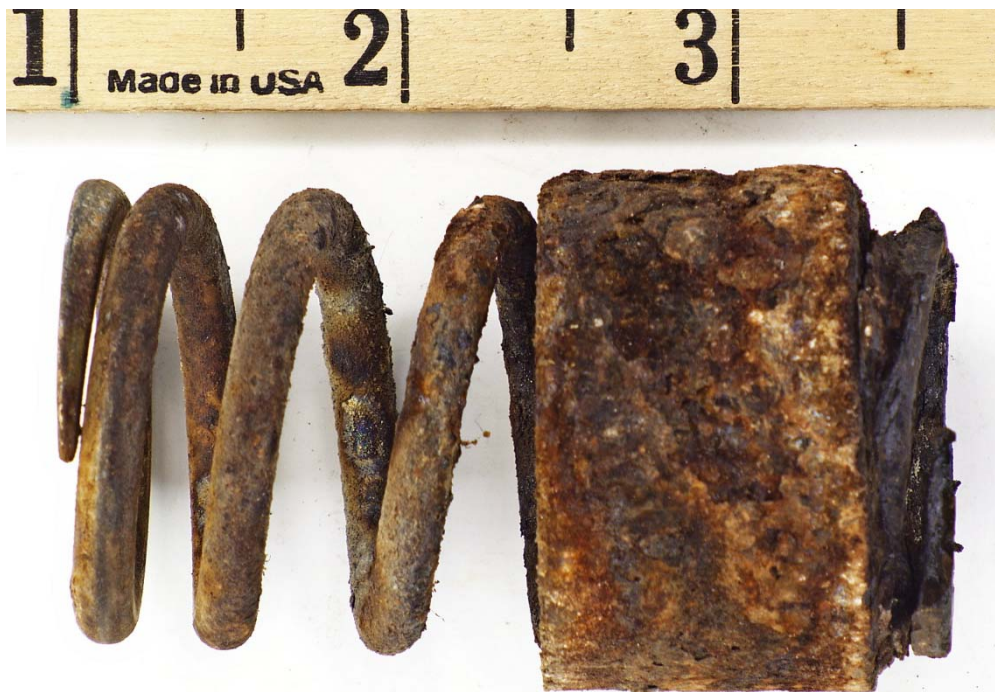
Figure A-4. Corroded Spring and Sleeve Surrounding the Spring from PRV 62

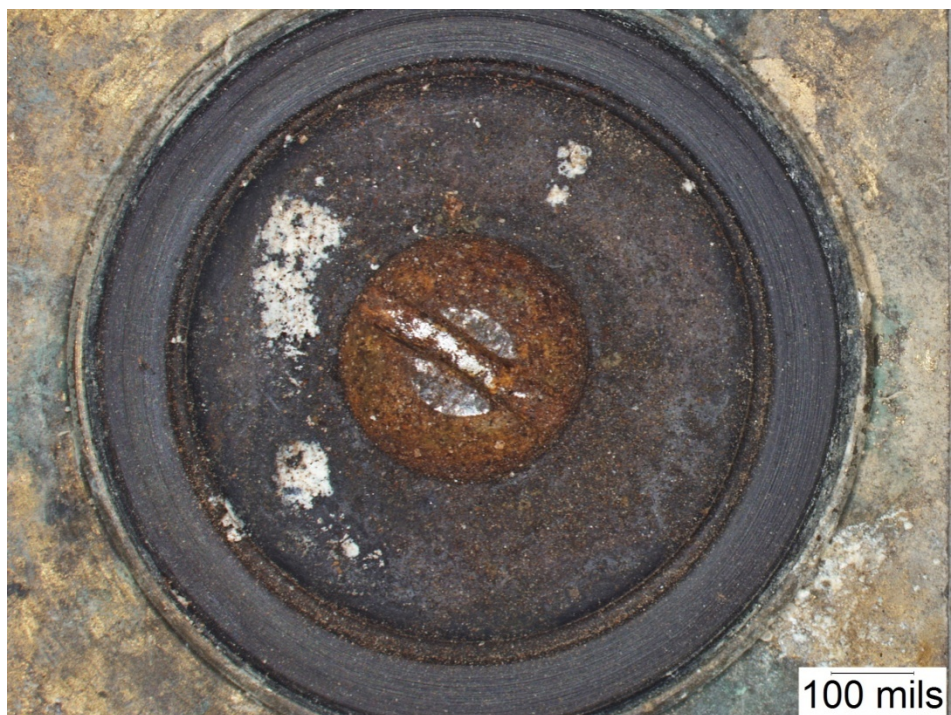
Figure A-5. Gasket Surface and Corroded Screw from PRV 62

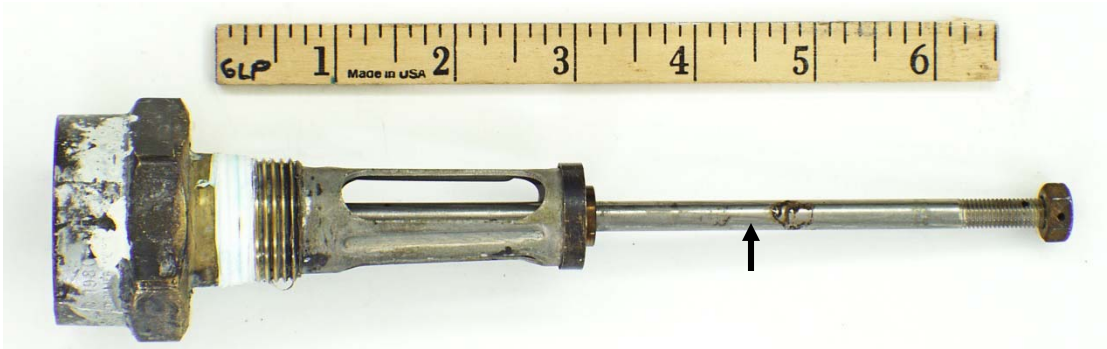
Figure A-6. PRV 173 after the Spring had been Removed Showing Discoloration of the Spacer and Corrosion on the Valve Stem (Arrow)

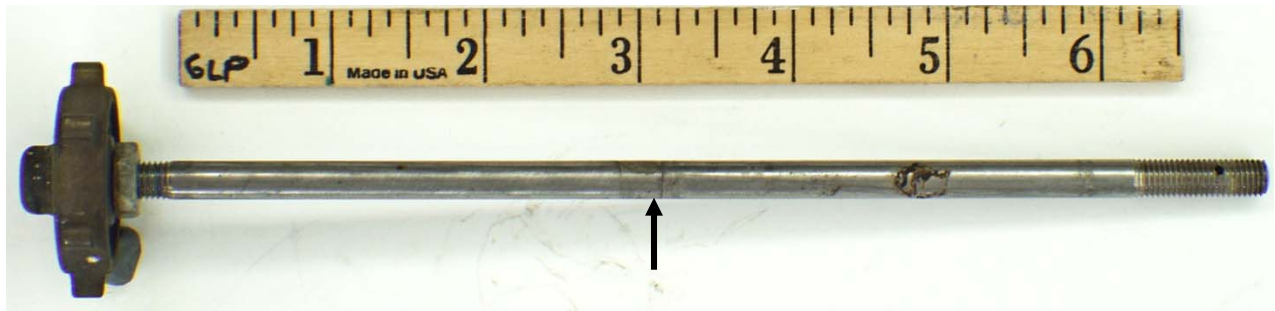
present study. However, the failure investigator believes that the interaction line may be indicative of a valve stem alignment problem with the spacer and guide washers used with this manufacturer's design.

Figure A-7. PRV 173 Valve Stem after Spacer was Removed Showing an Interaction Line and Corrosion Between the Spacer Washer and the Valve Stem

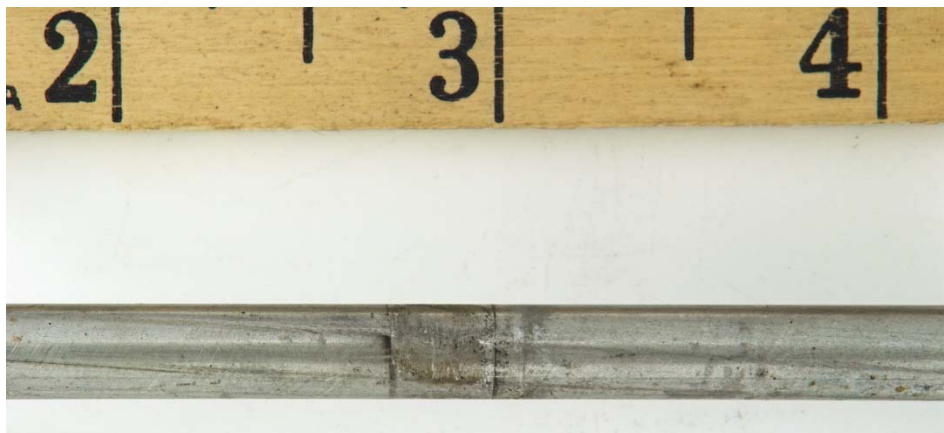
Figure A-8. Higher Magnification view of the Corrosion Interaction Line Between the Valve Stem and the Guide Washer at the Lower End of the Spacer

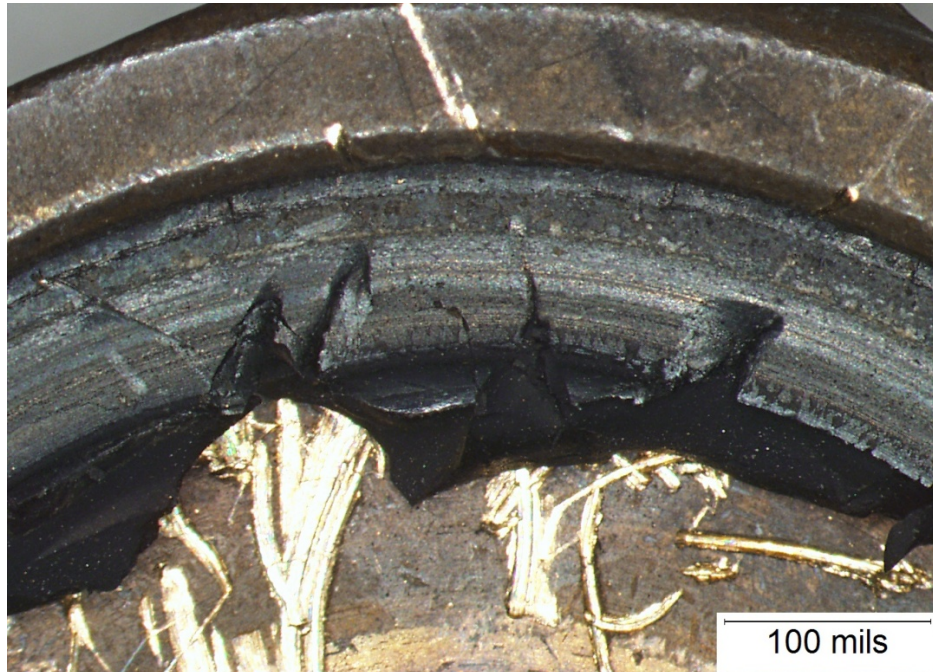
and pulled on to remove it. The portion of the gasket remaining in the holder after many small pieces tore off is shown in Figure A-9. Thus, the gasket may also have been stuck to the seat sealing surface causing the PRV to be ‘stuck’ shut in the original test program and to open at a high start-to-discharge pressure when retested under the ‘real world’ test conditions.

Figure A-9. Portion of the Gasket Stuck in the Seat Holder from PRV 173. This gasket contained radial cracks in the outer circumferential ring and it broke into many small pieces when it was pulled to remove it from the holder

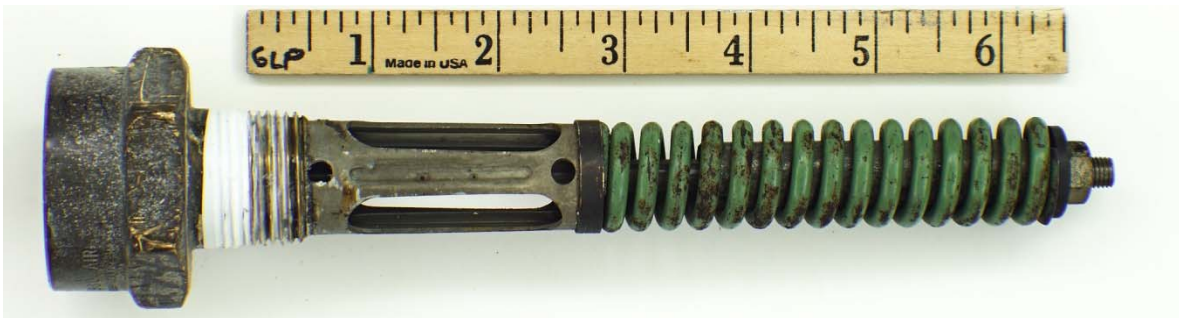
Figure A-10. PRV 274 Did Not Open when Tested during the Initial Study but Opened at 328 psig when Retested During the Present Study

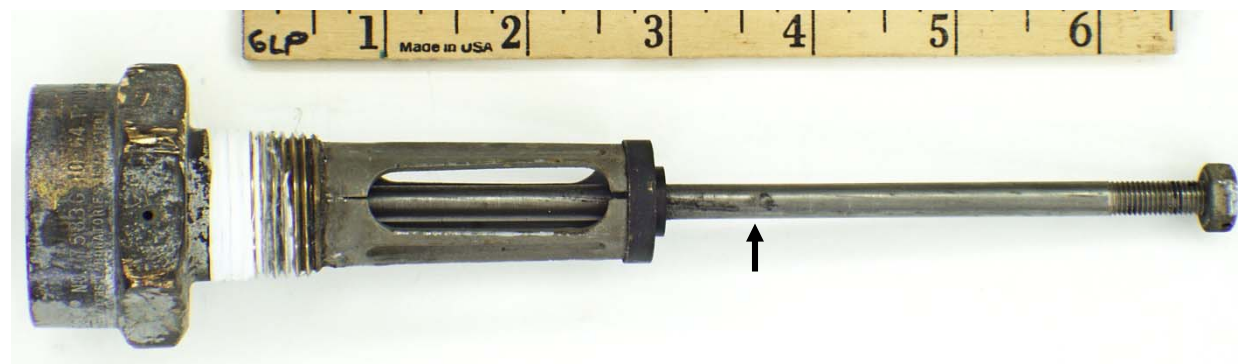
Figure A-11. PRV 274 after the Spring was Removed Showing Corrosion on the Valve Stem Below the Spacer (Arrow)

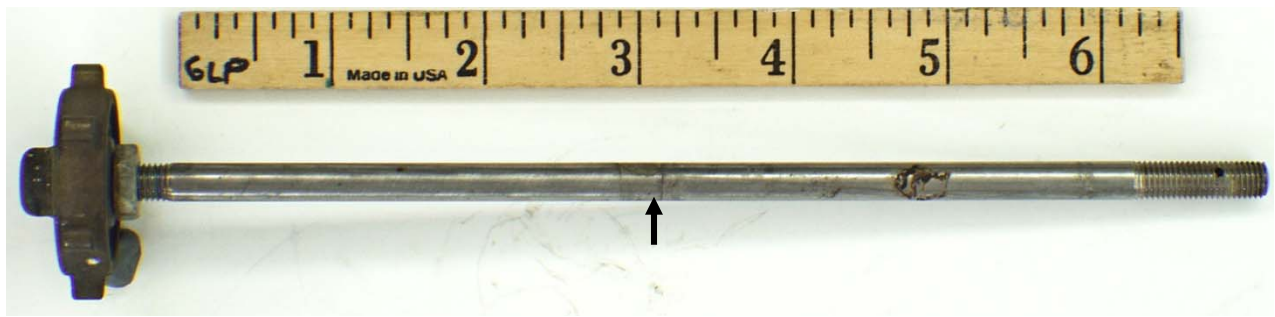
The investigator believes that the interaction region between the guide washer and the valve stem is indicative of possible mis-alignment issues with this PRV design.

Figure A-12. Valve Stem from PRV 274 Showing Corrosion/Interaction Region between the Guide Washer and the Valve Stem (Arrow)

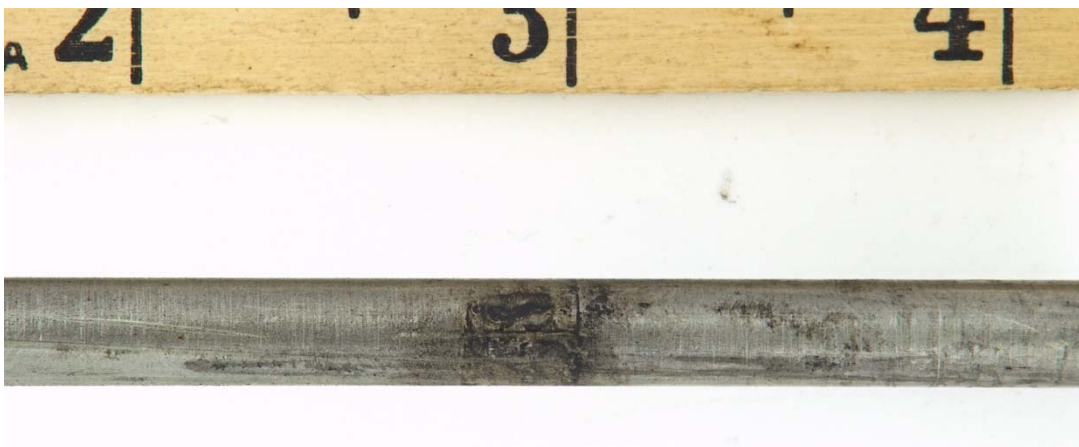
Figure A-13. Higher Magnification View of the Corrosion/Interaction Region between the Valve Stem and the Guide Washer from PRV 274

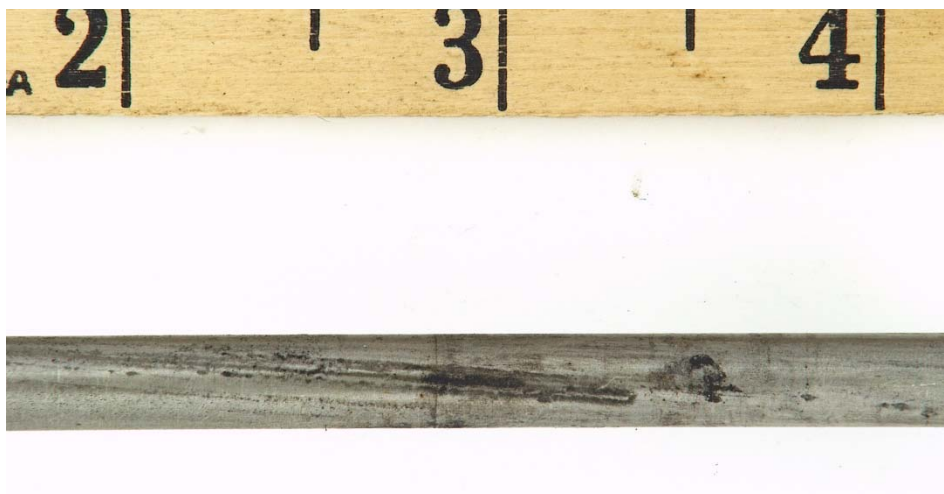
Figure A-14. Region of Interaction between the Valve Stem and the Guide Washer 180 Degrees from the Region Shown in Figure A-13, PRV 274

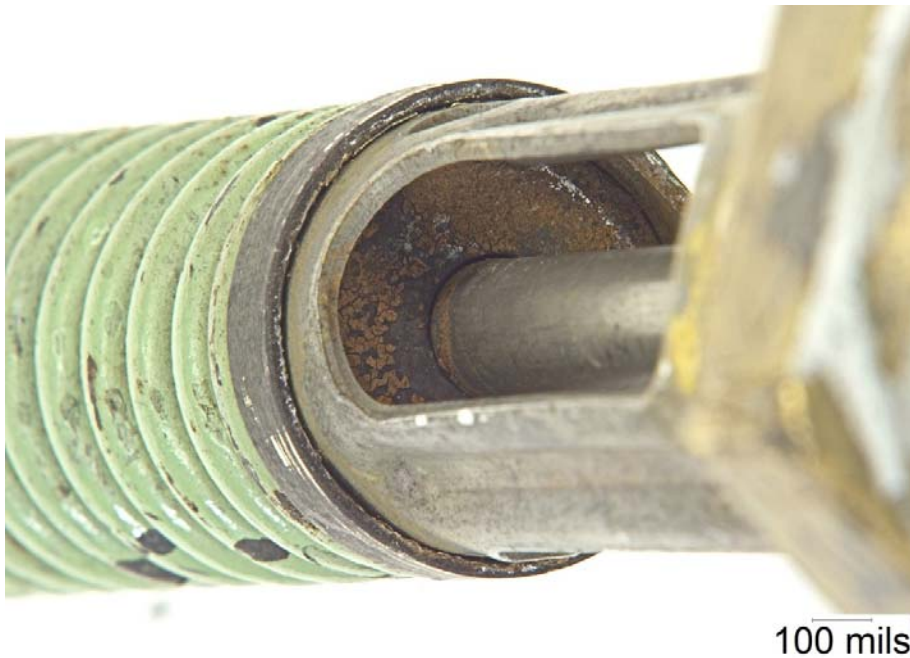
Figure A-17. Corrosion on the Top Surface of the Guide Washer and the Valve Stem at the Lower End of the Spacer in PRV 326

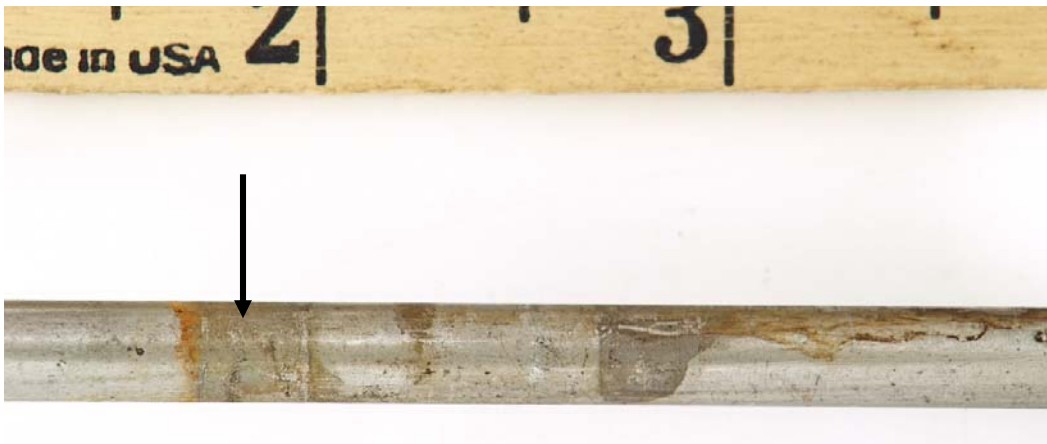
washer at the lower end of the spacer. That region is similar to the regions shown on the valve stems of PRV 173 and PRV 274. In addition, Figure A-19 also shows another region of corrosion on the valve stem below the corrosion/interaction region. This corrosion most likely contributed to the behavior of this PRV during testing. In addition, the gasket from the PRV was brittle and broke into many pieces when pulled from the valve with pieces remaining stuck in the disc holder. It appeared similar to the gasket in PRV 173 shown previously in Figure A-9.

Figure A-19. Corrosion/Interaction Line on the Valve Stem at the Location of the Guide Washer (Arrow) and Additional Corrosion on the Valve Stem Below That Region

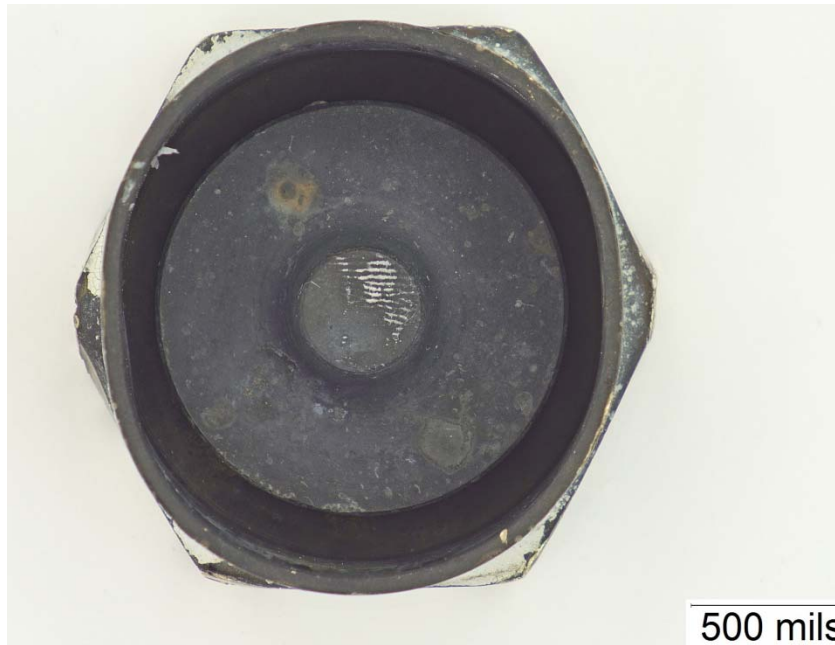
Figure A-21. Distorted Valve Body from PRV 350. Note the significant discoloration of the internal surfaces of the valve body and also the seat disc holder.

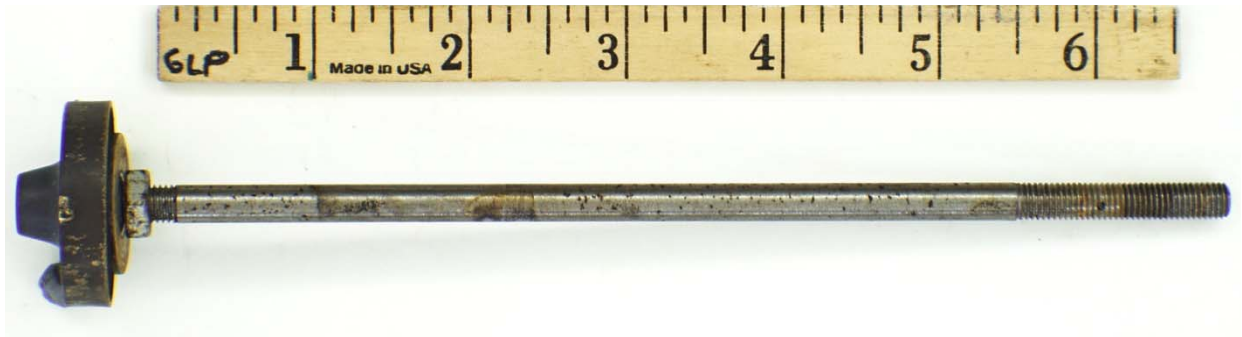
Figure A-22. Corrosion on the Surface of the Valve Stem from PRV 350

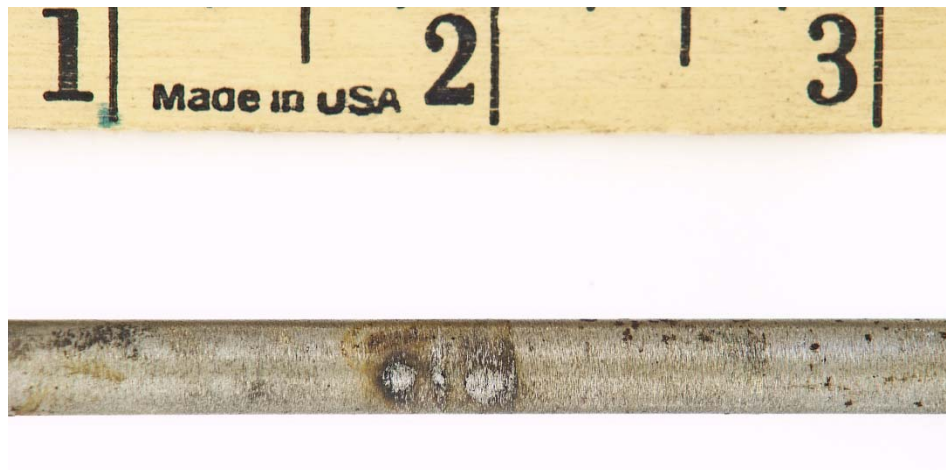
Figure A-23. Higher Magnification View of Some of the Corrosion on the Valve Stem from PRV 350

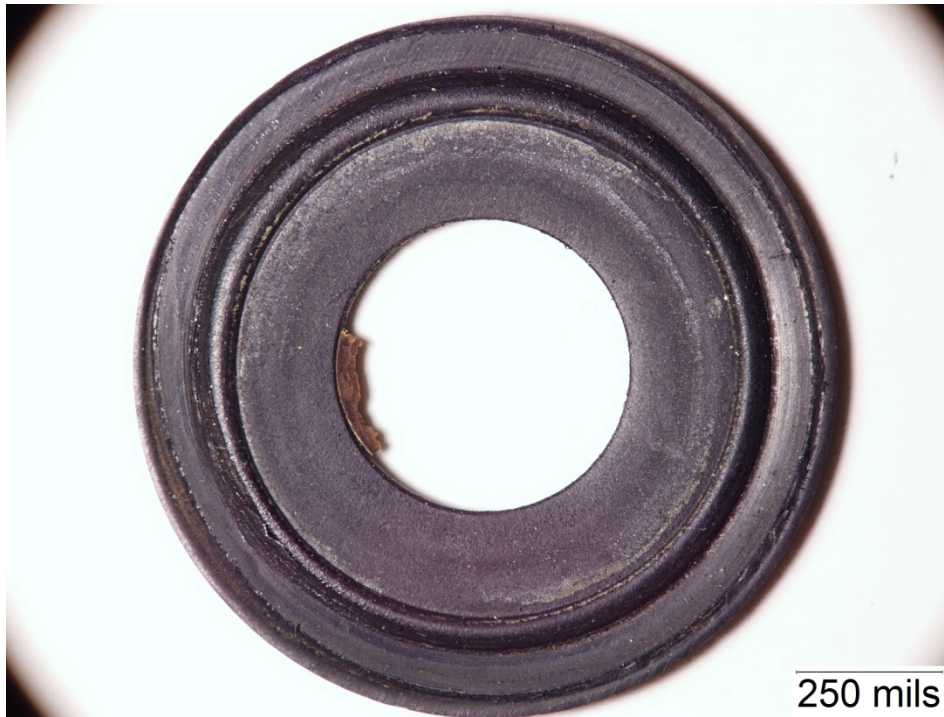
Figure A-24. Sealing Surface of the Gasket from PRV 350 Showing That the Compression Set Lines Were Somewhat Off Center Indicating Possible Alignment Problems

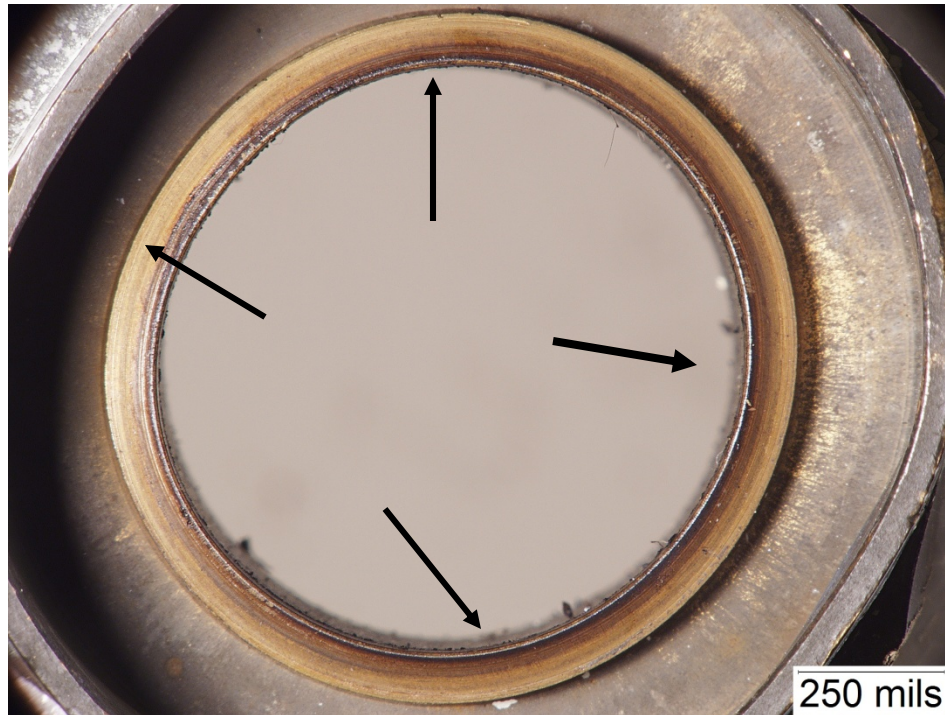
problems. Figure A-25 shows a region of pullout of the gasket material from the surface of the gasket and Figure A-26 shows staining and gasket material transfer to and from the gasket to the valve body surface of PRV 350. Thus, this analysis suggests three factors that likely contributed to the did not open and high-start-to-discharge conditions of PRV 350 during the pressure testing conducted during the initial study and the present study, respectively. Those conditions were: (1) corrosion of the valve stem and the guide spacer; (2) sticking of the gasket to the valve body sealing surface, and (3) possible misalignment of the valve that caused binding between it and the spacer guide.

Figure A-26. Stains from the Gasket and Region of Gasket Material Transfer onto the Valve Body Sealing Surface of PRV 350

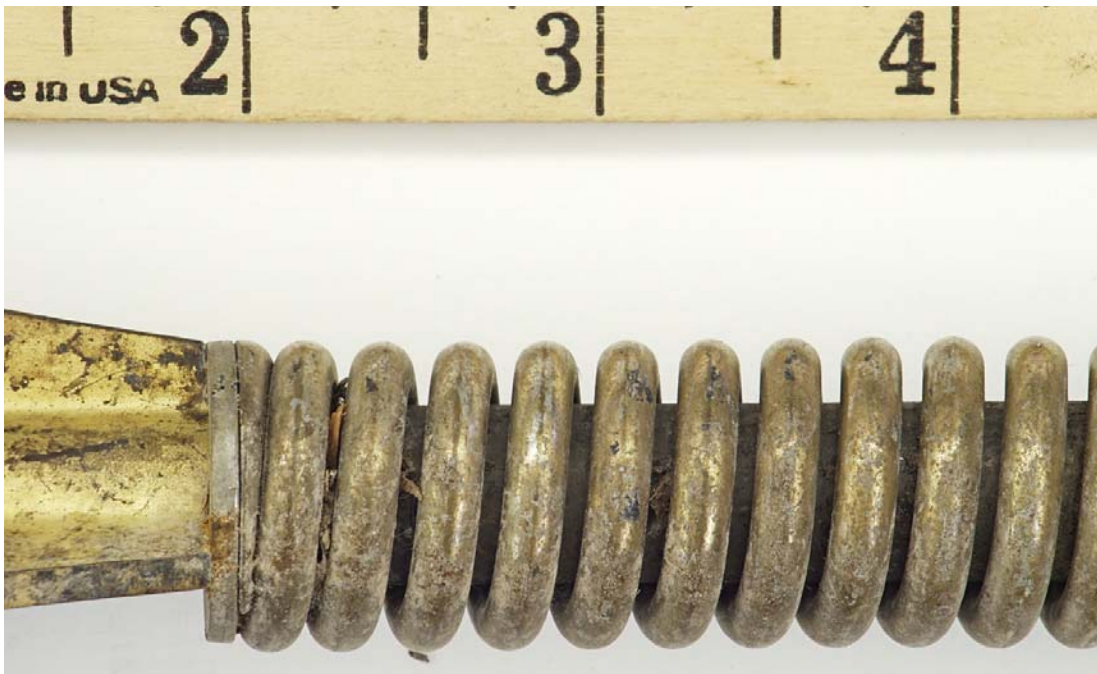
Figure A-28. White Residue on the Spring Coil Surfaces and Debris Inside the Spring

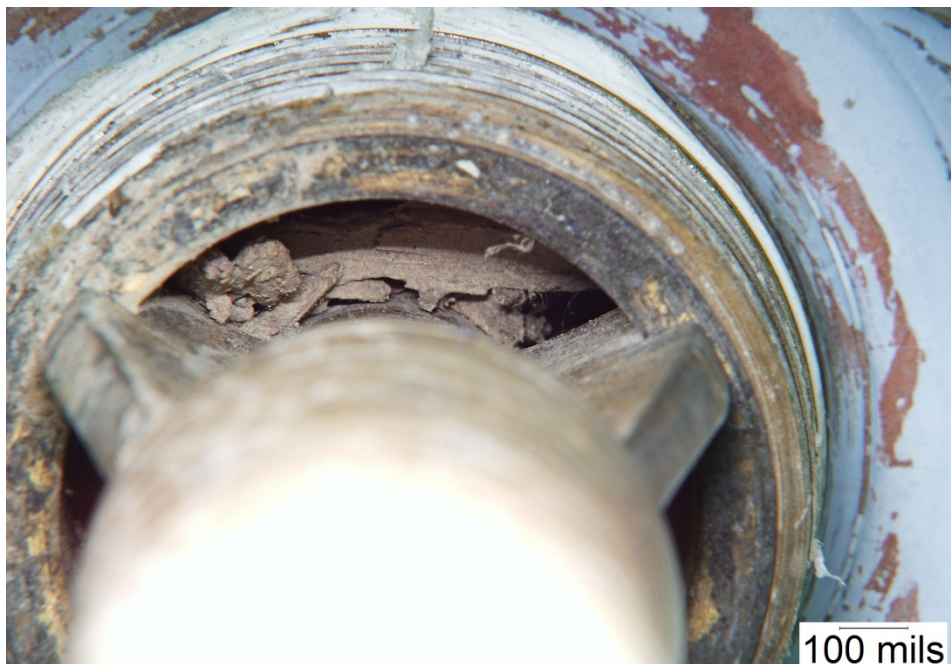
Figure A-30. Debris in the Valve Body Below the Sealing Surface

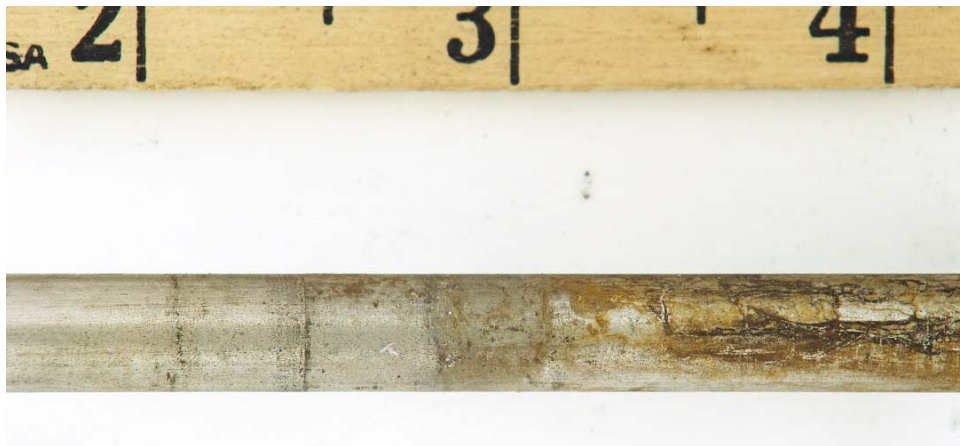
Figure A-32. Higher Magnification View of the Corrosion and Interaction Region on the Valve Stem from PRV 102. *The interaction region is where the valve stem contacts the inner surface of the guide spacer.*

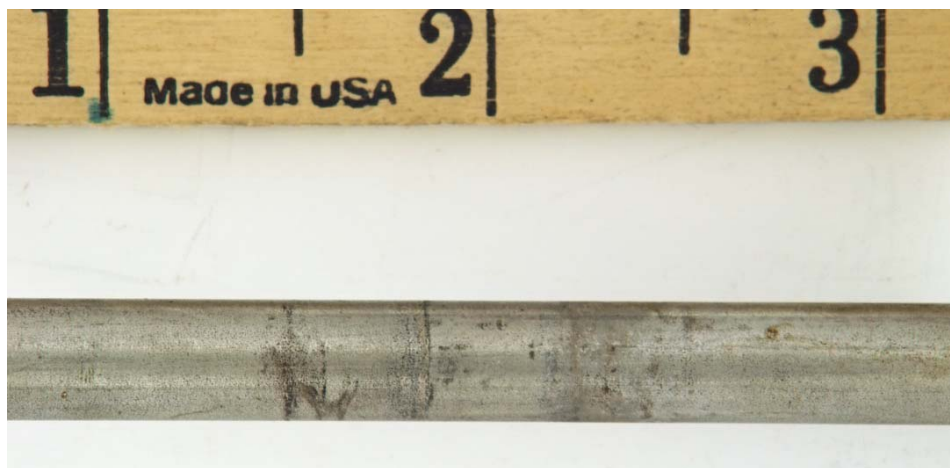
Figure A-33. Corrosion/Interaction Marks on the Surface of the Valve Stem from PRV 102. *This region was 180 degrees from the area shown in Figure A-30.*
