ADDENDUM TO THE FINAL REPORT ON:

TESTING AND ANALYSIS OF THE PERFORMANCE OF PRESSURE RELIEF VALVES FOR CUSTOMER TANKS

Battelle Project N007245
PERC Docket 15203

April 2011

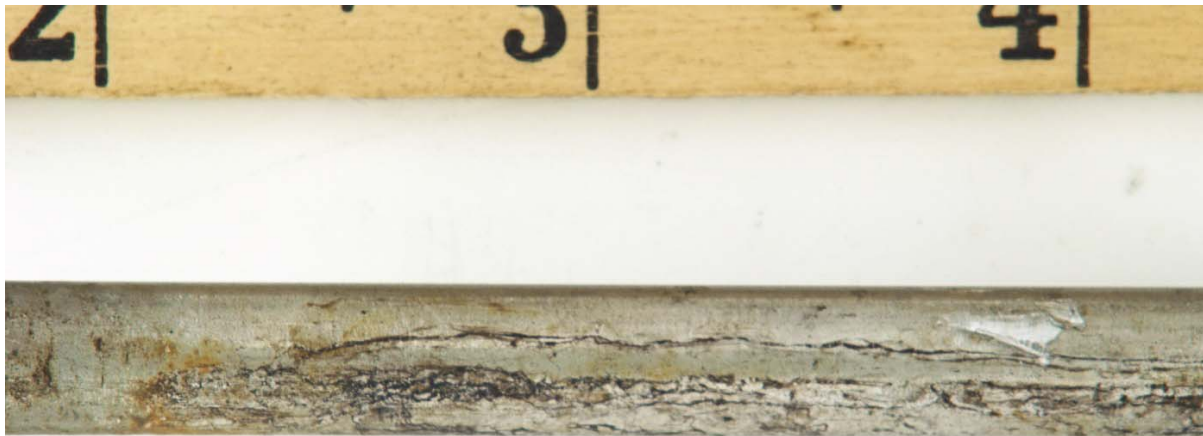
Figure A-34. Higher Magnification View of Another Region of corrosion on the surface of the Valve Stem from PRV 102

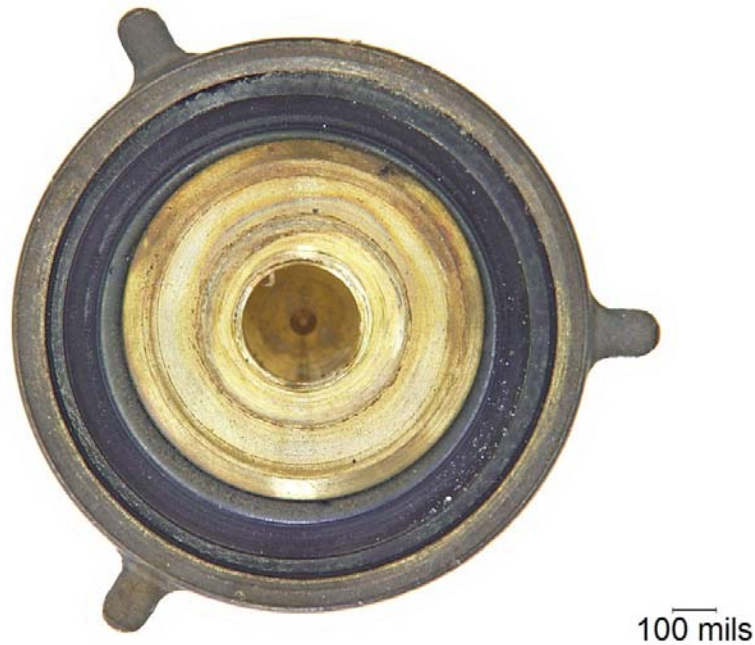
Figure A-36. Gasket from PRV 279 Showing that the Circumferential Set Rings were Somewhat Off-Center

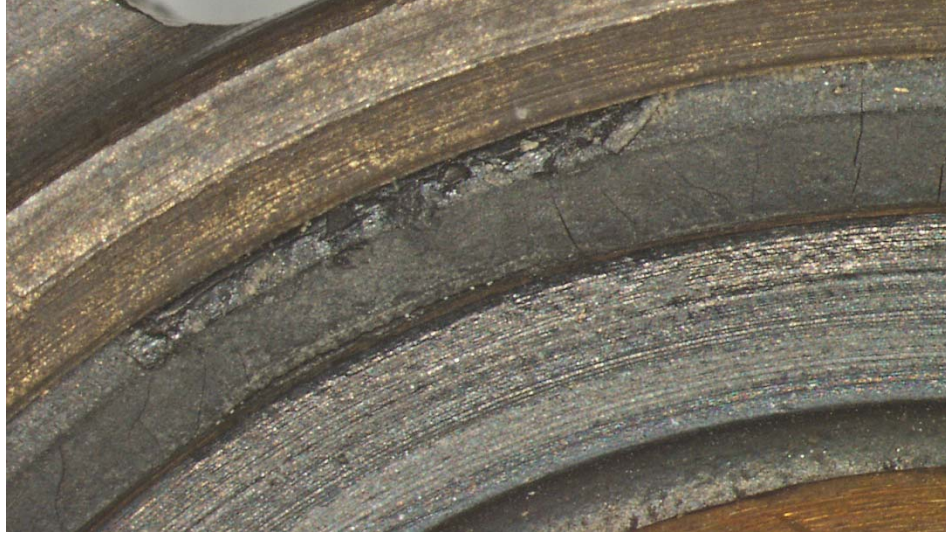
Figure A-37. Radial Cracks and Material Missing from the Outer Circumference of the Gasket from PRV 279

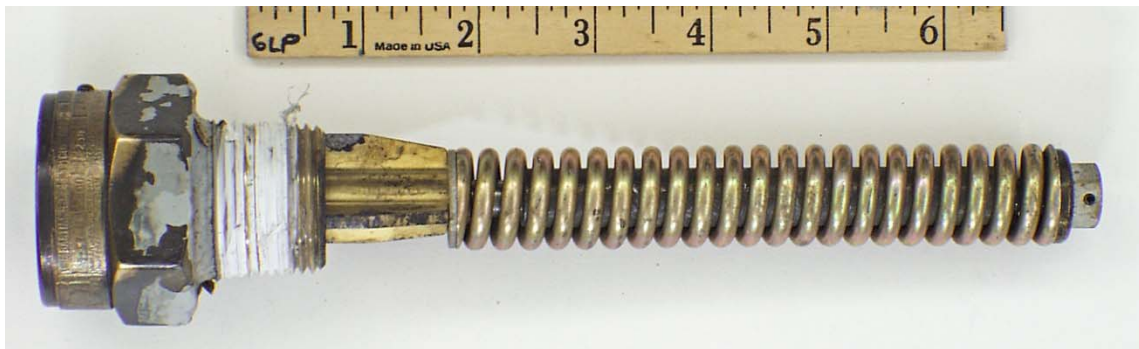
Figure A-40. PRV 250, Did Not Open During Initial Performance Testing Program

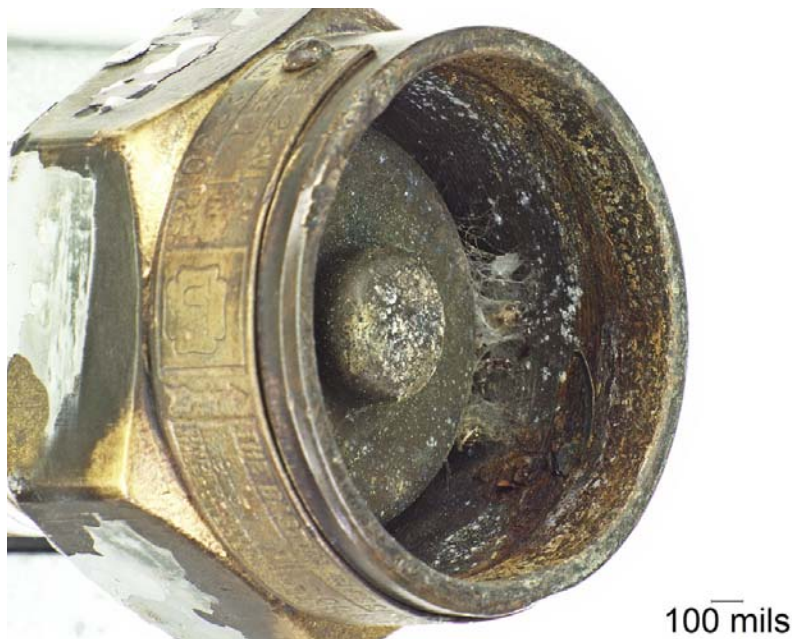
Figure A-41. Corrosion and Cobwebs in the Valve Body of PRV 250

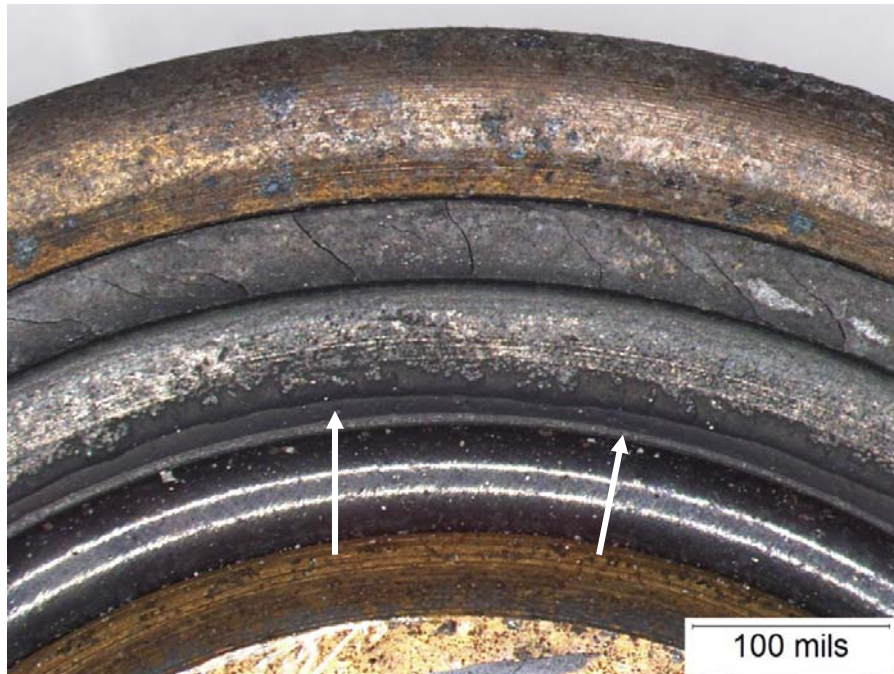
Figure A-43. Material Pulled Out of the Surface of the Sealing Region (Arrows) and Cracks in the Outer Circumferential Ring of the Gasket from PRV 250

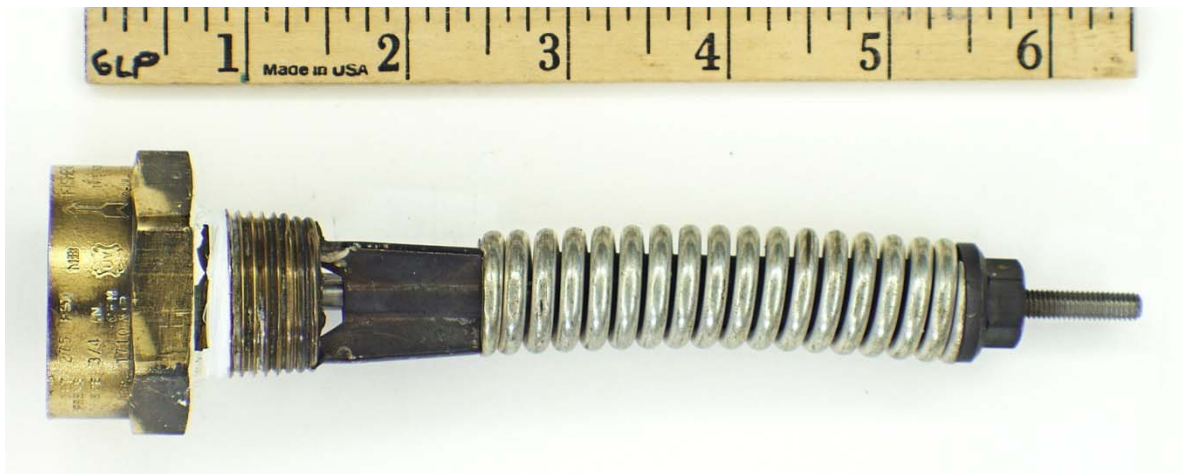
Figure A-44. PRV 5. Note the Absence of a Washer between the Guide Spacer and the Spring and the Bow in the Spring.

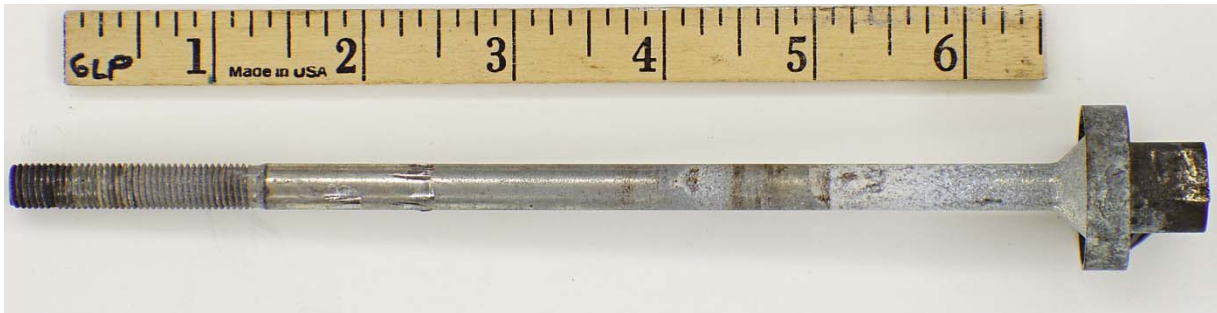
Figure A-46. White Corrosion Products, Rust, and an Interaction Band on the Surface of the Valve Stem from PRV 398

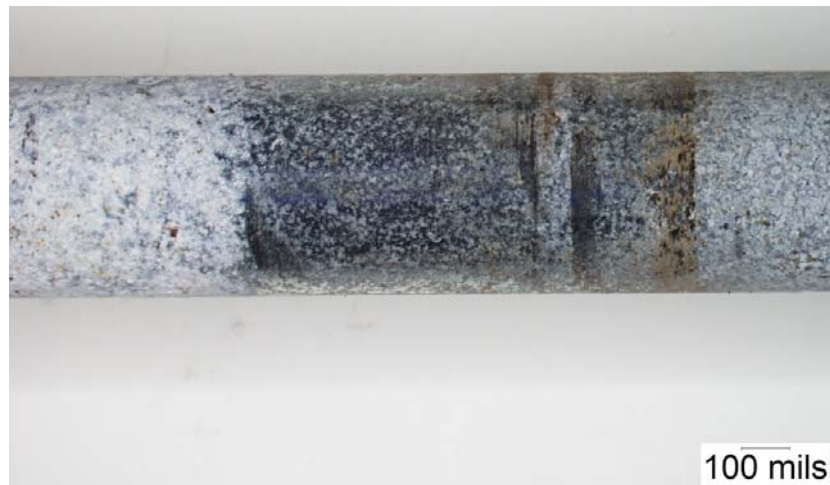
Figure A-47. Higher Magnification View of the Corrosion Products and Interaction Band on the Surface of the Valve Stem from PRV 398

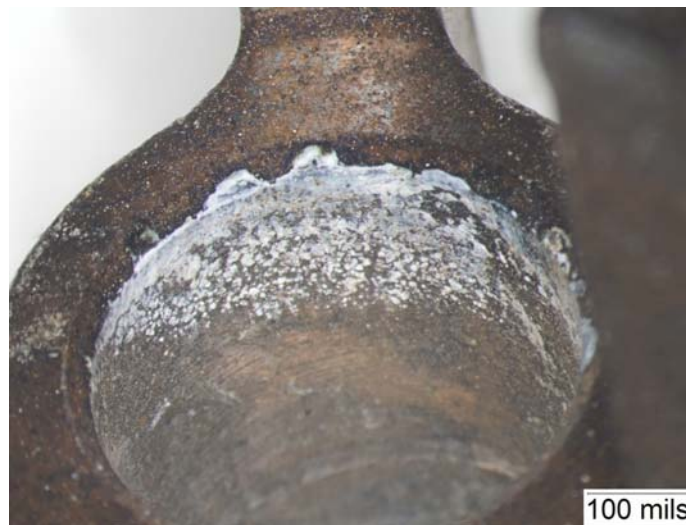
Figure A-48. White Corrosion Products on the Inner Surface of the Guide Spacer and General Oxidation of the Guide Spacer Surfaces from PRV 398

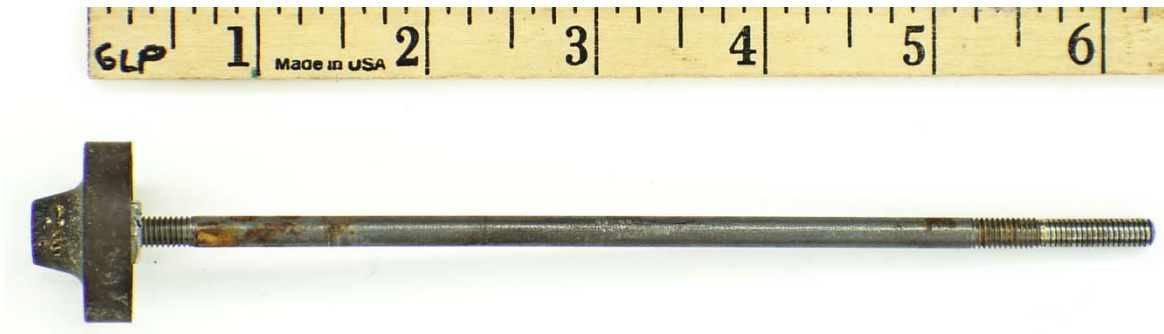
Figure A-58. Corrosion on the Surface of the Valve Stem from PRV 19

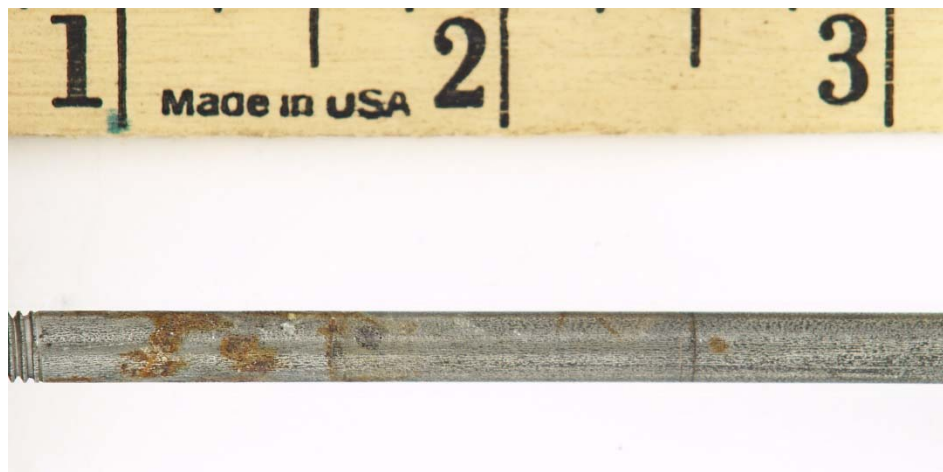
Figure A-59. Higher Magnification View of the Corrosion and an Interaction Line on the Surface of the Valve Stem from PRV 19
