# **TESTING AND ANALYSIS OF THE PERFORMANCE OF PRESSURE RELIEF VALVES FOR CUSTOMER TANKS**

## **Volume I – Main Report**

Battelle Project N007245  
PERC Docket 15203

April 2011

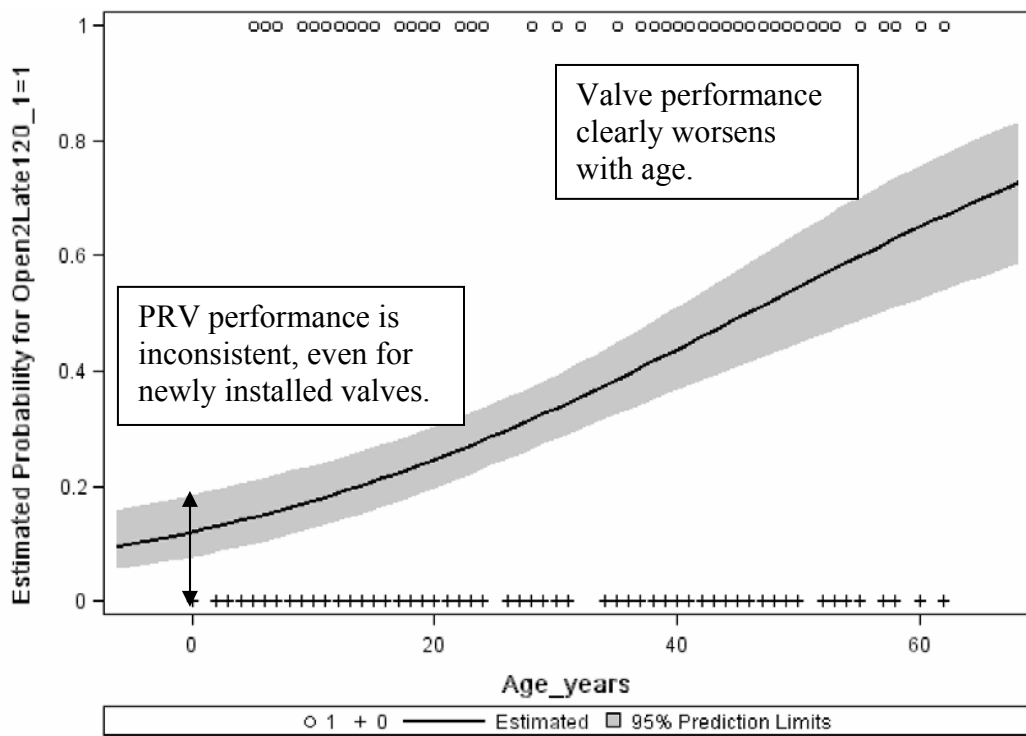
PRVs that discharged late (>120 percent of the set pressure) were also considered to have inadequate performance. As shown in Figure ES-5, the probability for a PRV to discharge above this limit increased significantly for older PRVs with as high as an 80 percent probability for valves older than 40 years of age to discharge late. Often, for the older PRVs or those that have been sitting for some time unpressurized, the start-to-discharge pressure for the first trial can be significantly higher than the subsequent trials indicating that the relief valve seat was stuck in place. The sticking of the PRV on older units was observed in two previous projects, one on cylinder relief valves<sup>1</sup> and one evaluating the relief device on propane regulators<sup>2</sup> as well as in this project. In most cases, once the pressure is high enough to overcome the adhesion force, the

**Figure ES-5. Tendency for 250-psi set point PRV to open too late (>120% of set pressure) vs. age (years)**

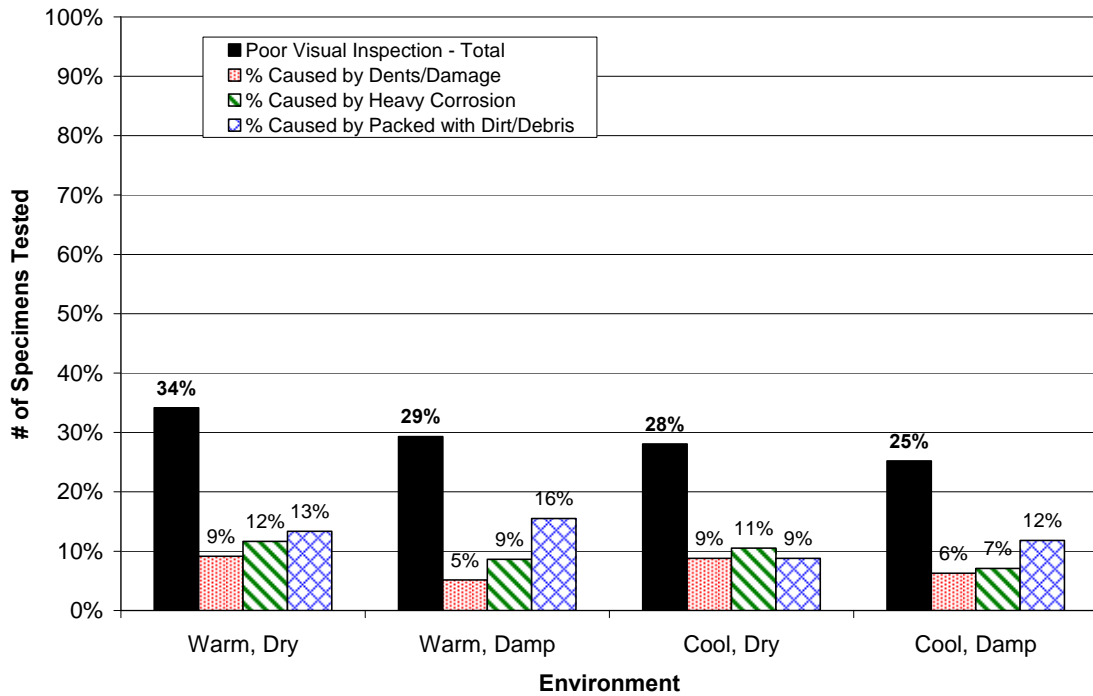
**Figure 25. Comparison of the percentage of PRVs collected from each source environment which performed poorly in the visual inspection for all causes and percentages by cause.**

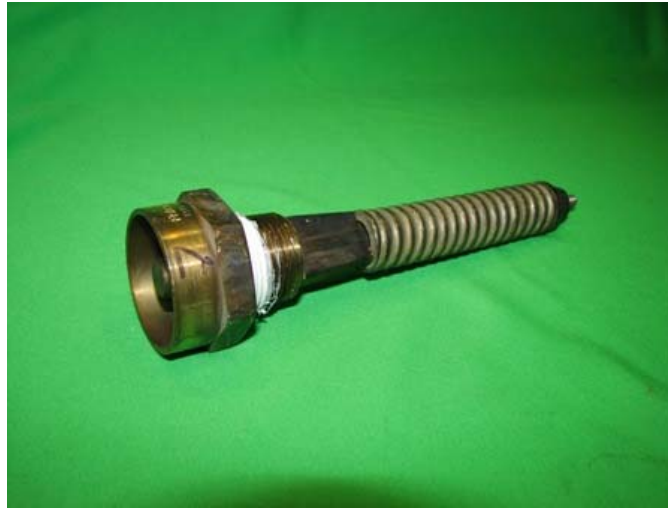
Figure C-1 - PRV 7

PRV 7 is a ¾-inch internal PRV, 21 years of age. This PRV was installed on a 172 gallon above ground tank. The PRV was from a warm and dry source environment with an initial start-to-discharge pressure of 275-psig. During pressure testing it failed to open by 375 psig. PRV 7 is shown in Figure C-1.

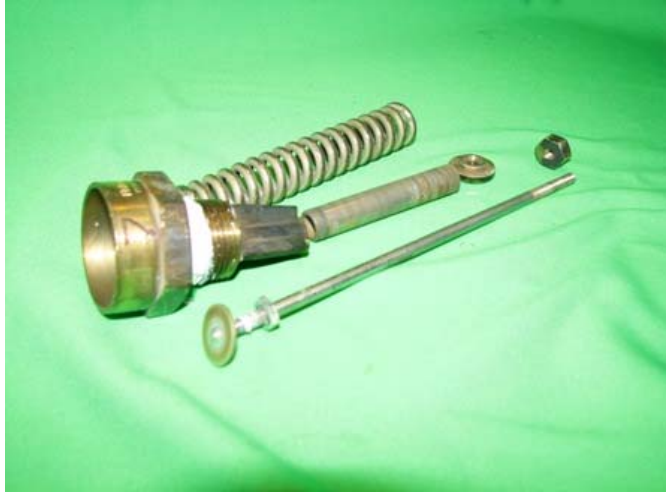
This PRV did not have a locking nut mechanism to prevent tampering of the set pressure. The nut was easy to turn and remove. As the nut came off there was some compression still on spring. The spring appeared to be in good working condition without any noticeable defects. After disassembly, the gasket (seat disc) /rod assembly was stuck to PRV body. Moderate force was required to separate the assembly (recall that this PRV failed to open at 375 psig). See Figure C-2

**Figure C-2 – PRV 7 Disassembled**

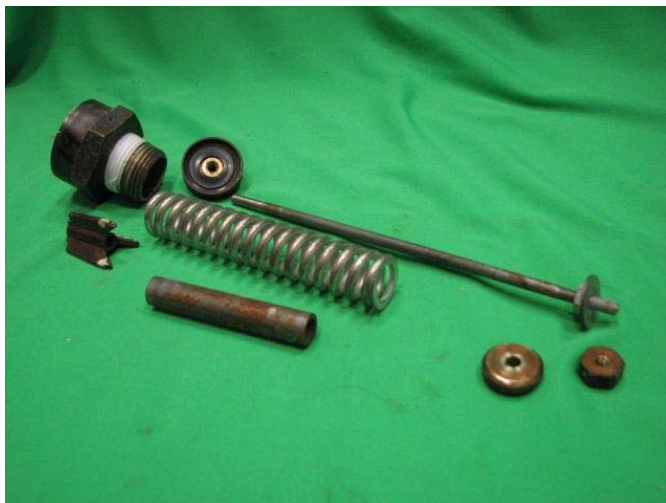
This PRV used a single pin to prevent tampering with set pressure. Disassembly and changing set pressure was easily accomplished. The single nut/with pin provided little safety against tampering. The spring showed slight surface corrosion but seem to be in good mechanical condition (see Figure C-8). During disassembly, the 3 point spring spacer came loose from PRV body. The exposed surfaces on the top of the valve had reflective speckles as shown in Figure C-9. The speckles are likely silver paint. Most of the metal components showed some type of corrosion, however all parts appeared to be in good working condition.

**Figure C-7 - PRV 19 Disassembled**

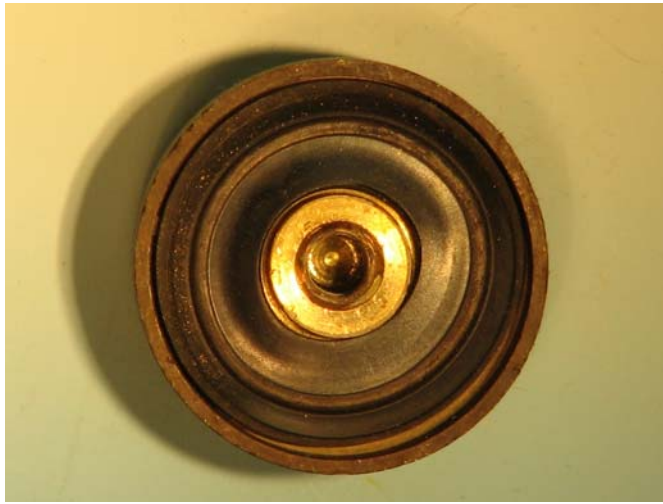
**Figure C-10 –PRV 19 Gasket (seat disc)**

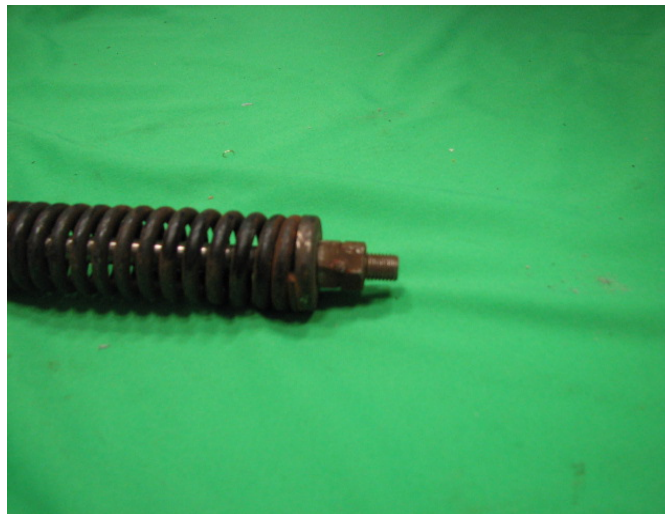
Figure C-12 -PRV 41 Lock Nuts

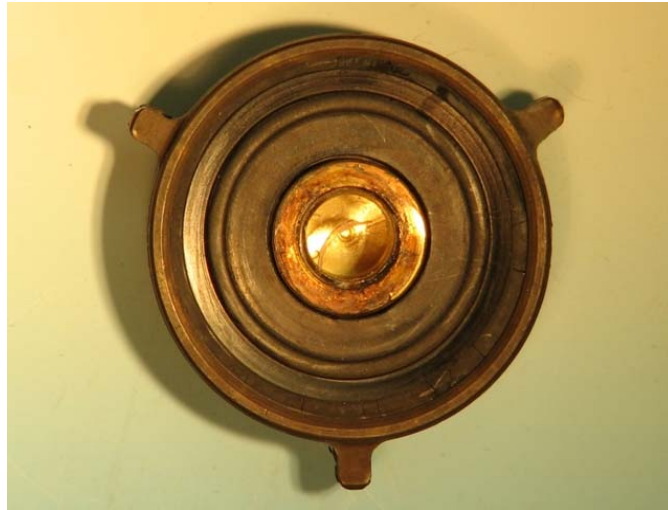
**Figure C-13 - PRV 41 Gasket (seat disc)**

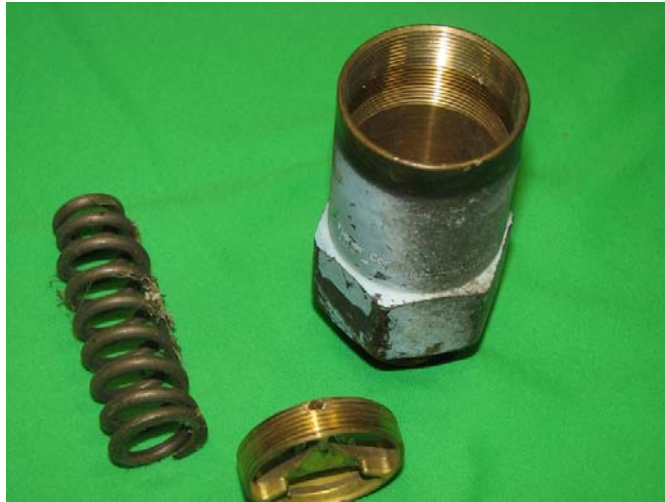
**Figure C-14 - PRV 75 with Nut and Spring Removed**

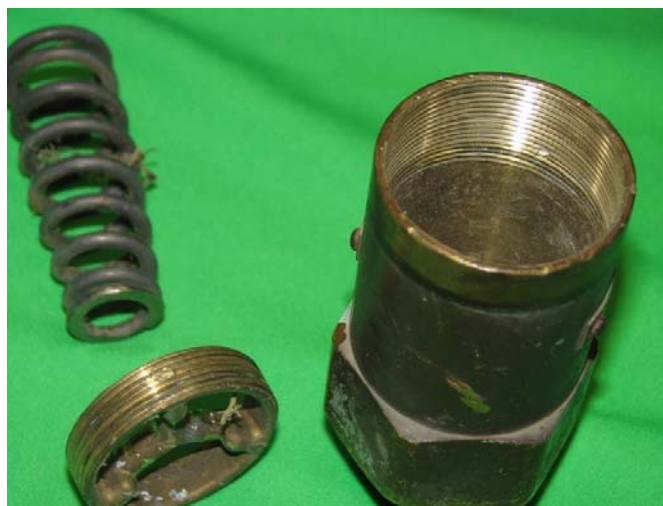
**Figure C-19 - PRV 80 with Spring Removed**

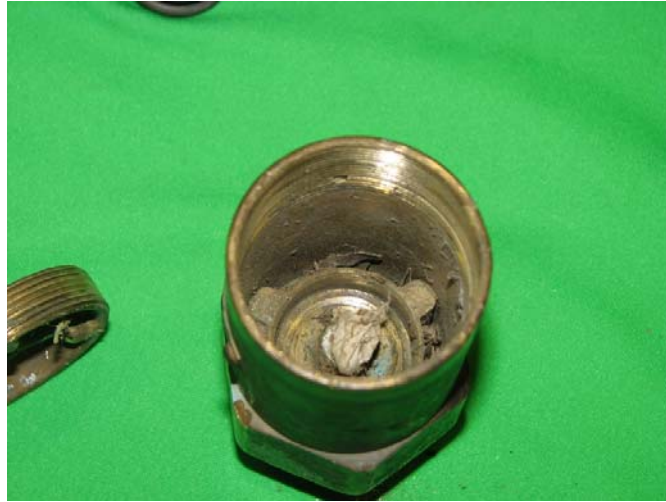
**Figure C-20 - Debris inside PRV 80 After Spring Removal**

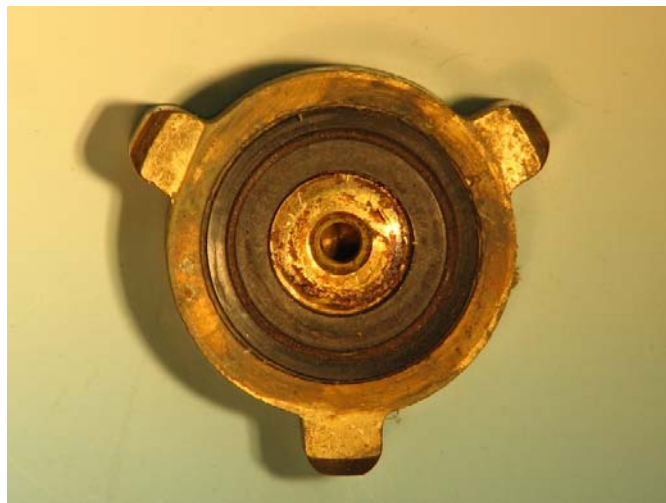
**Figure C-21 - PRV 80 Gasket**

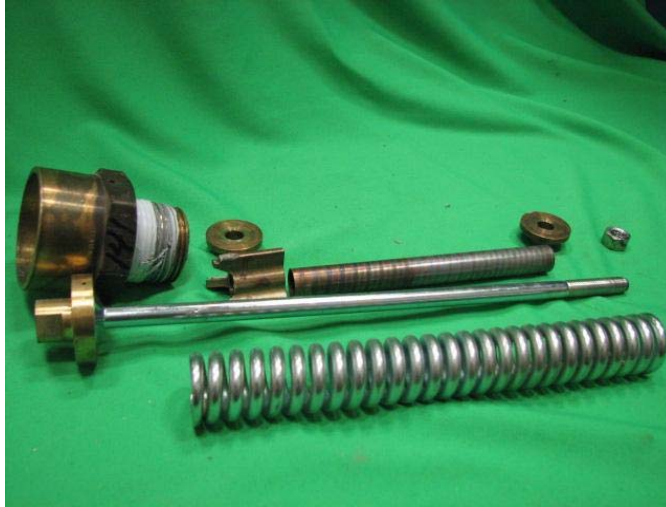
**Figure C-23 - PRV 141 Disassembled**

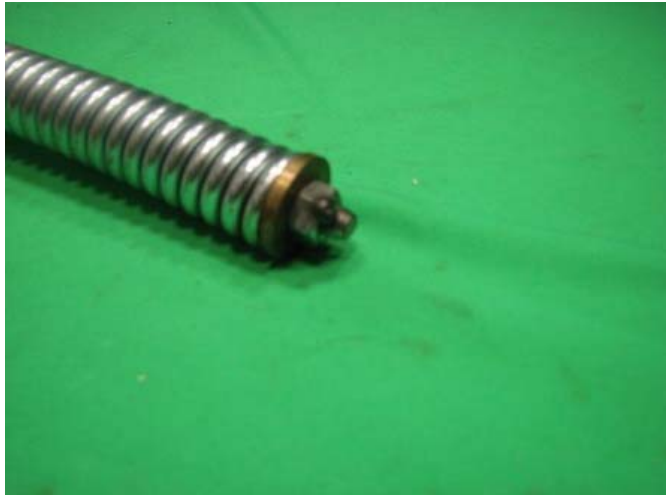
**Figure C-24 – PRV 141 Spring and Lock Nut**

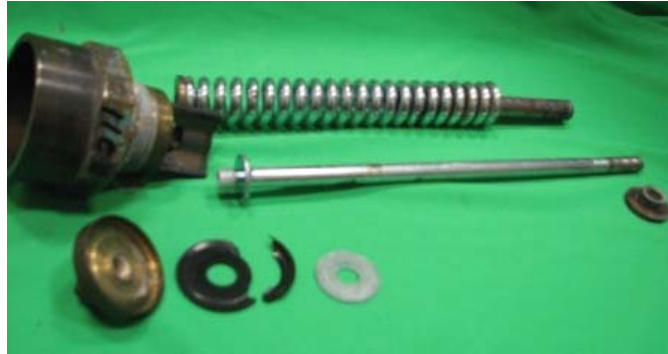
**Figure C-28 - PRV 211 Disassembled**

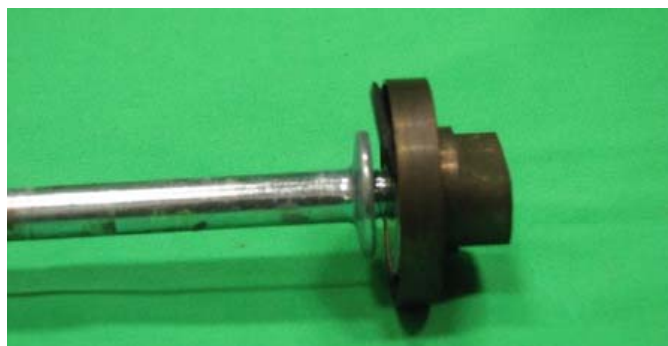
**Figure C-30 - PRV 211 Gasket (Still Assembled), Side View**

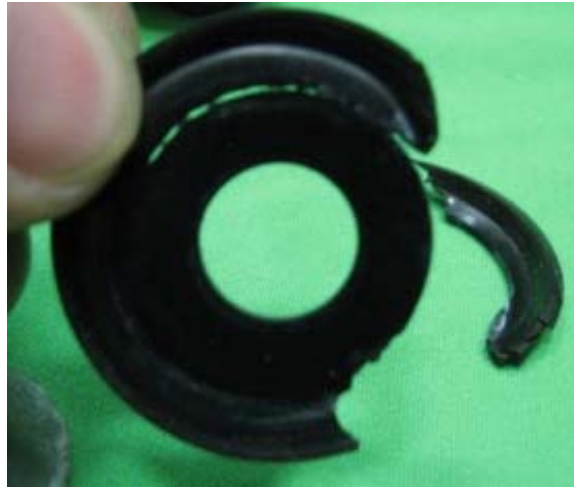
**Figure C-31 – Cracked Gasket from PRV 211**

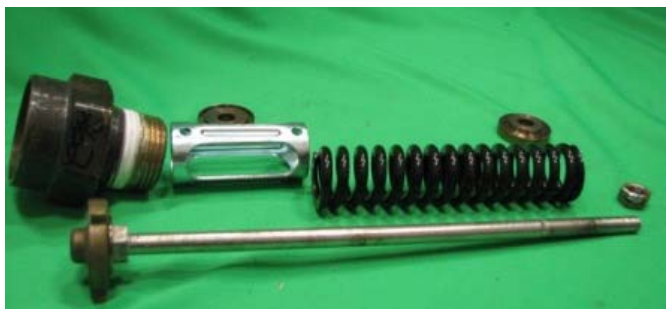
**Figure C-33 - PRV 262 Disassembled**

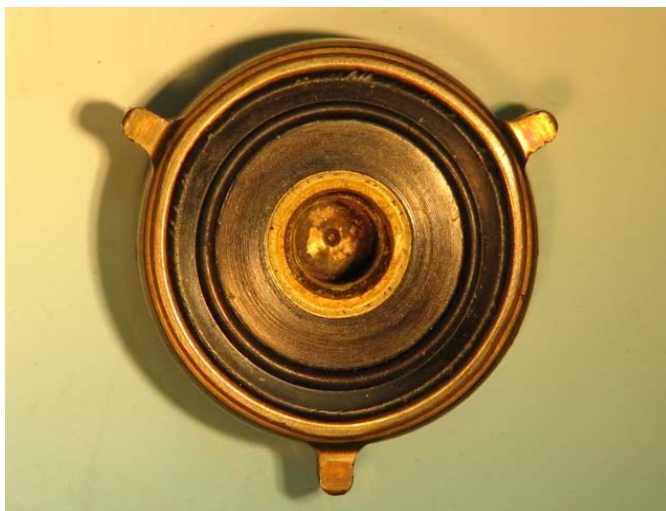
**Figure C-35 - PRV 262 Gasket**

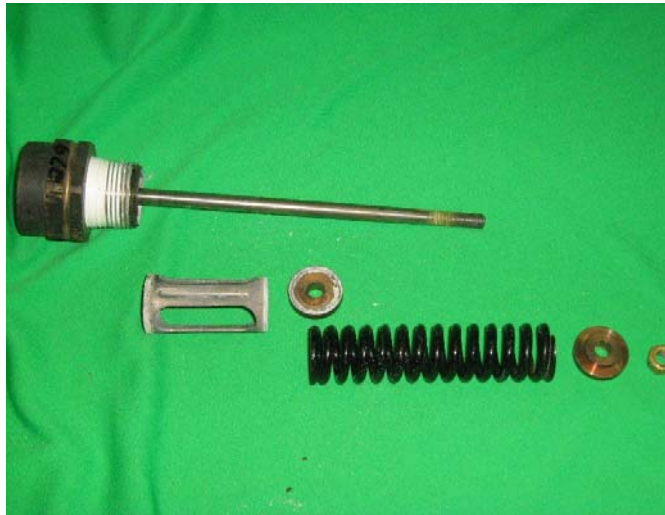
**Figure C-36 - PRV 279 Components**

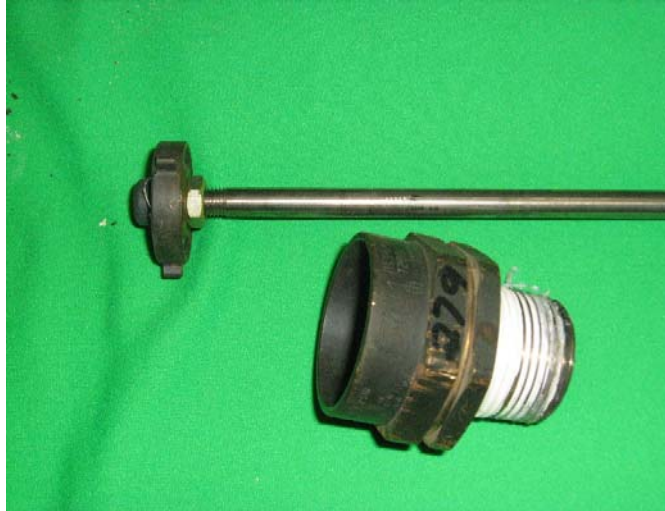
**Figure C-37 - PRV 279 Stem and Body**

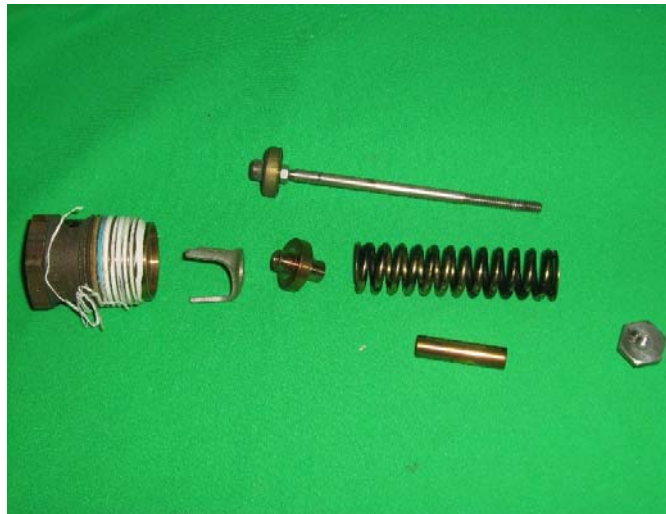
**Figure C-39 - PRV 281 Disassembled**

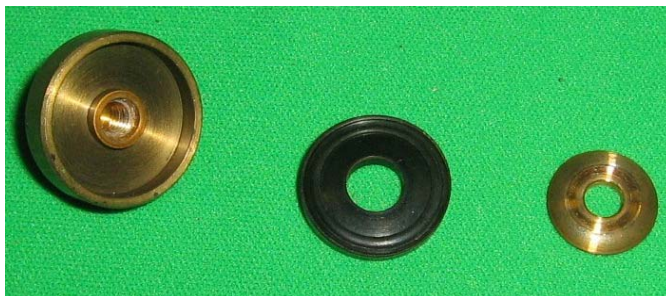
**Figure C-40 - PRV 281 Gasket and Holder**

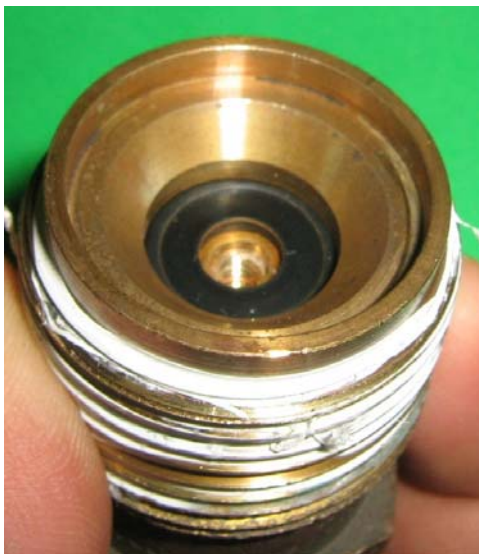
**Figure C-42 - PRV 281 Gasket as Installed**

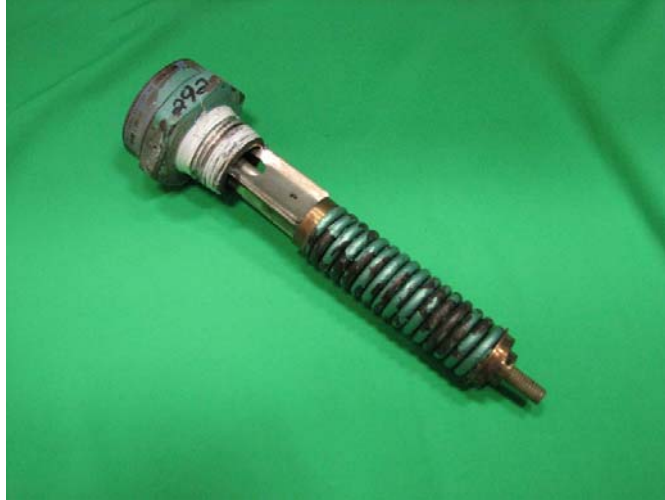
**Figure C-44 - PRV 292 Fully Assembled**

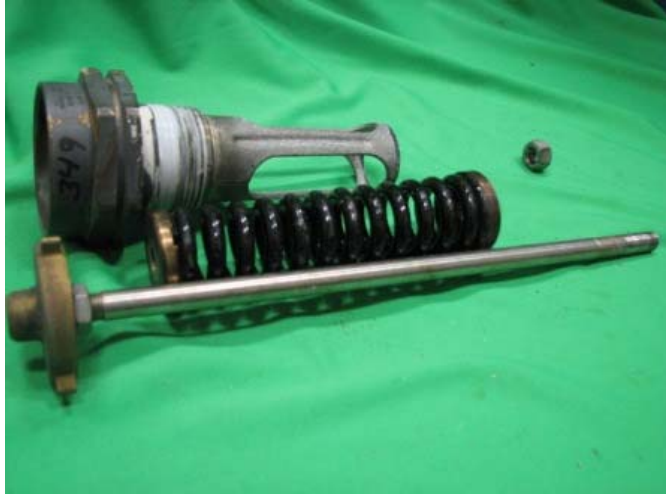
**Figure C-46 –PRV 349 Disassembled**

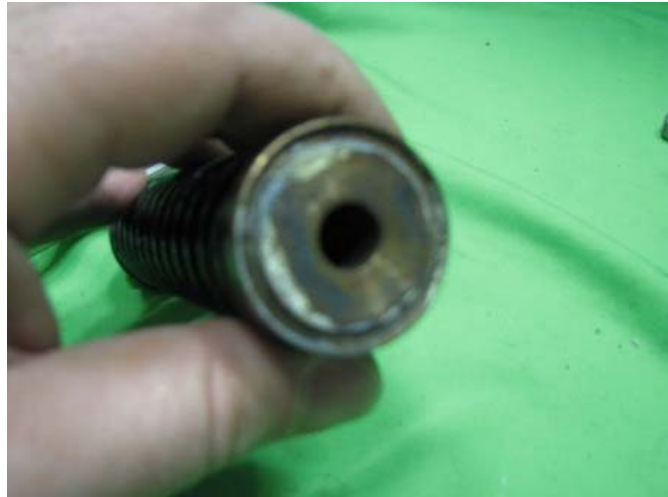
**Figure C-49 – PRV 349 End of Spring Flange**

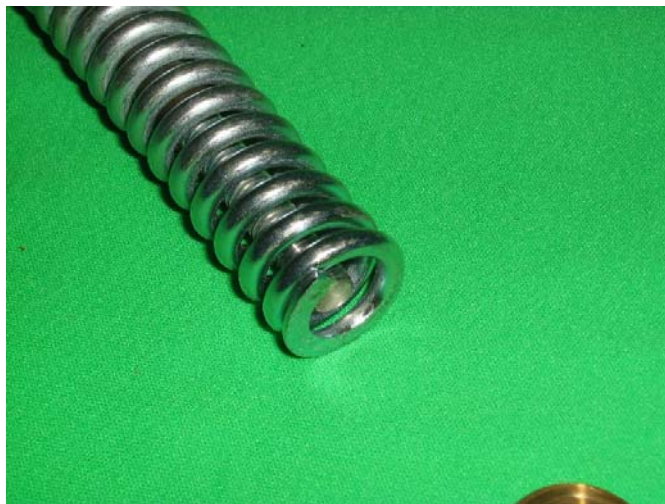
**Figure C-51 - Uncompressed Spring Length on PRV 468**

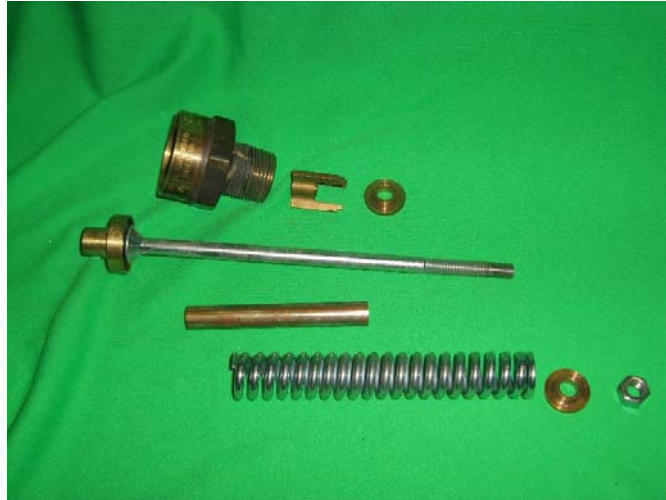
**Figure C-52 – PRV 468 Disassembled**
