**TESTING AND ASSESSMENT OF
CG-7 PRESSURE RELIEF VALVE AND
PROPANE CYLINDER PERFORMANCE**

VOLUME 1: RESULTS AND EVALUATION

January 31, 2003

BATTELLE
505 King Avenue
Columbus, Ohio 43201-2693

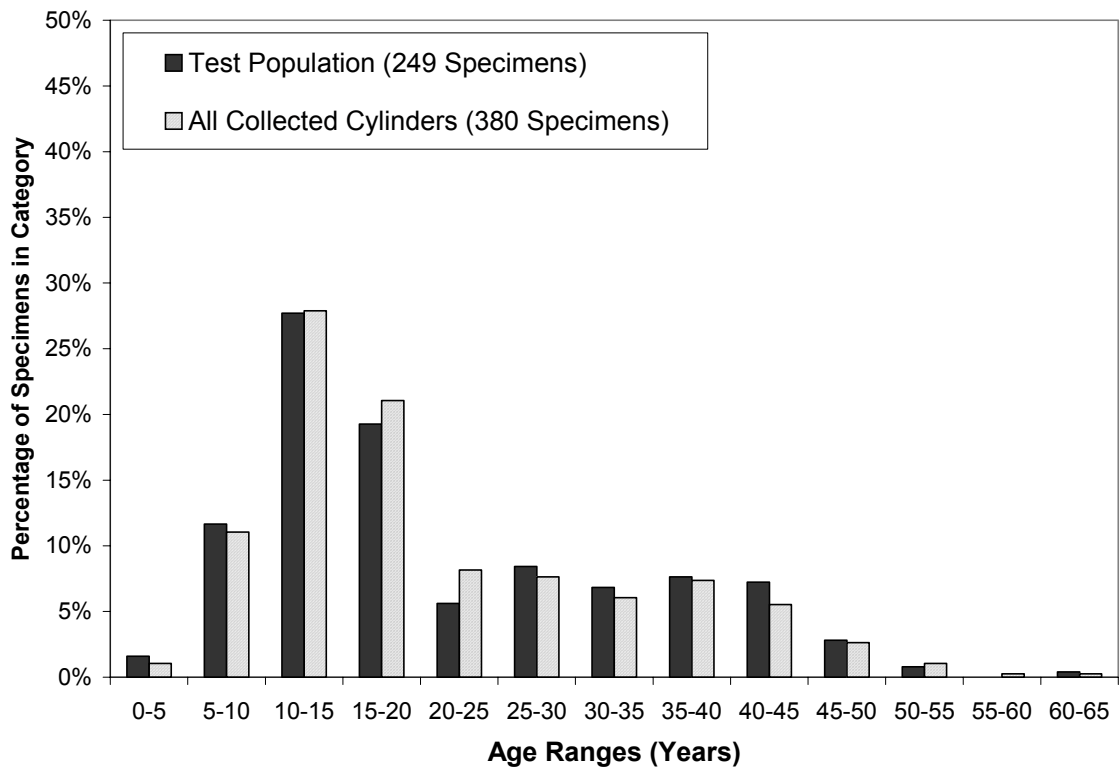
Figures 5 through 9 summarize the characteristics and subsets of the cylinders and valves which were selected for detailed testing and evaluation. Figure 5 compares the age of the cylinders. The majority of the cylinders collected and tested ranged in age from 10 to 20 years, although cylinders of up to 60 years old were tested. Four of the cylinders were 5 years old or less and 32 of the cylinders were 10 years old or less.

Figure 5. Age distribution of test cylinders.

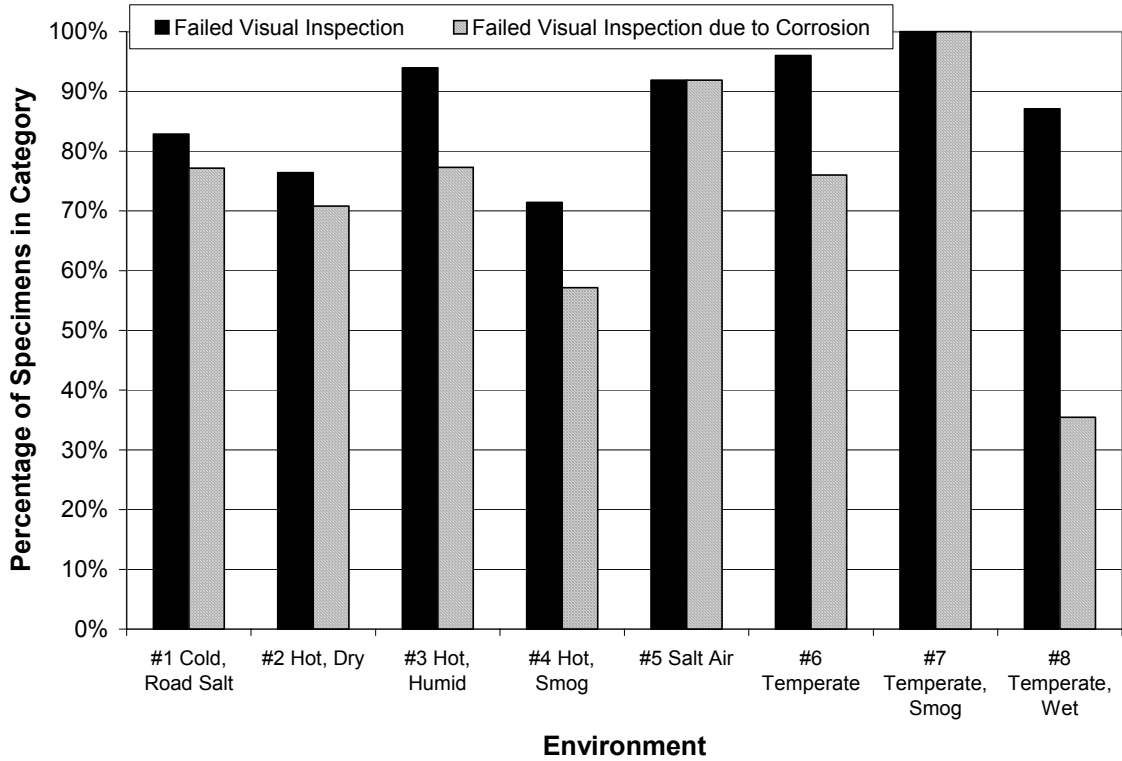
Figure 11 compares the visual inspection results on the basis of the environment where the cylinder was obtained. According to this figure, the percentage of cylinders which failed visual inspection ranged from 71 to 100 percent. The percentage of cylinders failing visual inspection due to corrosion ranged from 35 to 100 percent. Of the eight environments under consideration, it is worthy to note that all of the

specimens from the salt air (Virginia and Florida) environment and the temperate, smog (New Jersey) environments that failed visual inspection did so due to corrosion. In addition, less than half of the cylinders from the temperate, wet (Yuba City, CA) environment failed due to corrosion, whereas the majority failed due to corrosion in other areas.

Figure 11. Comparison of the percentage of cylinders collected from each source environment which failed visual inspection for all causes and those which failed inspection due to corrosion.

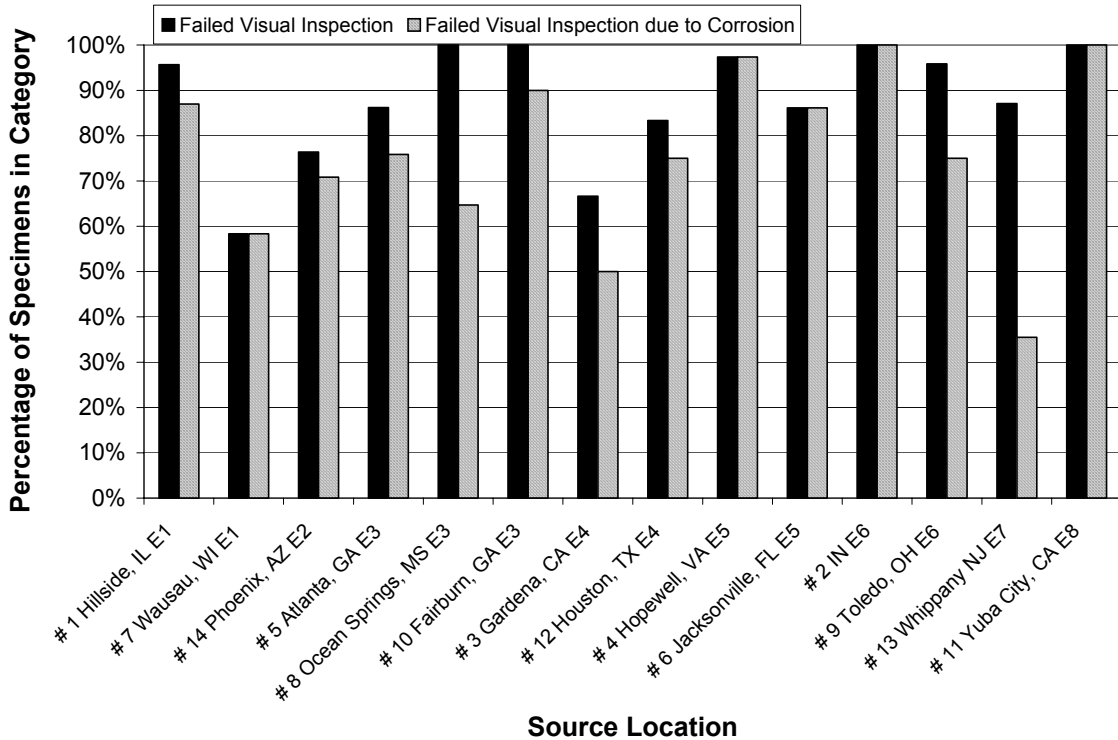
Figure 12. Comparison of the percentage of cylinders collected from each source location which failed visual inspection for all causes and those that failed inspection due to corrosion.

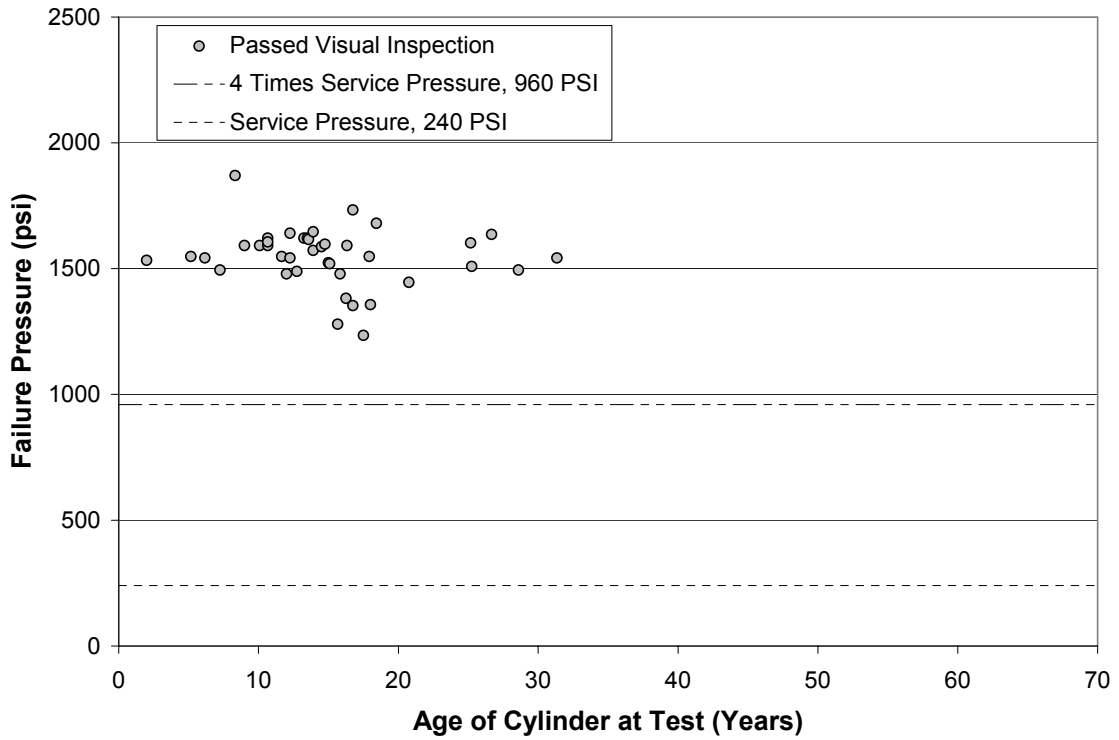
The results in Figure 14 show that all of the cylinders that passed visual inspection failed at pressures above 4 times service pressure. The lowest failure pressure of any cylinder which passed visual inspection was 1235 psi, over 5 times service pressure. Figure 15 shows the failure pressure of cylinders which failed visual inspection. Only 8 cylinders (3.4 percent of test cylinders) failed at pressures below 960 psi. It is important to note that each of those 8 that failed the visual inspection procedure and would have been rejected and removed from service.

Figure 14. Failure pressure of cylinders that passed visual inspection as a function of age.

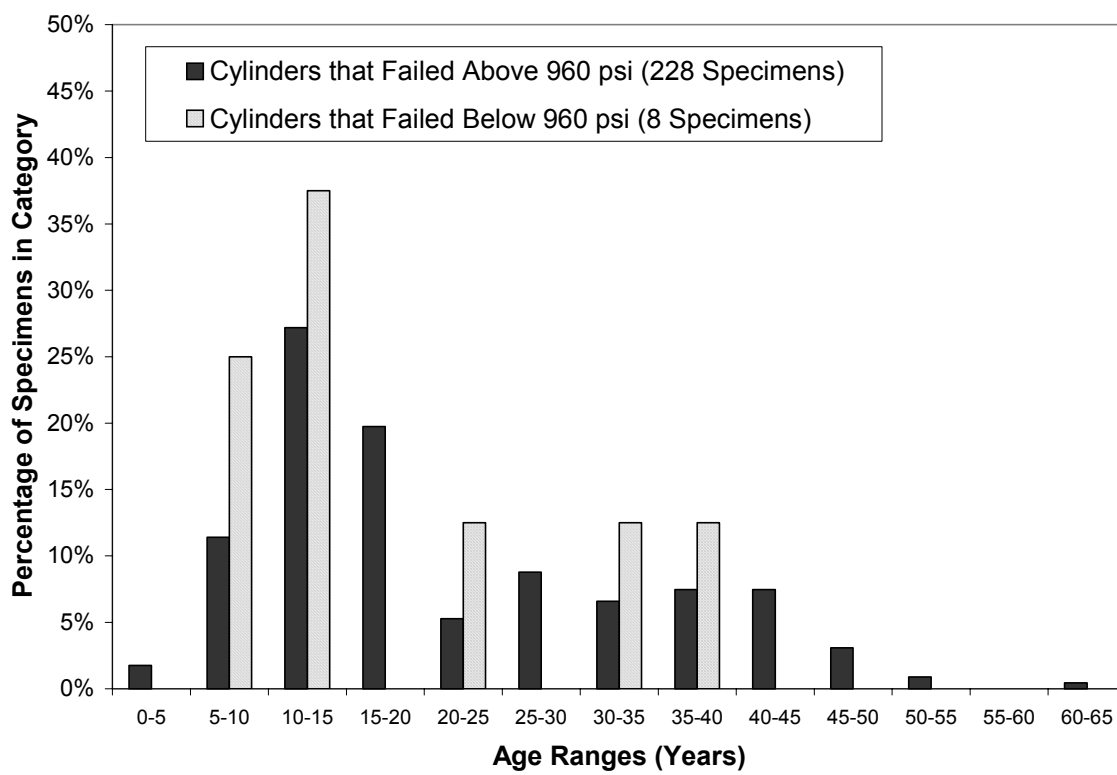
For further examination, Table 2 summarizes the condition of the eight specimens that failed below 960 psi and Figures 16 through 18 compare the burst pressure results on the basis of age, source environment, and source location. The results in Figure 16 show that 25 percent of the cylinders that failed below 960 psi were less than 10 years old and 37.5 percent were between 10 and 15 years old. This suggests cylinders do not degrade continuously with age, but that newer cylinders may be damaged or degraded as much as older cylinders. Figures 17 and 18 indicate that the majority of cylinders that failed below 960 psi were from a single location and environment in Georgia. Table 2 shows that, of the 8 that failed the criterion, 6 were related to corrosion. Five of the 6 failures from the Georgia environment were related to corrosion. The burst test results confirm the visual inspection results that, for this set of propane cylinders, corrosion was the primary cause of degradation.

Figure 16. Comparison of the age distribution of cylinders that failed above and below 960 psi.

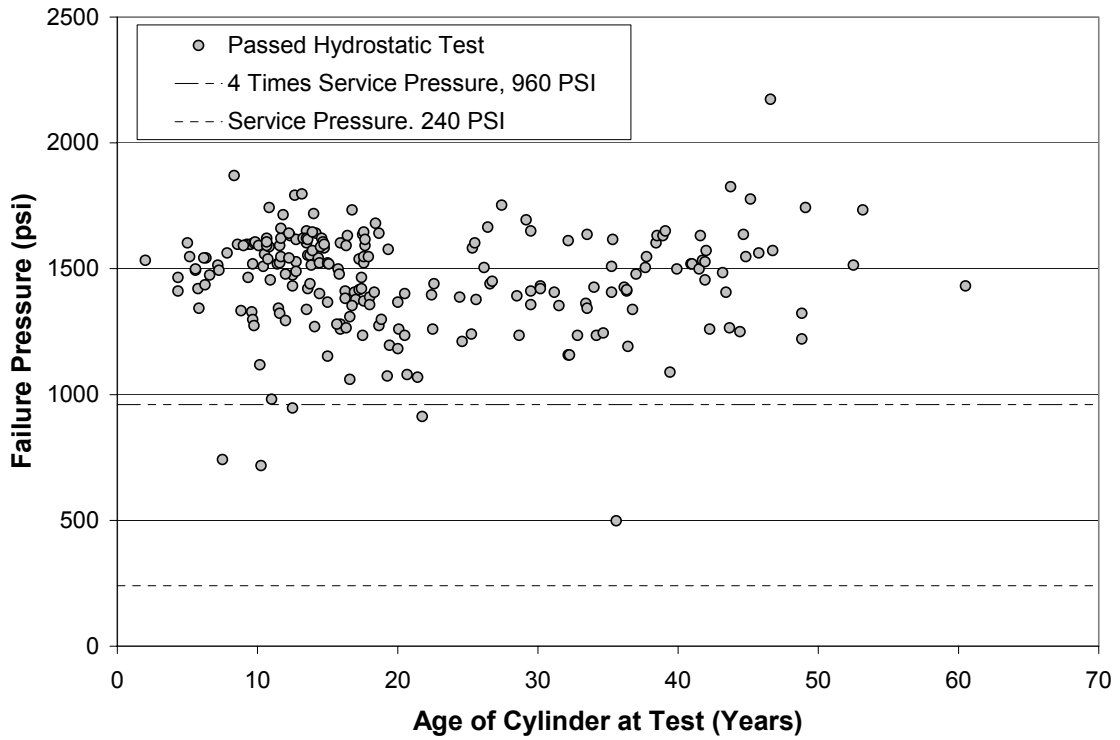
Figure 19 and Table 2 summarize the results for cylinders which passed hydrostatic expansion test. Figure 20 and Table 3 summarize the results for cylinders which failed the hydrostatic expansion test. In examining the results in Figure 19, five specimens which passed the hydrostatic expansion test had failure pressures below 960 psi, meaning they were actually unsatisfactory to remain in service. In examining the results in Figure 20, six specimens that failed the hydrostatic test had failure pressures above 960 psi, meaning they were satisfactory to remain in service.

Figure 19. Failure pressure of cylinders that passed hydrostatic expansion test as a function of age.

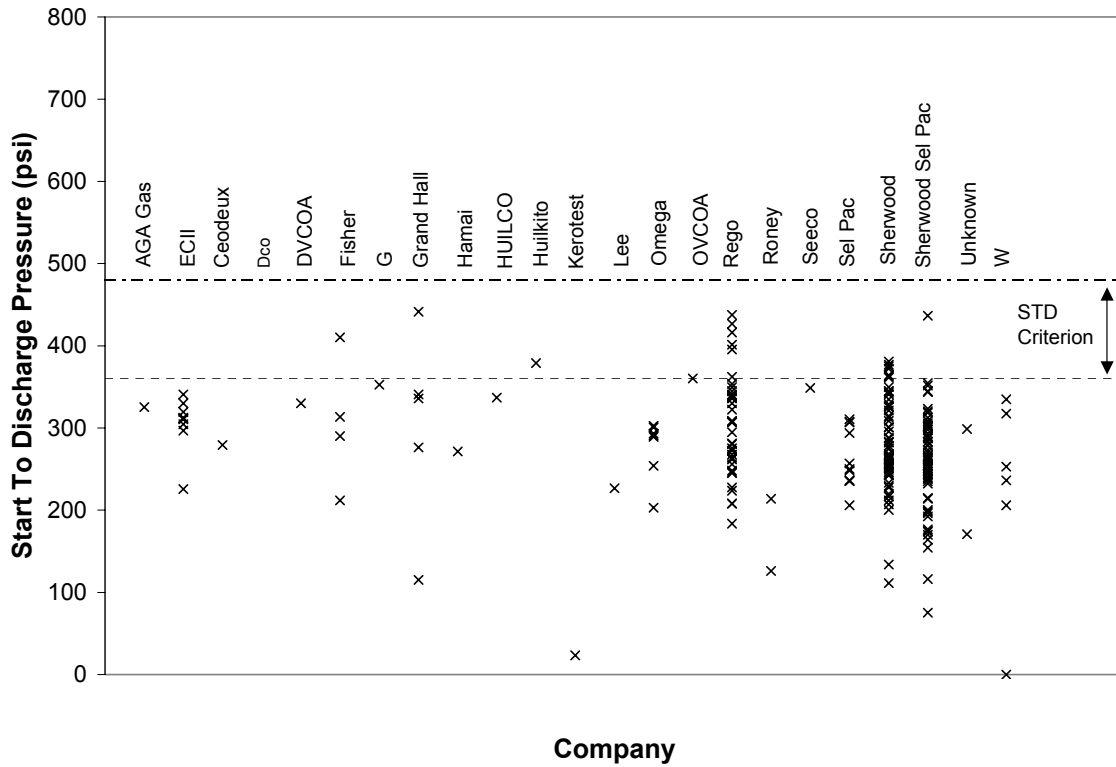
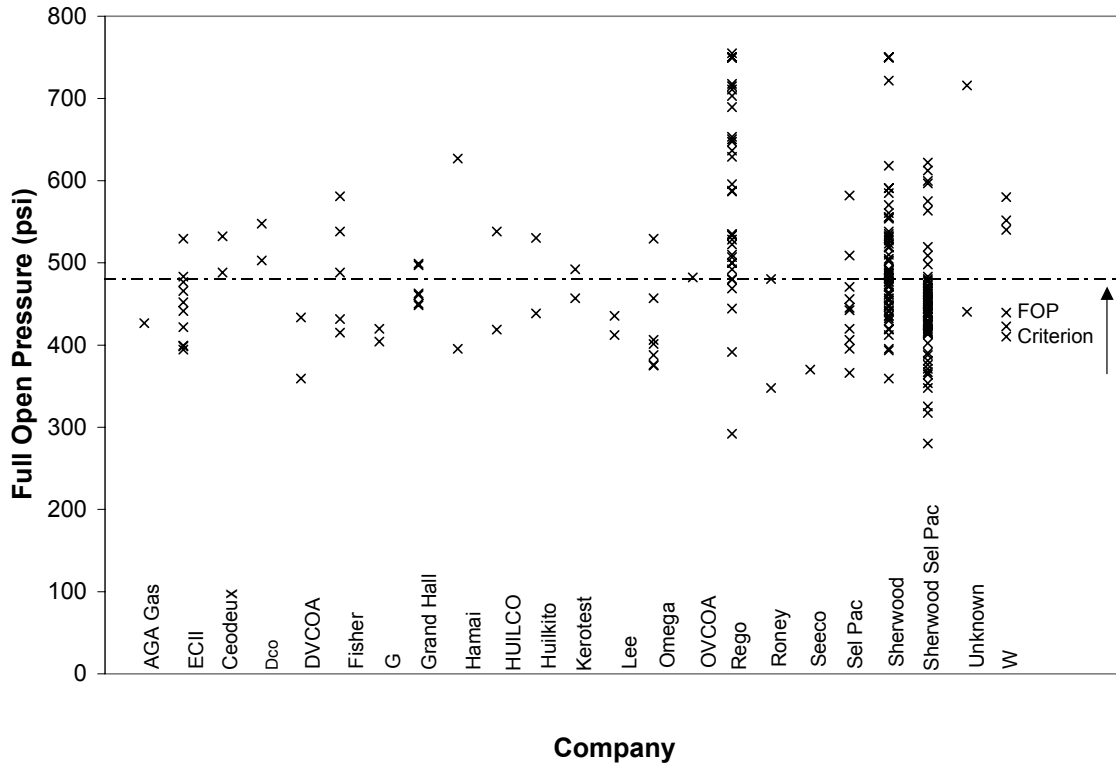
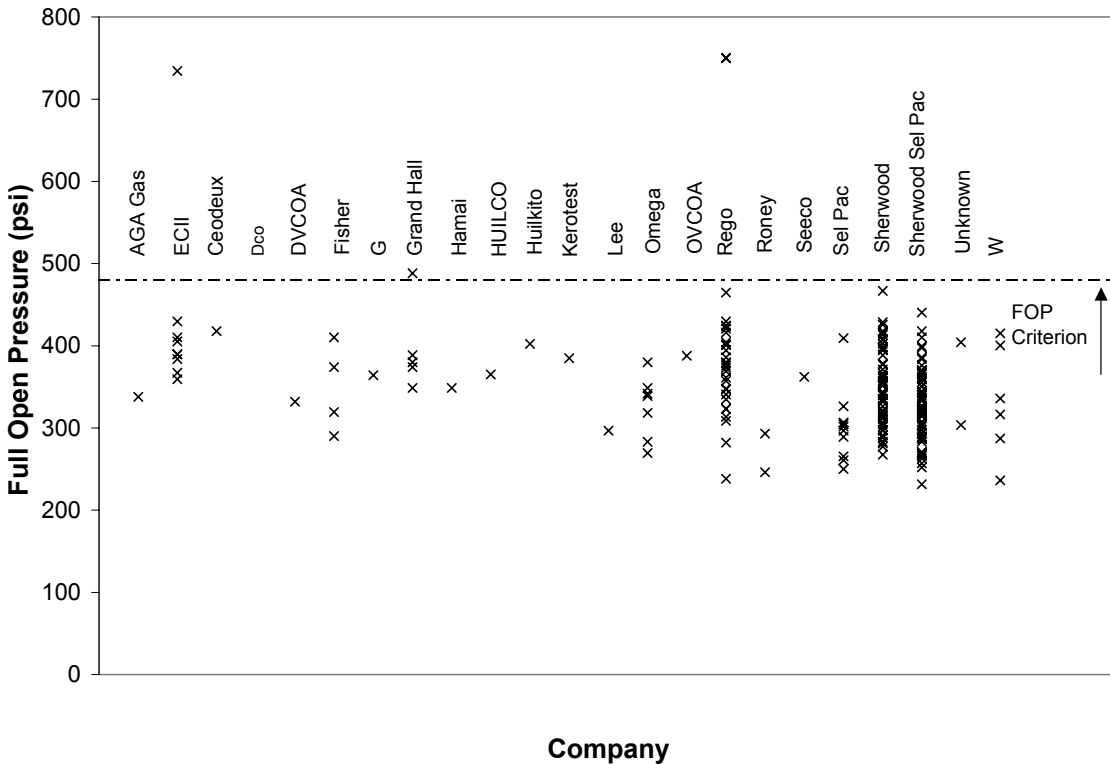
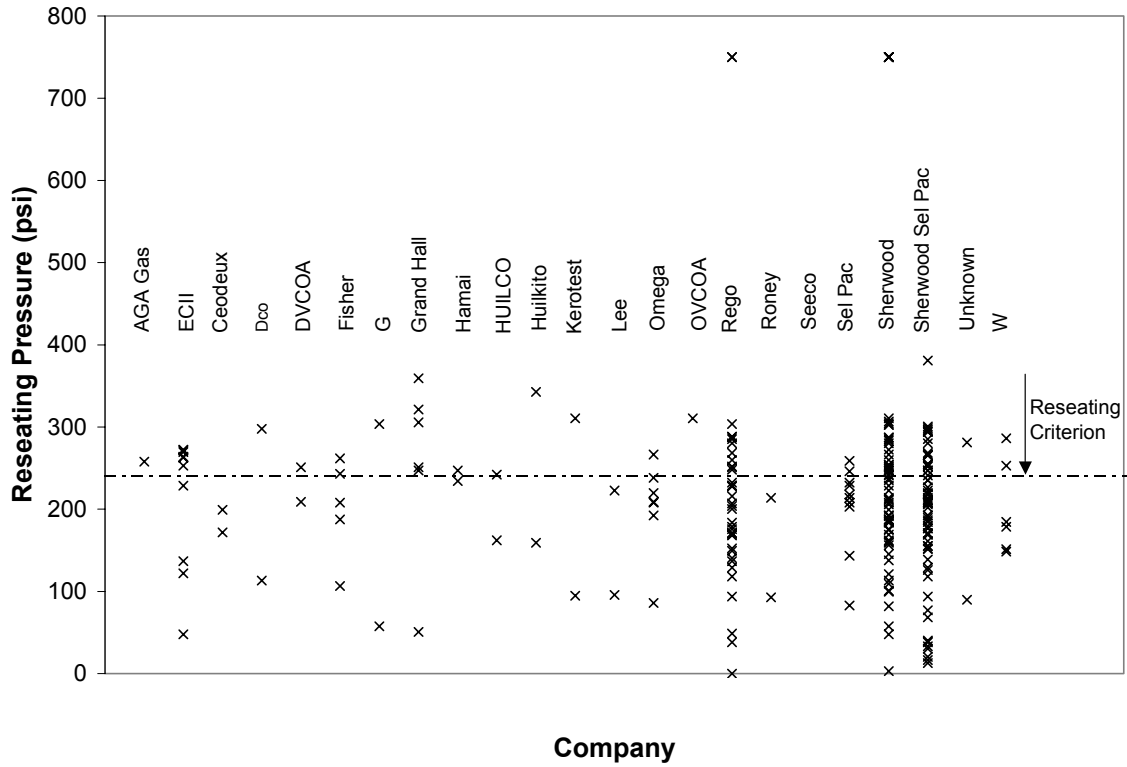
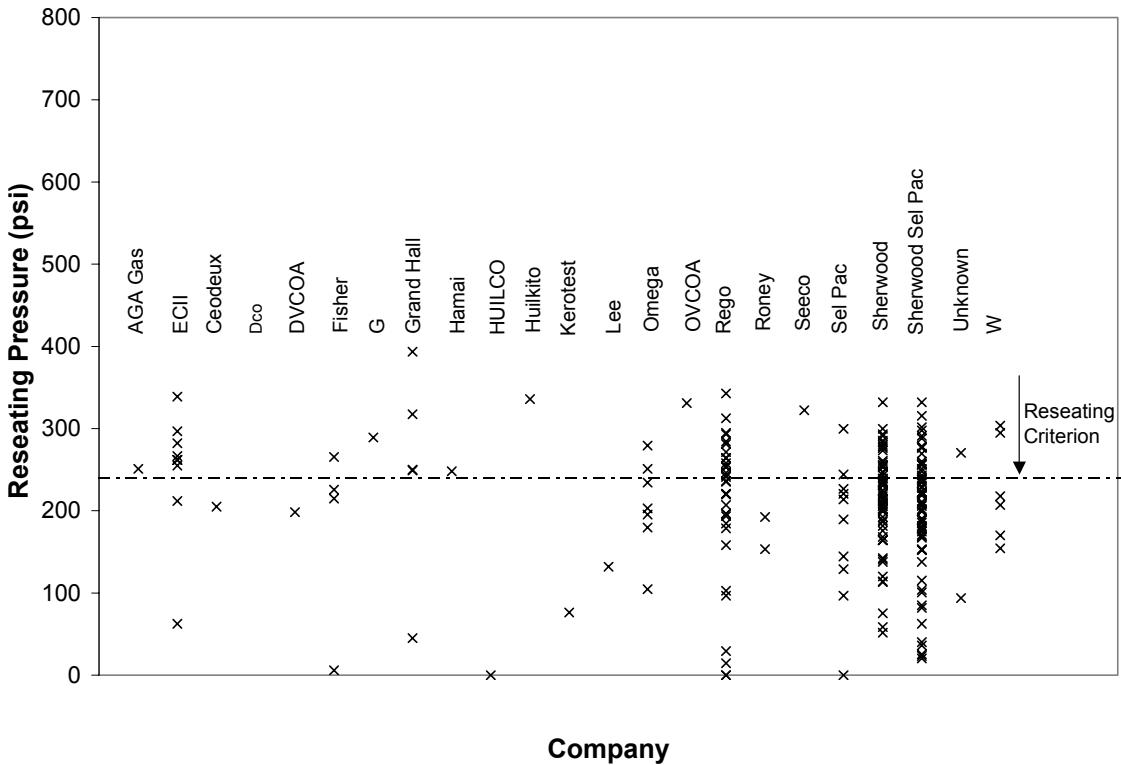
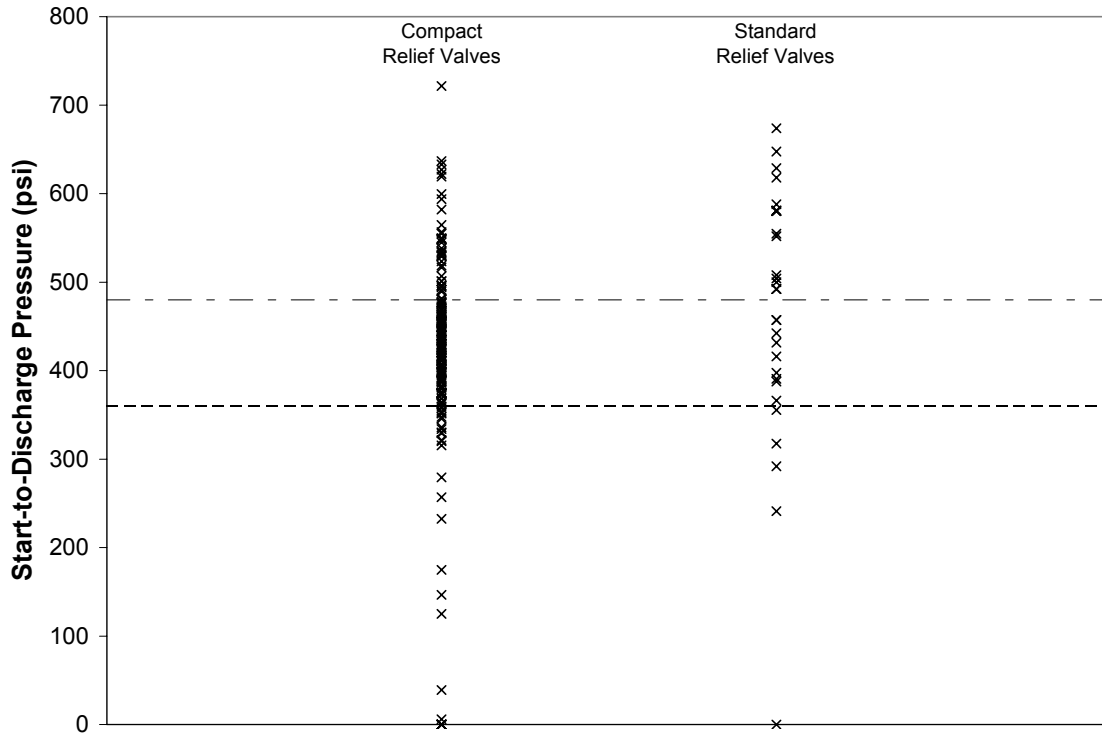
Lastly, the valve manufacturer comparison in Figures 48 through 53 suggests that the manufacturers with the largest number of valves showed the greatest span of results. More Rego, Sherwood and Sherwood Sel Pac valves were tested than the other manufacturers as shown by Figure 9. Roughly 20 percent of the valves tested were from Rego, approximately 30 percent were labeled Sherwood and about 28 percent were labeled Sherwood Sel Pac. Each of these showed similar range of results for start-to-discharge, full open and reseal pressures. While the overall range was similar, more of the Sherwood and Sherwood Sel Pac met the test criteria.

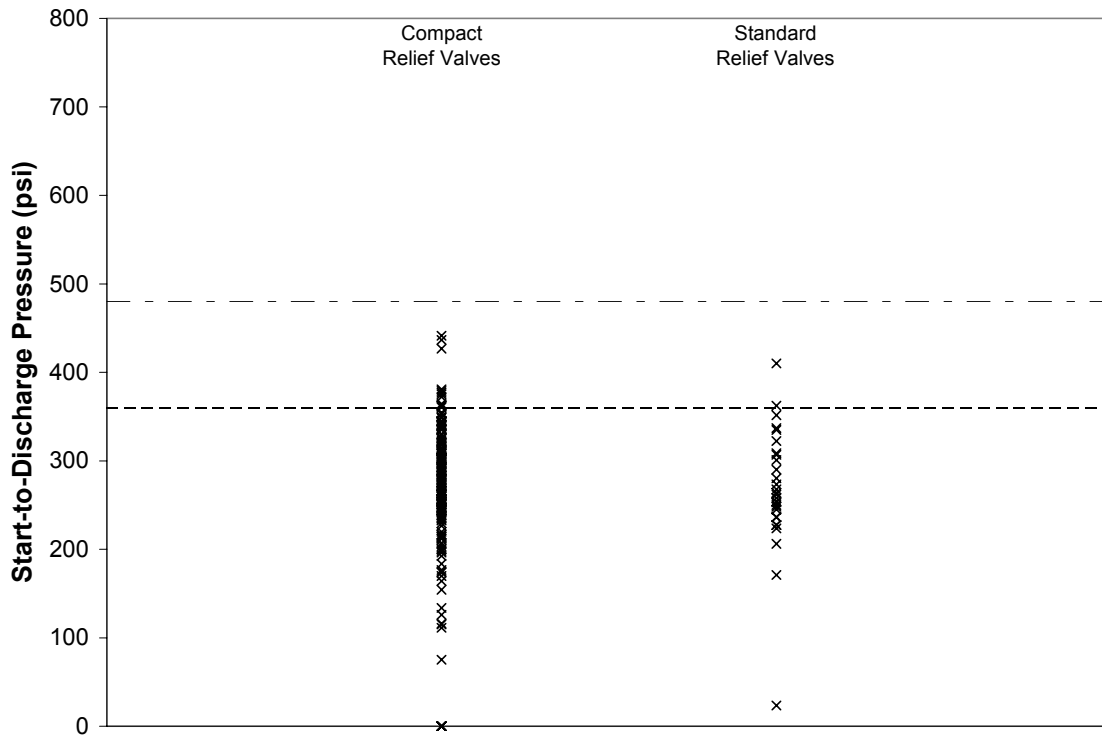
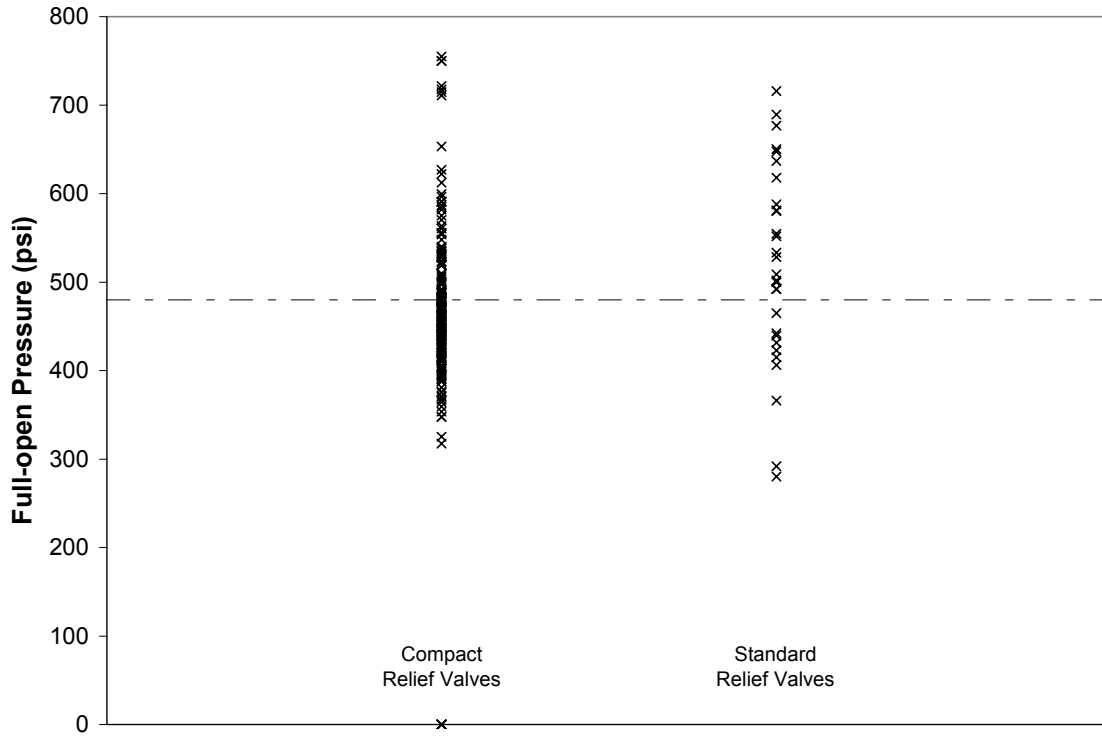
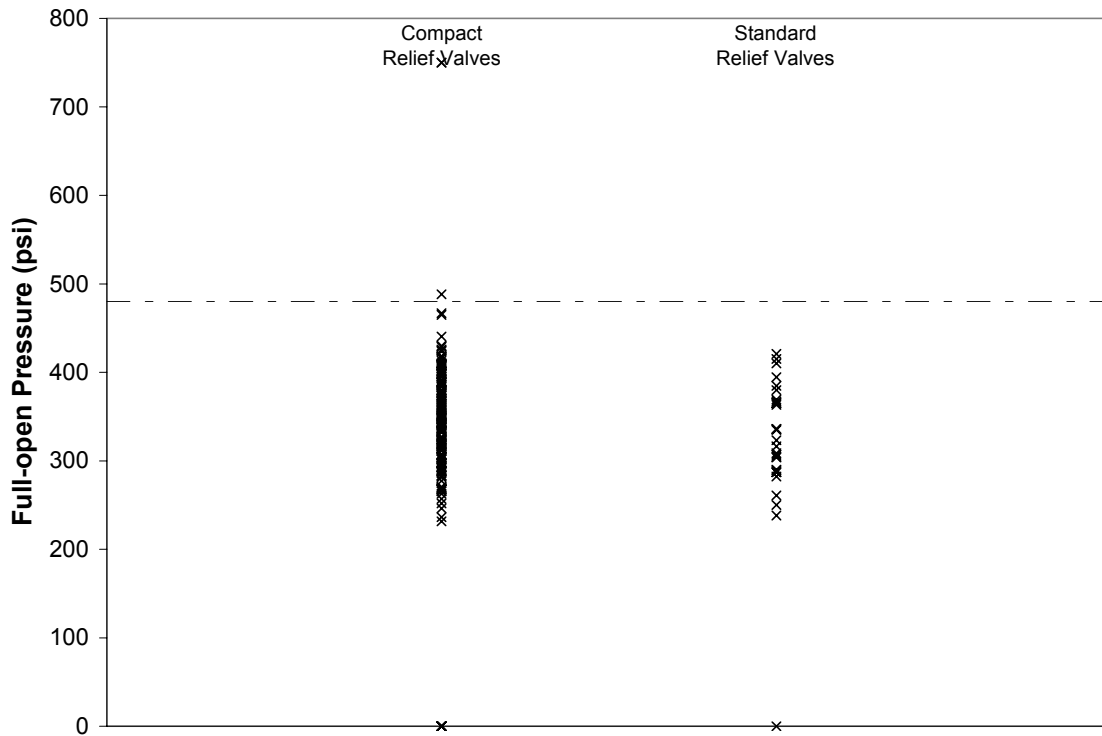
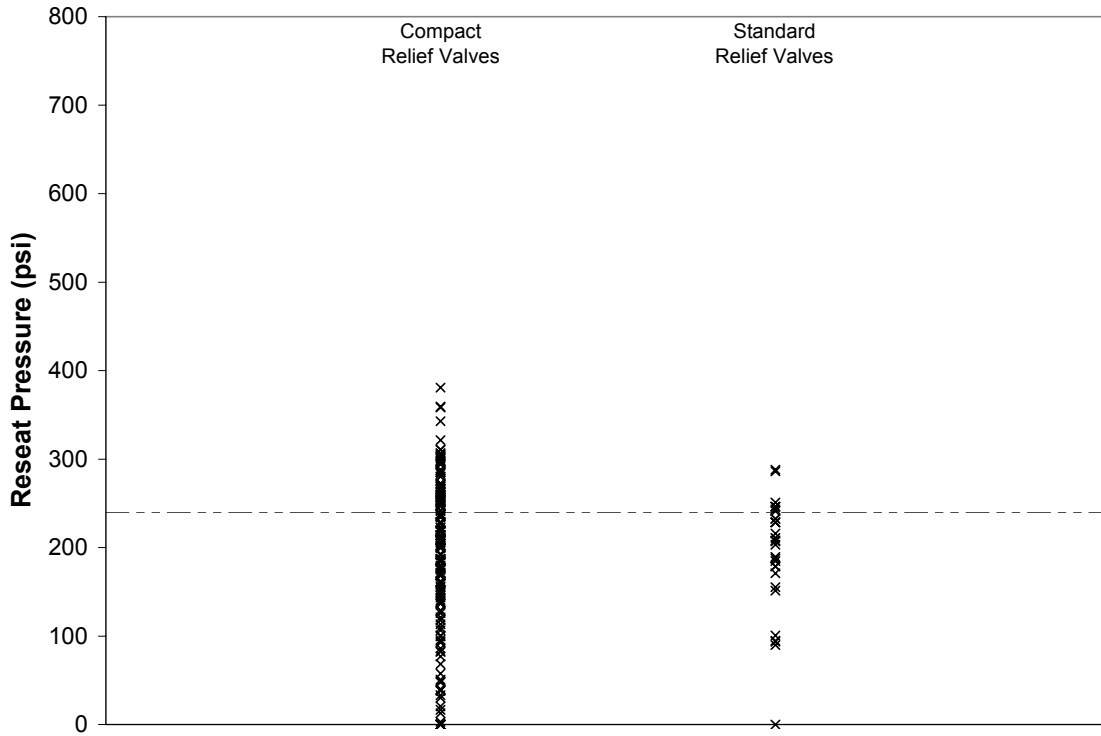
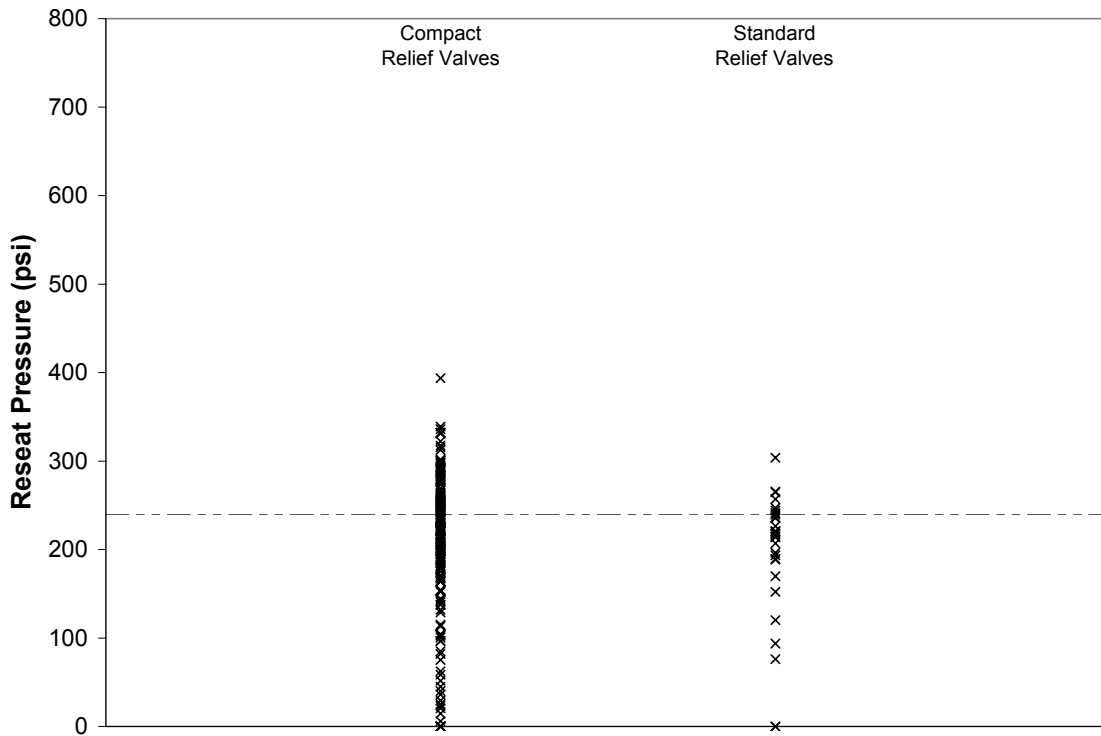
As noted earlier in this report, the majority of relief valves tested were “compact” having a bore diameter of the order of 7/16 inch. Some of the older “standard” relief valves tested had a large bore with a diameter of the order of 5/8 inch. All of the relief valves that opened met the minimum flow rate criterion required by CGA S-1.1. Figures 54 through 59 compare the start-to-discharge, full-open and reseal results for compact and standard relief valves. The data in the figures don’t appear to indicate major distinctions between the performance of the compact and standard valves. Many more compact valves were tested than standard, and, consequently, they appear to have more scatter. However, any apparent differences are more likely the result of the number of each tested than actual differences in performance.

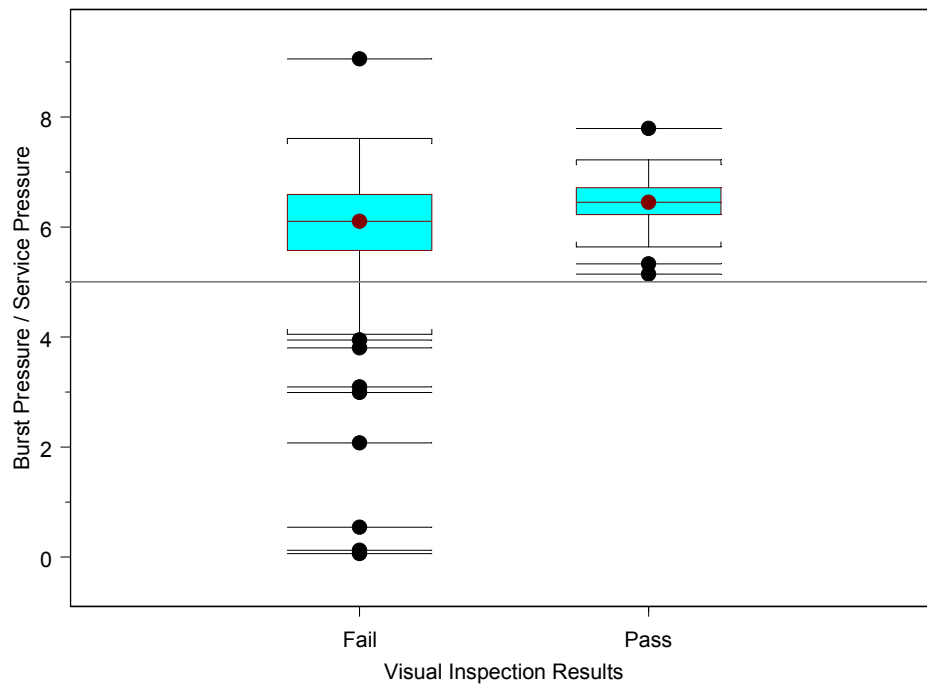
Margin of Safety: Visual Inspection

Failure Pressure / Service Pressure		N	MIN	MAX	MEDIAN	MEAN	STD
Visual Inspection Results	Fail	194	0.06	9.05	6.10	5.92	1.12
	Pass	40	5.15	7.79	6.45	6.44	0.48

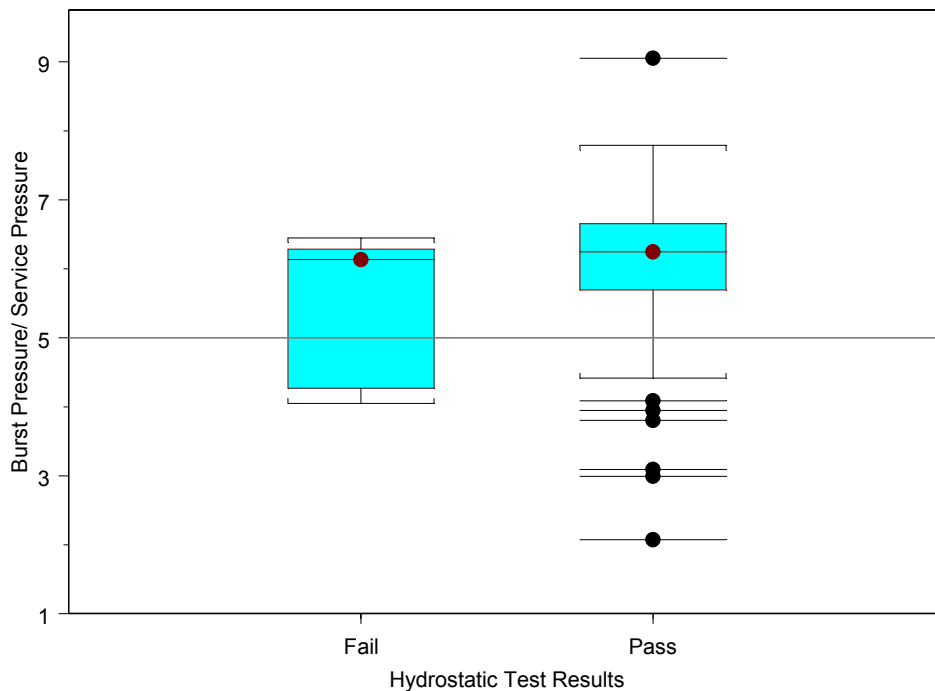
Margin of Safety: Hydrostatic Test

Again, margin of safety is the ratio of failure pressure to service pressure (240 psi). The “typical” or median failure pressure to service pressure ratio for cylinders failing hydrostatic testing is 6.13, while the median of the cylinders passing testing is 6.25.

Failure Pressure / Service Pressure		N	MIN	MAX	MEDIAN	MEAN	STD
Hydrostatic Test Results	Blank	5	0.06	6.59	0.54	2.58	3.23
	Fail	6	4.05	6.45	6.13	5.55	1.09
	Pass	223	2.08	9.05	6.25	6.10	0.82
