ADDENDUM TO THE FINAL REPORT ON:

TESTING AND ANALYSIS OF THE PERFORMANCE OF PRESSURE RELIEF VALVES FOR CUSTOMER TANKS

Battelle Project N007245
PERC Docket 15203

April 2011

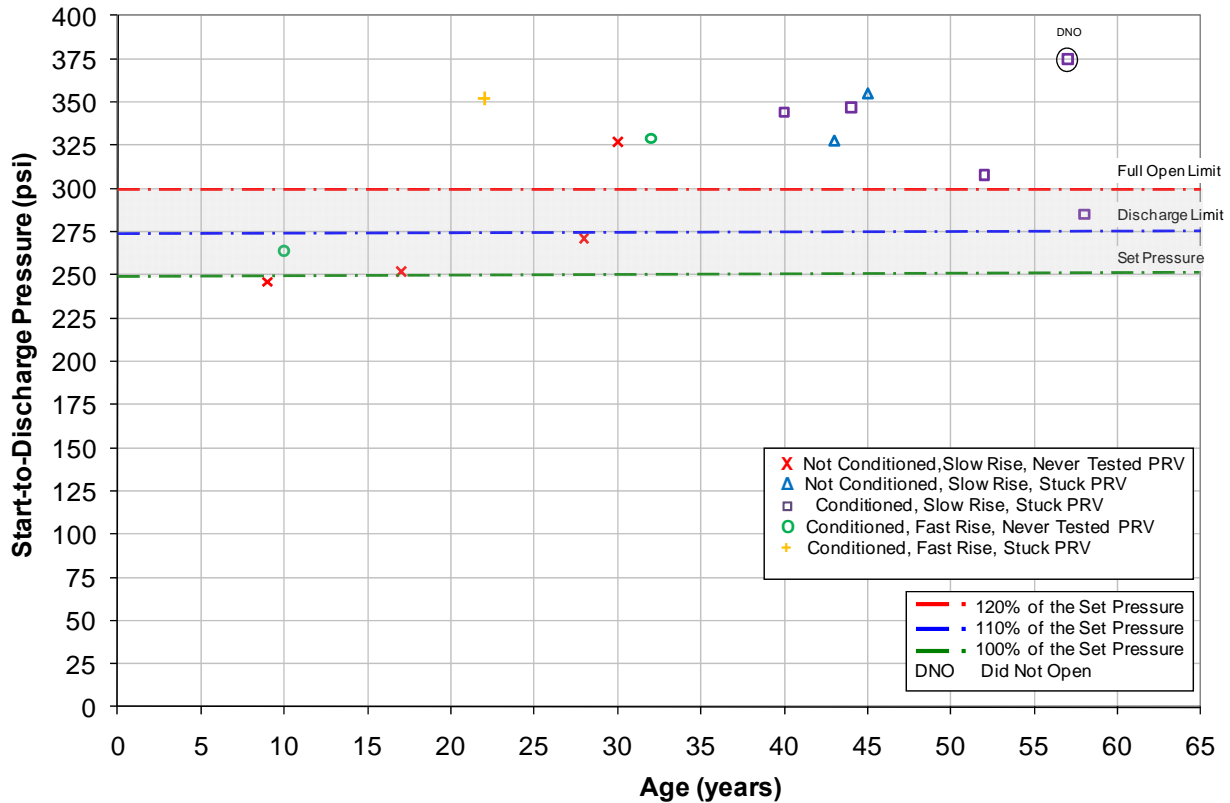
Figure ES-1 - Results of All Additional Testing for 250-psig Set Point PRVs

The results for the new test conditions show that PRVs less than 20 years old generally performed within the UL 132 criteria for new valves (with one opening 2 psi lower than its set pressure). One 22 year old PRV had high start-to-discharge and resealing pressures. When this valve was examined, it was found to have the highest spring load and load-displacement value of all PRVs with comparably sized springs. The high spring load caused by a higher load-displacement value and a greater installed displacement may indicate that the PRV factory set pressure was set high. All PRVs 30 years old and greater opened at high start-to-discharge pressures (>275 psig).

Of the eight previously stuck PRVs tested, seven opened under the new test conditions indicating that propane conditioning, heating, and/or low pressure rise rates have an influence on the performance of PRVs removed from the field. All seven of the previously ‘stuck’ closed PRVs that opened under the new test conditions still exhibited high start-to-discharge pressures (in excess of 110 percent of the set pressure) but opened within 1.5 times the set pressure (hydrotest pressure for ASME tanks with a working pressure of 250 psi). Additional analyses of PRV 62 (external type valve no longer installed on new tanks) indicated severe corrosion caused it to remain stuck under the new test conditions.

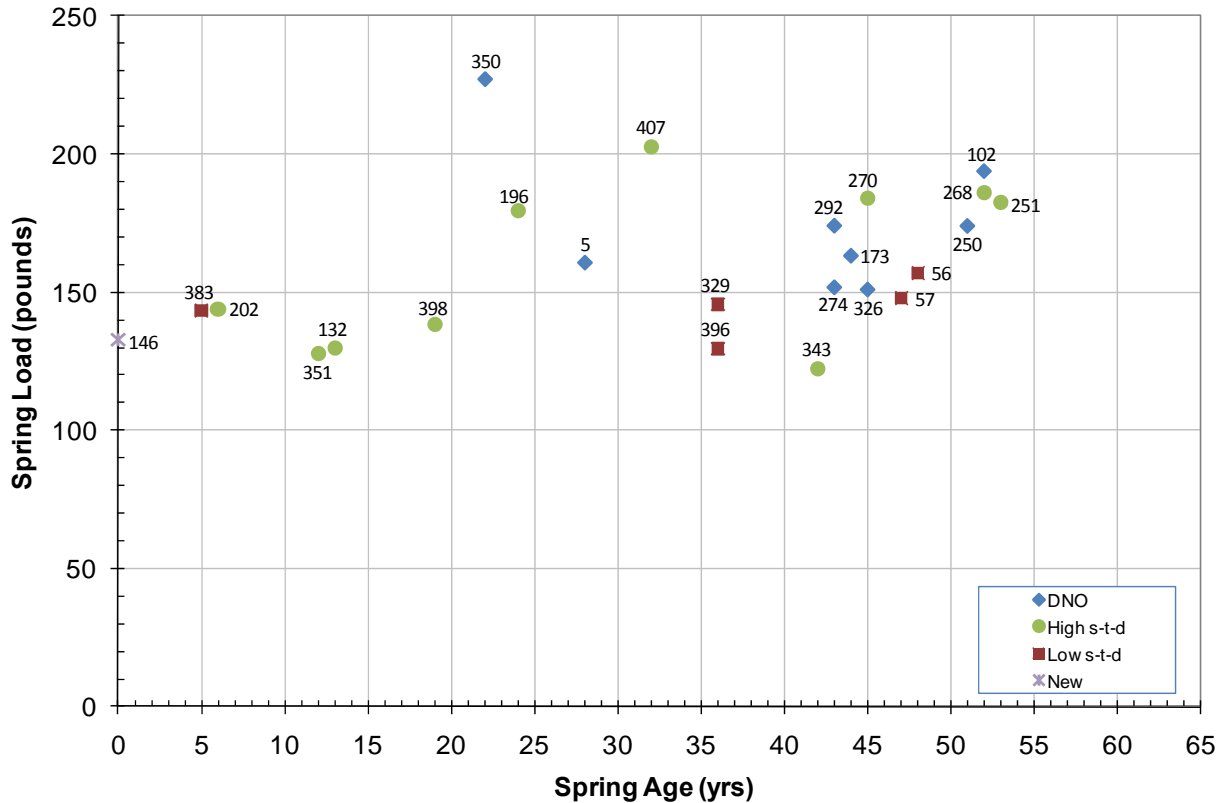
Figure ES-2 – PRV Spring Load versus Age

Figure ES-2 does not indicate a loss in PRV spring load as a function of time in service. Thus the spring analyses from the various PRVs evaluated does not indicate that stress relaxation (load loss) contributed to the deterioration in PRV performance. Figure ES-2 does indicate that spring loads for the PRVs that were less than 20 years old ranged between about 130 and 145 pounds; whereas for the PRVs that were greater than 20 years old, the spring loads had greater variation between 125 and 227 pounds. In addition, all of the PRVs that did not open during the initial test program had spring loads of 150 pounds or greater. Unfortunately, many variables related to the valve and spring sizes will influence the spring load and those variables may account for the greater scatter in the older PRVs. Since the manufacturing specifications for the springs and the PRVs produced at different times were not available for review, it cannot be concluded that the differences observed reflect changes in design requirements or spring manufacturing procedures.

As shown in Figure ES-2, there was one PRV (PRV 350) that had a higher spring load, 227 pounds, than the others. That spring also exhibited the highest load-displacement value and had the largest installed spring displacement for the group of comparably sized springs. Calculations of the spring load and exposed gasket area indicate a pressure of approximately 315 psig would be required to open the valve (overcome the spring load). Thus, the high spring load for PRV 350 was caused by a spring with a higher load-displacement value and a greater installed displacement, i.e. the PRV factory set pressure likely was set high.

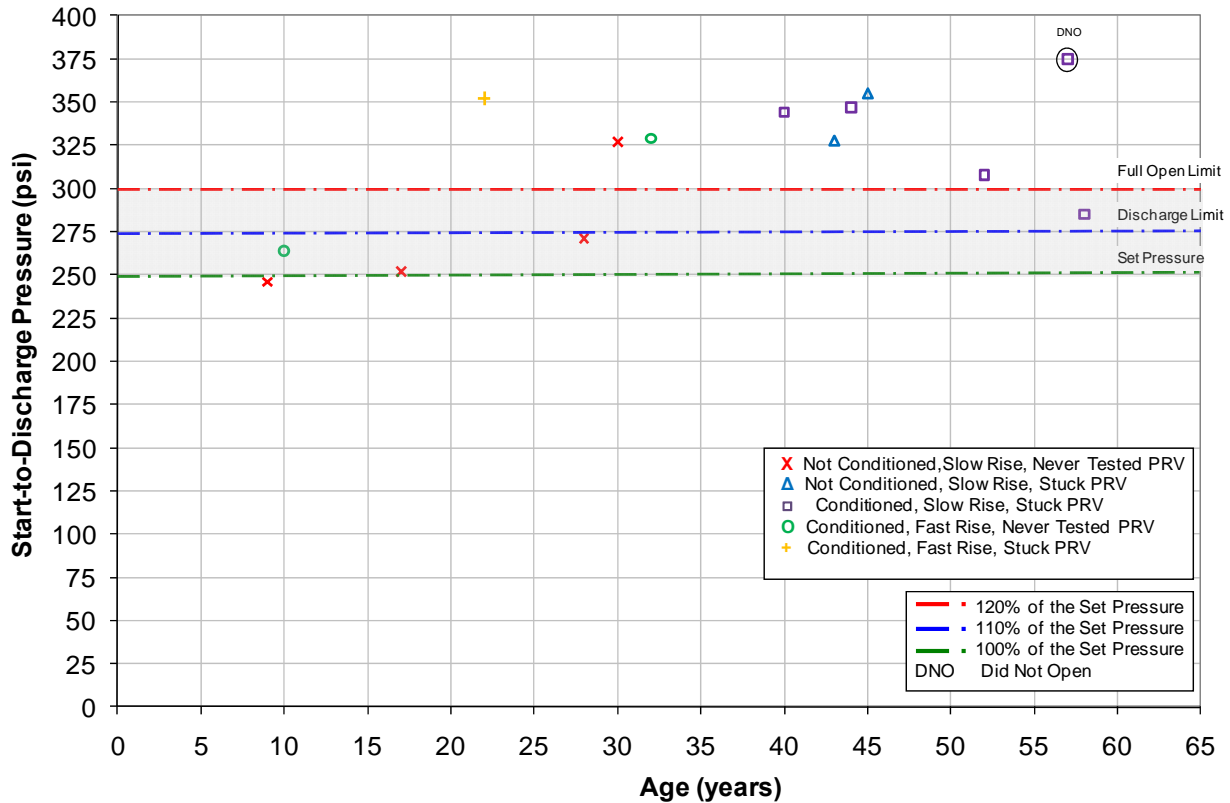
Figure 4 - Results of All Additional Testing for 250-psig Set Point PRVs

The results for the new test conditions show that PRVs less than 20 years old generally performed within the UL 132 criteria for new valves (with one opening 2 psi lower than its set pressure). One 22 year old PRV had high start-to-discharge and resealing pressures. When this valve was examined, it was found to have the highest spring load and load-displacement value of all PRVs with comparably sized springs (see Section 4.1). The high spring load caused by a higher load-displacement value and a greater installed displacement may indicate that the PRV factory set pressure was set high. All PRVs 30 years old and greater opened at high start-to-discharge pressures (>275 psig).

Of the eight previously stuck PRVs tested, seven opened under the new test conditions indicating that propane conditioning, heating, and/or low pressure rise rates have an influence on the performance of PRVs removed from the field. All seven of the previously ‘stuck’ closed PRVs that opened under the new test conditions still exhibited high start-to-discharge pressures (in excess of 110 percent of the set pressure) but opened within 1.5 times the set pressure (hydrotest pressure for ASME tanks with a working pressure of 250 psi). Additional analyses of PRV 62 (external type valve no longer installed on new tanks) indicated severe corrosion caused it to remain stuck under the new test conditions.

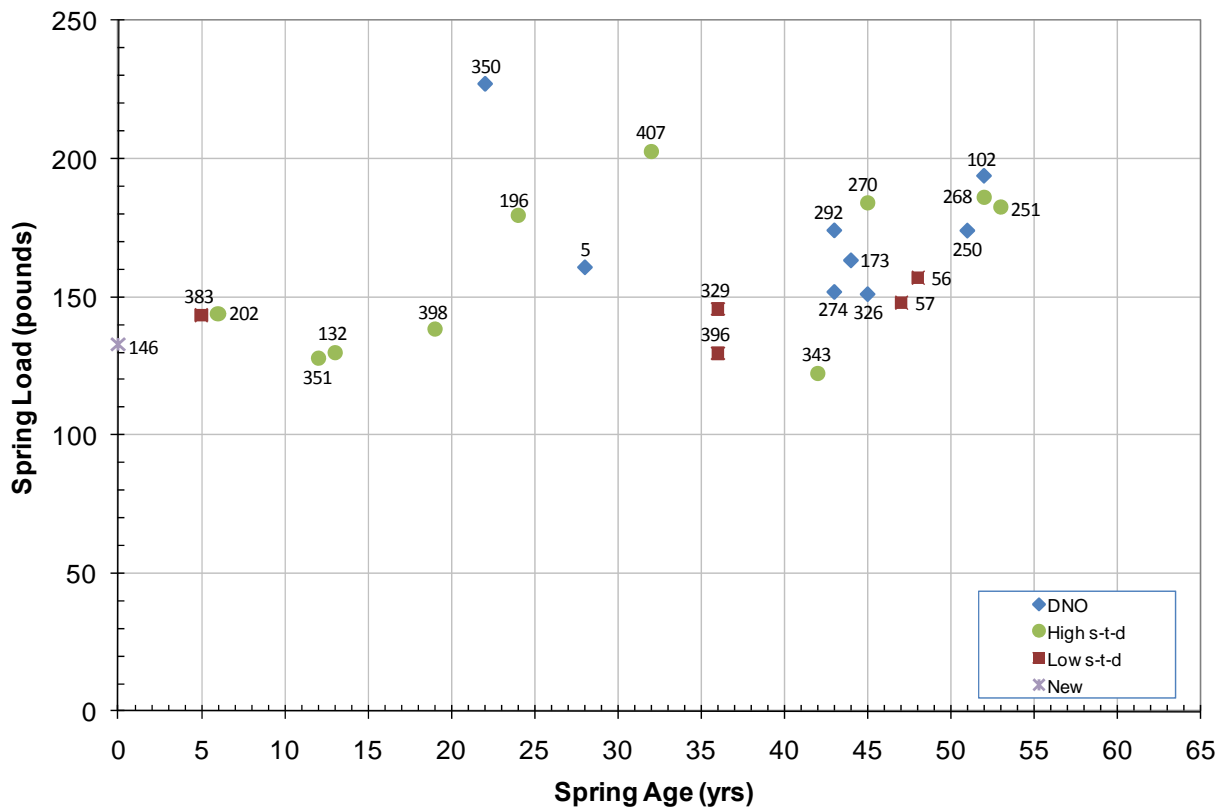
Figure 6 – PRV Spring Load versus Age

Figure 6 and Figure 7 do not indicate a loss in PRV spring load as a function of time in service. Thus the spring analyses from the various PRVs evaluated does not indicate that stress relaxation (load loss) contributed to the deterioration in PRV performance (did not open, high start-to-discharge, or low start-to-discharge) when pressure tested. Figure 7 does indicate that spring loads for the PRVs from Manufacturers A, B, and C that were less than 20 years old ranged between about 130 and 145 pounds, whereas for the PRVs that were greater than 20 years old, the spring loads had greater variation between 125 and 227 pounds. In addition, all of the PRVs that did not open during the initial test program had spring loads of 150 pounds or greater. Unfortunately, many variables related to the valve and spring sizes will influence the spring load and those variables may account for the greater scatter in the older PRVs. Since the manufacturing specifications for the springs and the PRVs produced at different times were not available for review, it cannot be concluded that the differences observed reflect changes in design requirements or spring manufacturing procedures.

As shown in Figure 6 and Figure 7, there was one PRV (PRV 350) that had a higher spring load, 227 pounds, than the others. That spring also exhibited the highest load-displacement value and had the largest installed spring displacement for the group of comparably sized springs. The area of the gasket from this PRV that would be exposed to the propane tank pressure was calculated to be 0.72 in². With the PRV spring load of 227 pounds, the calculated pressure required to open the valve (overcome the spring load) would be approximately 315 psig. Thus, the high spring

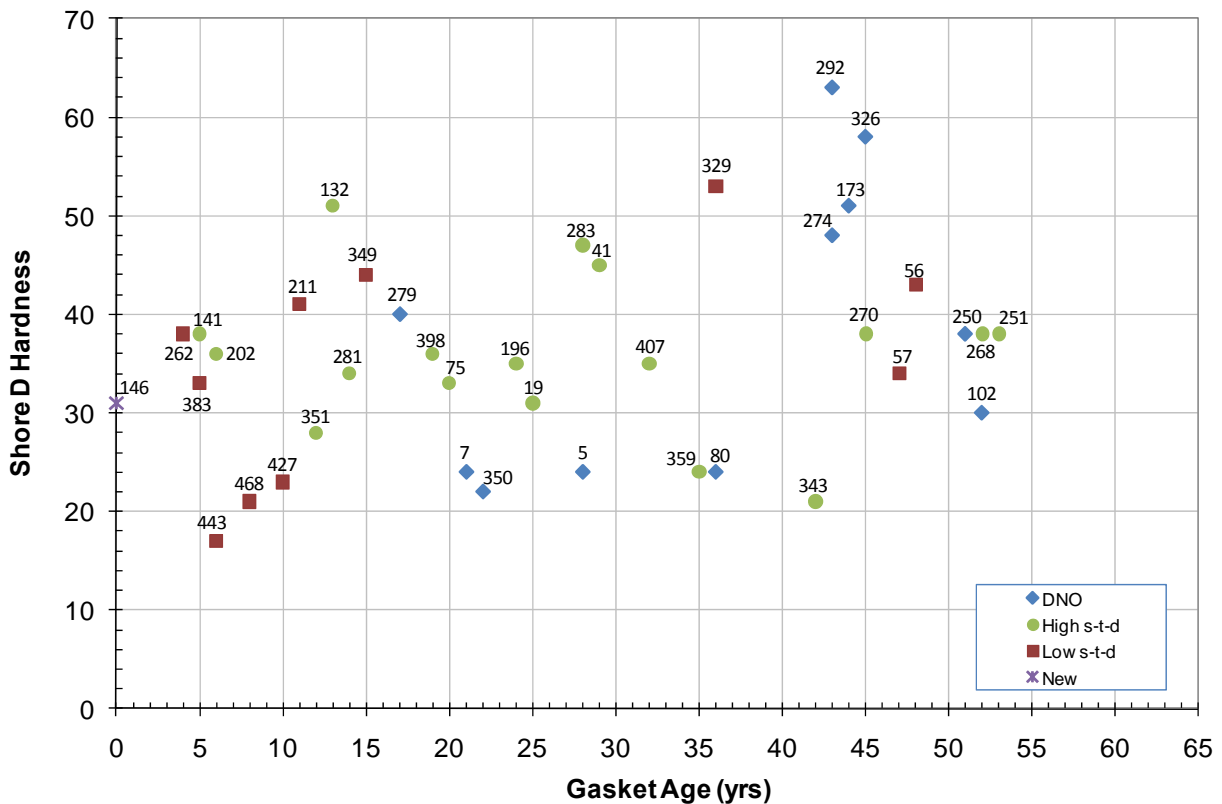
Figure 8 – Gasket Hardness versus Age

The hardness of all the gaskets by performance issue (did not open, high s-t-d, low s-t-d) was plotted versus their age to see if there were general trends in their behavior over time (see Figure 8). The data shows no strong trends or correlations.

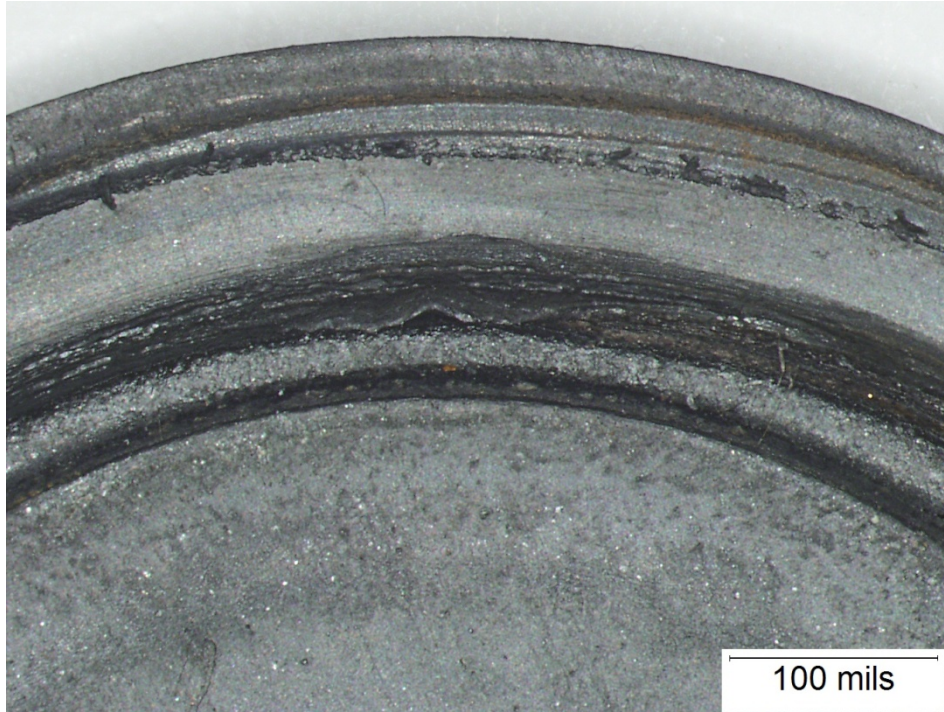
Figure 19 - Material Pull-Out Region on the Sealing Surface of the Gasket from PRV 350

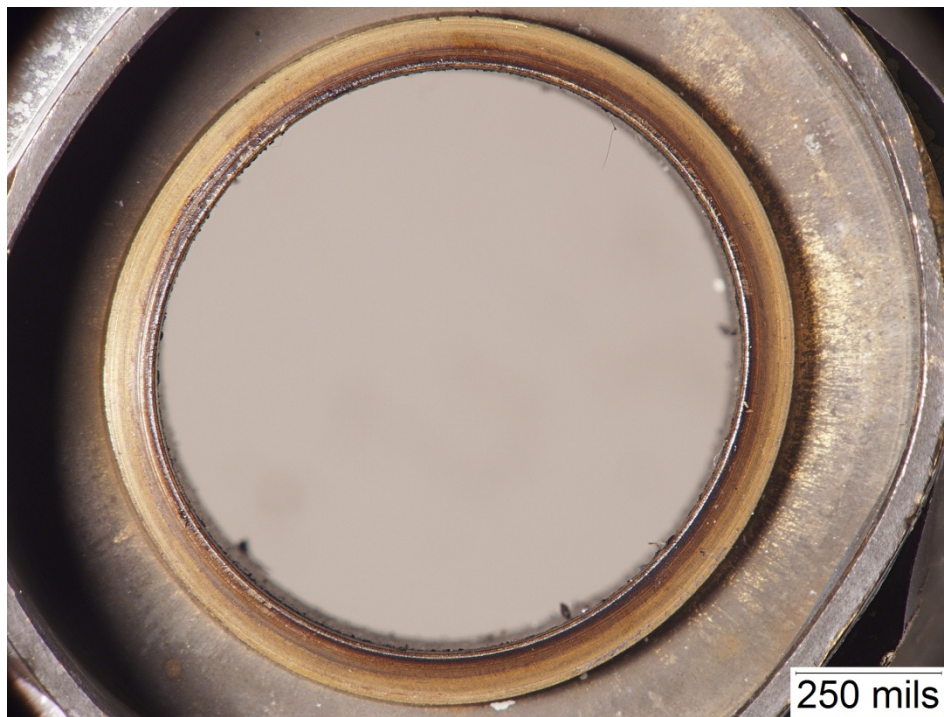
Figure 20 - Gasket Material Transferred on the Sealing Surface of the Valve Body from PRV 350

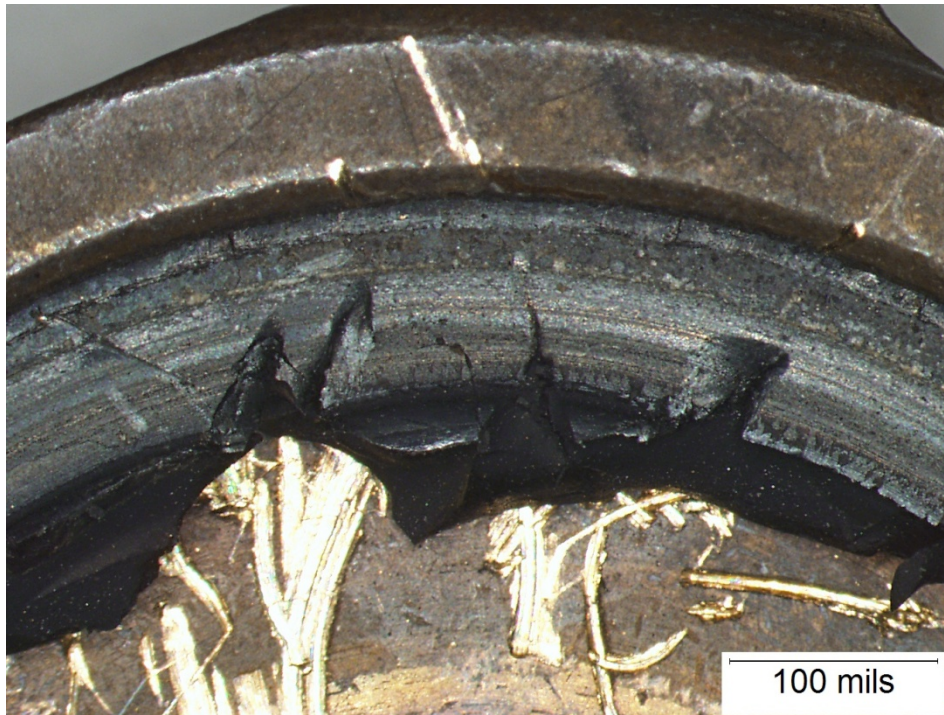
Figure 21 - Portion of the Gasket from PRV 273 Remaining in the Holder of PRV 273
This gasket tore into many small pieces when pulled on when trying to remove it from the holder.

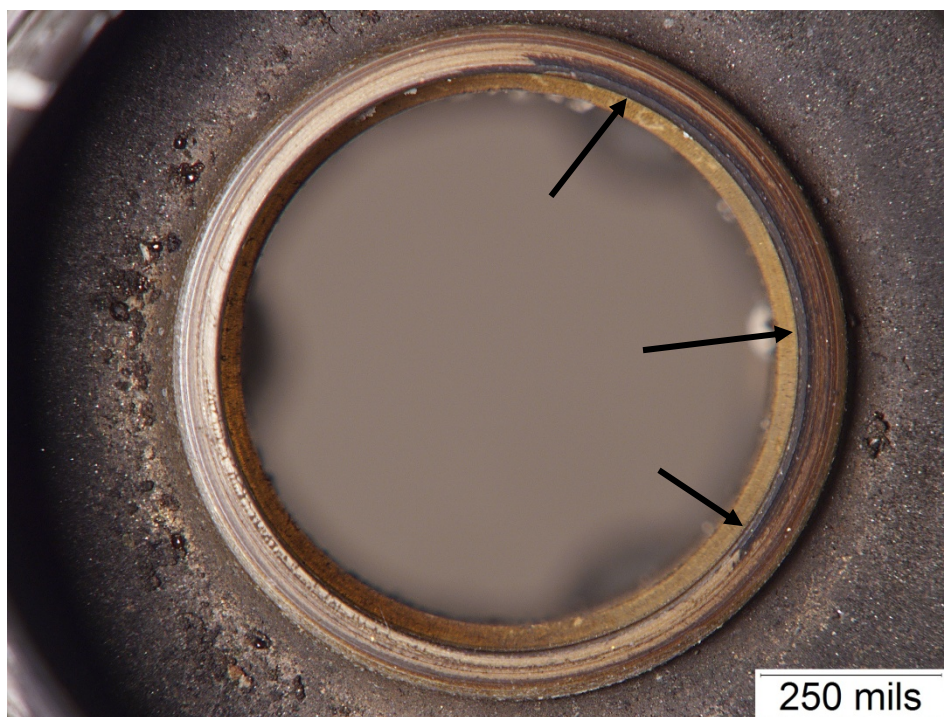
Figure 22 - Gasket Material (Arrows) Transferred to the Seal Surface on the Valve Body from PRV 273

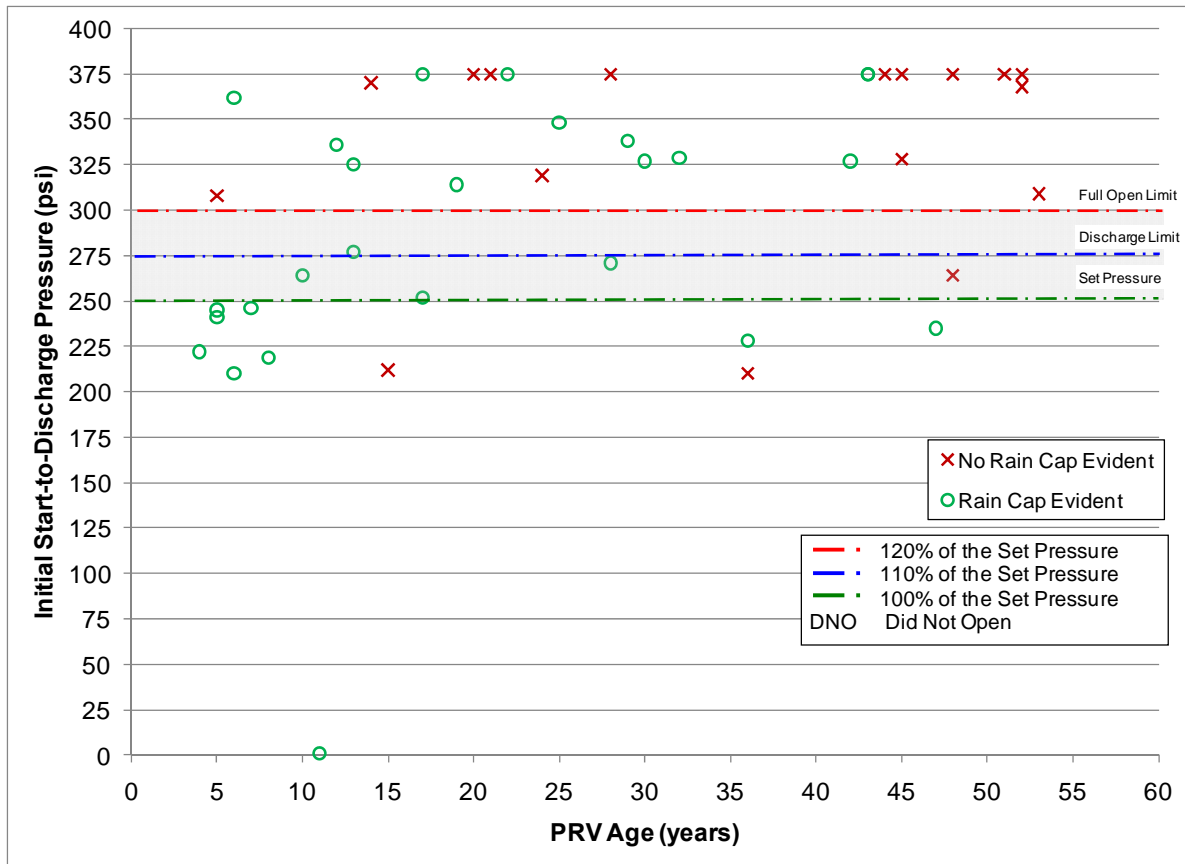
Figure 25 – Comparison of PRV Performance by PRVs with Evidence of a Rain Cap Line vs. PRVs without Evidence of a Rain Cap Line

This portion of the study has shown that about 60-percent of the PRVs that were studied had evidence of a rain cap being present even though none was included with the valve provided for study. For the 40-percent of PRVs without evidence of a rain cap being present, eight of these PRVs did not open in the original test program and only one met the UL 132 performance criteria for new valves (see Figure 25). The Battelle investigators strongly suggest that more attention to the presence of rain caps be given by tank users and tank service personnel. Keeping a rain cap in place should minimize debris from entering the valve.

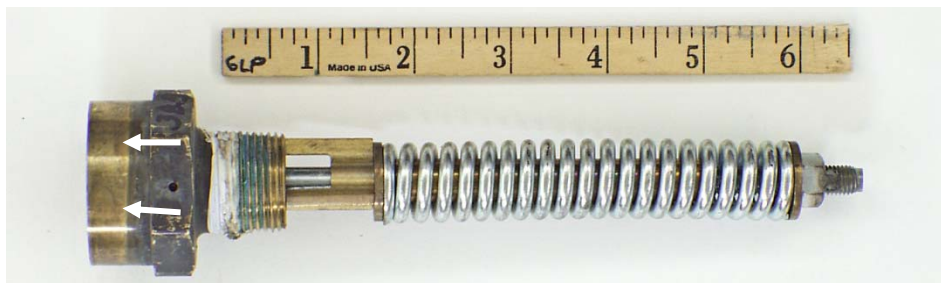
The results show that 25 of the 43 valves examined had evidence of a rain cap line. In some cases the rain cap line was very distinct, as is shown in Figure 26, in which the external rain cap line (protected area free from discoloration) on the external surface of the valve body from PRV 351 is quite evident. Although less evident, Figure 27 also shows a rain cap line in which the external surface of PRV 343 is discolored where the rain cap was affixed. Figure 28 shows the absence of a rain cap line on the external surface of the valve body from PRV 120; an internal rain cap line also was not visible on this valve.

Figure 26 - Distinct Rain Cap Line on PRV 351

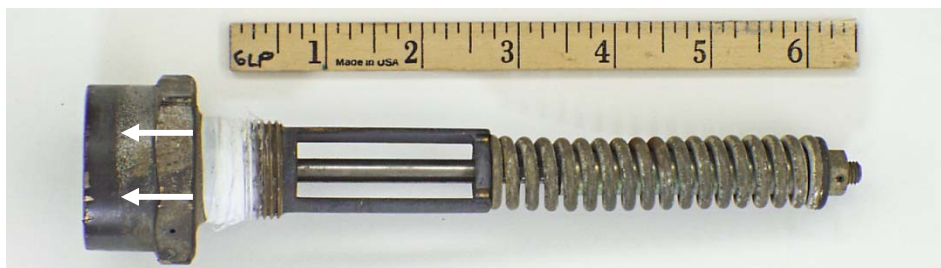
Figure 27 - Discolored External Surface of Valve Body under Rain Cap Line on PRV 343

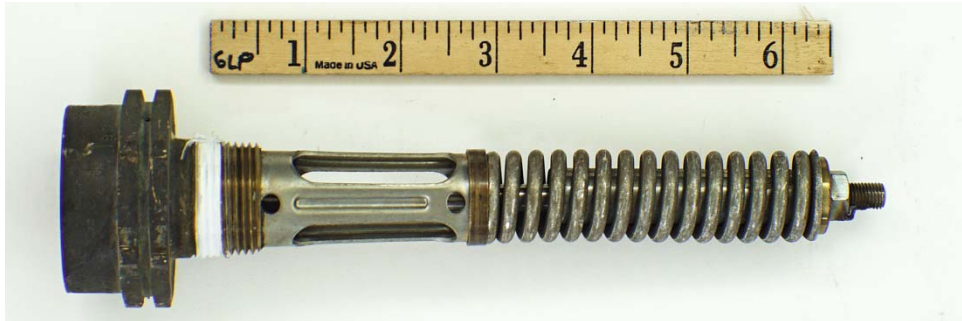
Figure 28 - Absence of Rain Cap Line on the External Surface of the Body of PRV 120

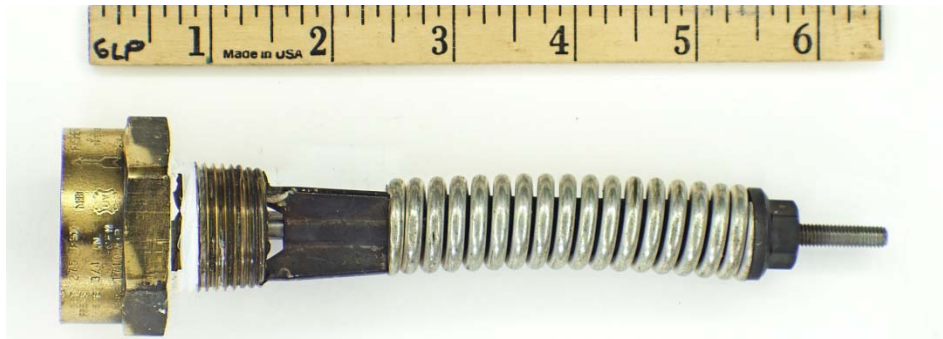
In some instances the external surface of the valve body had been wire brushed or buffed to remove the oxide films to read the valve data and, as a result, it could not be determined whether a rain cap had been present. That condition on PRV 5 is illustrated in Figure 29.

Figure 29 - External Surface of Valve Body that had been Buffed after Removal from Service; Unable to Determine if Rain Cap had been Present in PRV 5

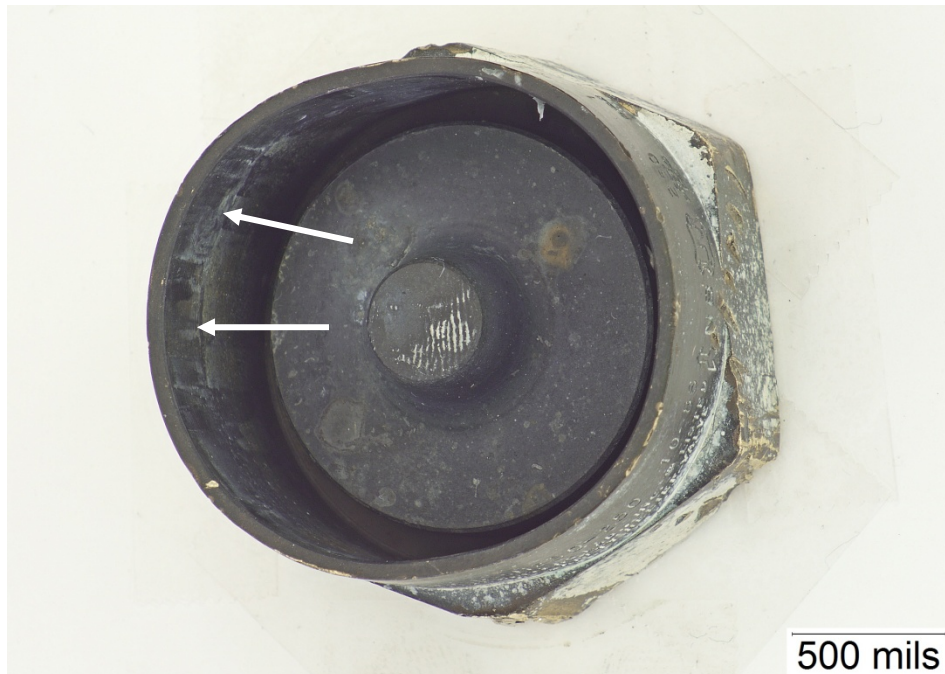
Figure 30 shows a faint rain cap line on the internal surface of the valve body from PRV 350. This PRV had an internal rain plug as is shown in Figure 31. Several other PRVs had very faint internal rain cap lines.

Figure 30 - Faint Rain Cap/Plug Line on the Internal Surface of the Body of PRV 350

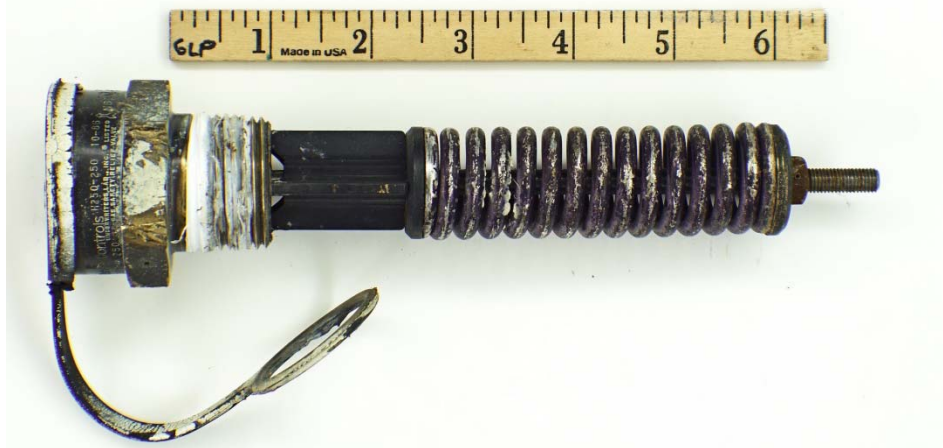
Figure 31 - Internal Rain Cap/Plug on PRV 350

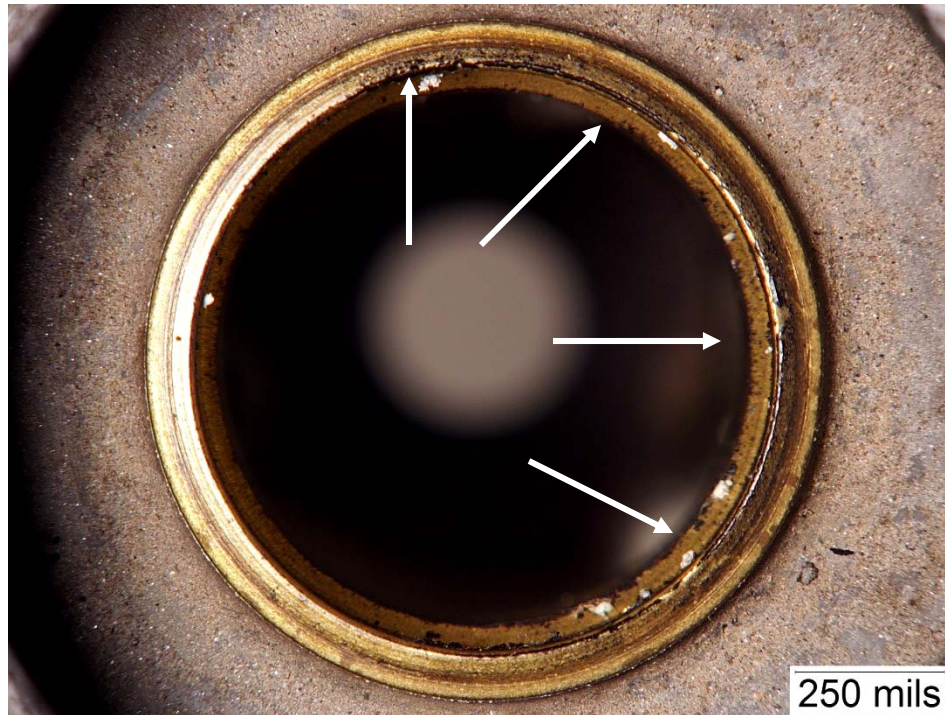
Figure A-15. Valve Body Seal Seat Surface from PRV 274 Showing Gasket Material Transfer

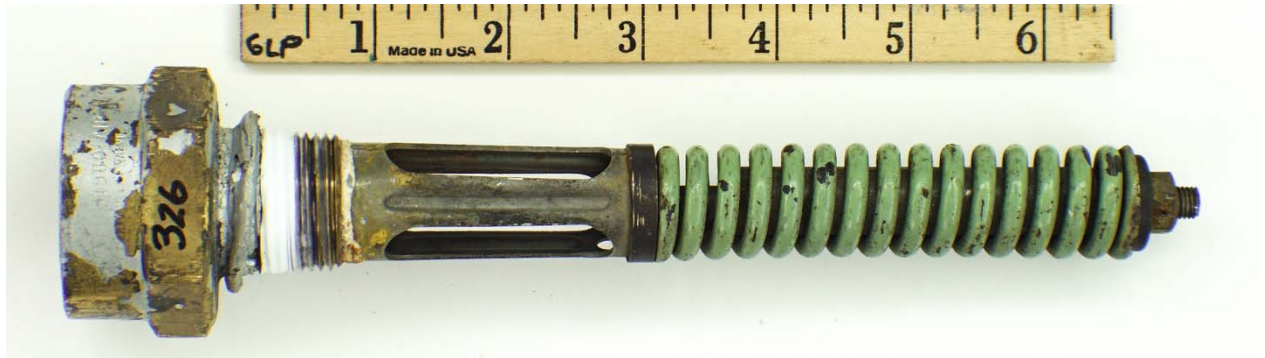
Figure A-16. Appearance of PRV 326

There also was corrosion on the top guide washer and on the valve stem at the lower end of the spacer as shown in Figure A-17. Rust was also present on the bottom surface of the bottom guide washer adjacent to the adjustment nut. The locking mechanism was a drive pin through the nut and the valve stem; the drive pin was corroded. There was no evidence of tampering with the adjustment nut. Figure A-18 illustrates the various corroded regions on the valve stem and Figure A-19 shows the corrosion/interaction region between the valve stem and the guide

washer at the lower end of the spacer. That region is similar to the regions shown on the valve stems of PRV 173 and PRV 274. In addition, Figure A-19 also shows another region of corrosion on the valve stem below the corrosion/interaction region. This corrosion most likely contributed to the behavior of this PRV during testing. In addition, the gasket from the PRV was brittle and broke into many pieces when pulled from the valve with pieces remaining stuck in the disc holder. It appeared similar to the gasket in PRV 173 shown previously in Figure A-9.

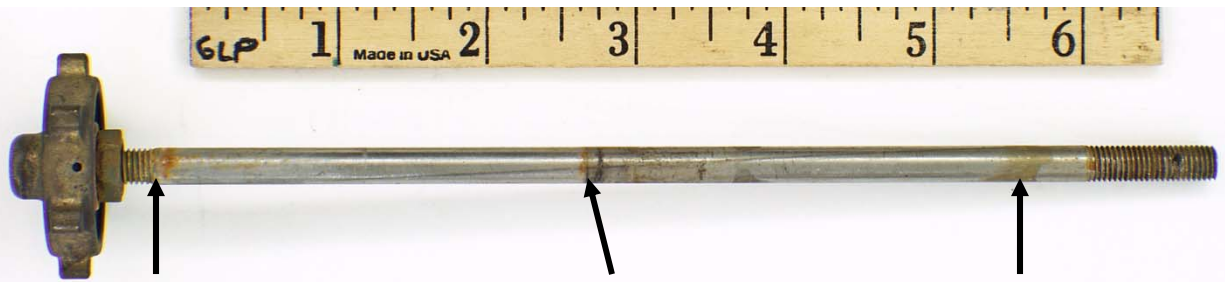
Figure A-18. Corrosion/Interaction Region on the Valve Stem from PRV 326

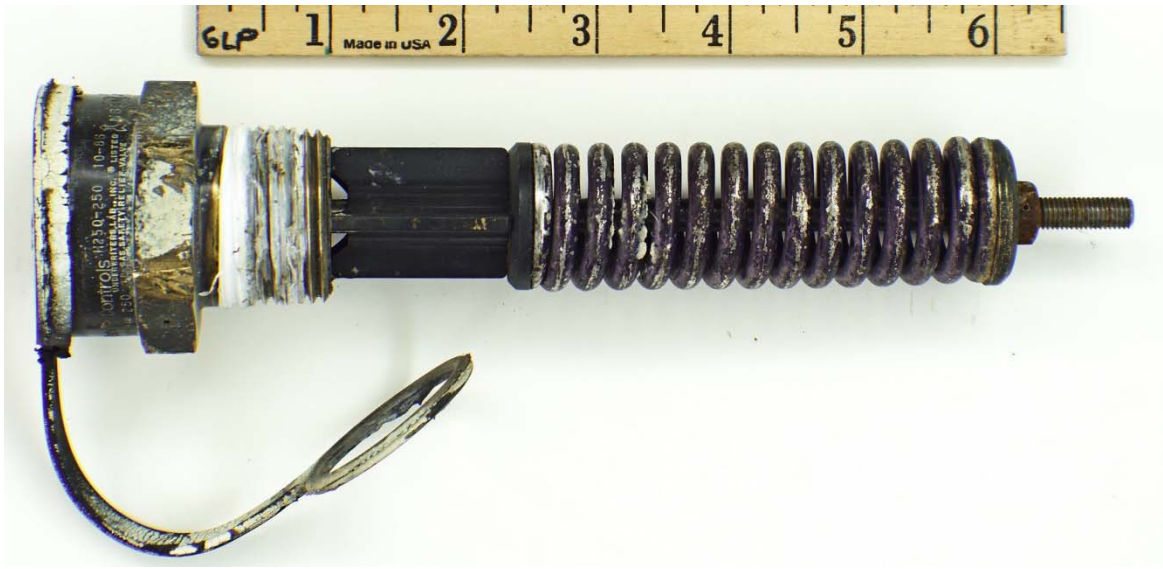
The appearance of PRV 350 is shown in Figure A-20. Visual examination of PRV 350 revealed that the external and internal surfaces of the brass valve body, brass spacer, and brass gasket holder were discolored; they were almost black. There was no debris inside the valve body but there were some white surface deposits on the gasket holder. The valve body was distorted to an oval shape as is shown in Figure A-21. The spring had a purple coating and much of the coating had flaked off and there was no sleeve in the spring (the investigator believes that sleeves were present inside the springs and around the valve stem to minimize buckling of the spring when the valve opening pressure was set). The locking mechanism was a drive pin through the adjustment nut and valve stem. The adjustment nut and the threads on the valve spring beyond the nut were slightly corroded, but there was no evidence of tampering with the adjustment nut.

Figure A-20. Appearance of PRV 350 Including Its Rain Cap

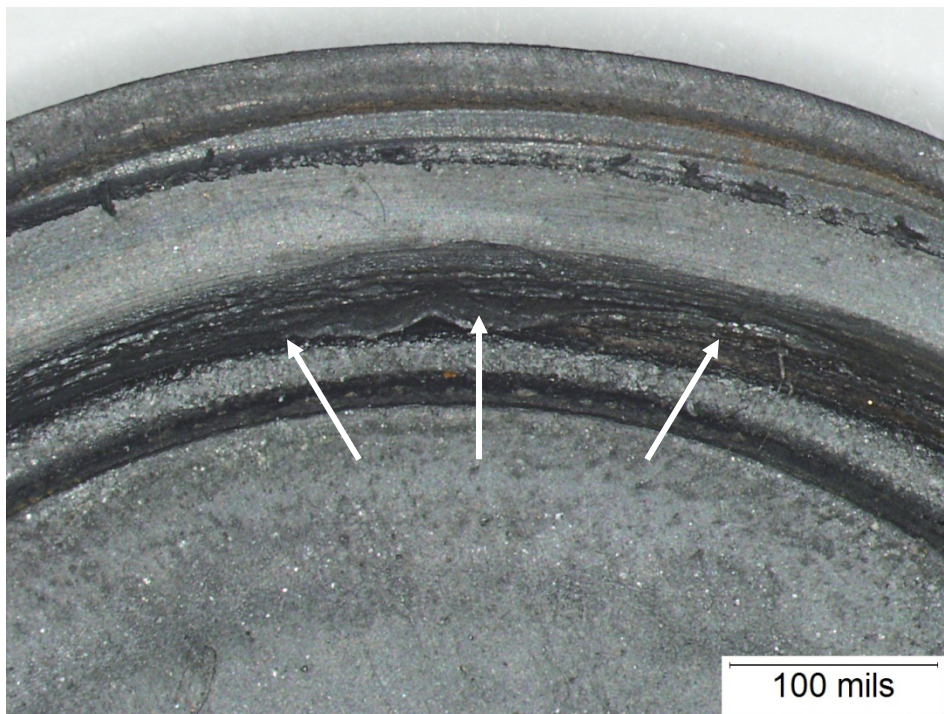
problems. Figure A-25 shows a region of pullout of the gasket material from the surface of the gasket and Figure A-26 shows staining and gasket material transfer to and from the gasket to the valve body surface of PRV 350. Thus, this analysis suggests three factors that likely contributed to the did not open and high-start-to-discharge conditions of PRV 350 during the pressure testing conducted during the initial study and the present study, respectively. Those conditions were: (1) corrosion of the valve stem and the guide spacer; (2) sticking of the gasket to the valve body sealing surface, and (3) possible misalignment of the valve that caused binding between it and the spacer guide.

Figure A-25. Pullout Regions (Arrows) from the Surface of the Gasket from PRV 350

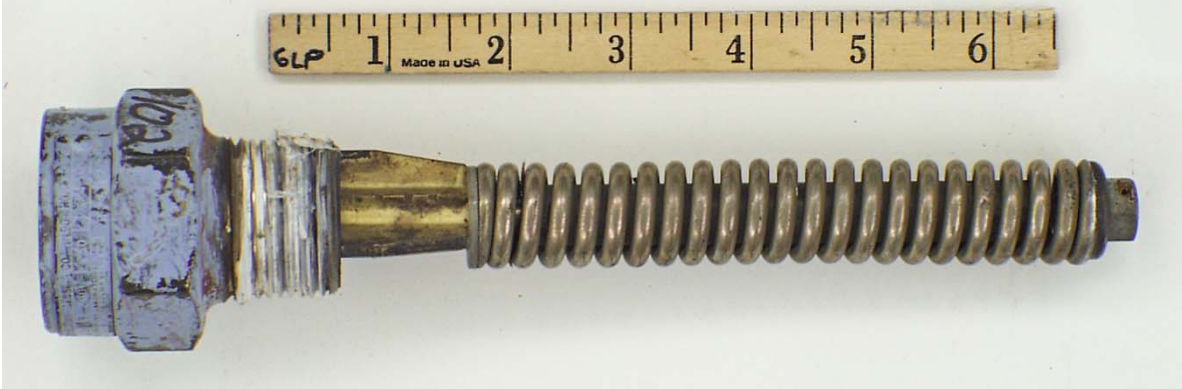
Visual examination of PRV 102 revealed dried mud on the internal surfaces of the valve body and mud and debris in the valve body below the valve sealing region. The presence of the mud indicates that the valve may have been dropped into mud after it was removed from the tank. Those features are shown in Figures A-27 and A-28, respectively. There also was blue paint on the outside surface of the valve body. The spacer guide in this PRV was a three-finned brass component. The other valves examined during this study produced by Manufacturer A had tubular spacers. The spring was gold color and there was some white residue on the spring surface and debris inside the spring, as shown in Figures A-29 and A-30. There was a sleeve inside the spring and the locking mechanism was a drive pin through the adjustment nut and the valve stem. There was no evidence of tampering with the adjustment nut.

Figure A-27. Appearance of PRV 102. *Note the absence of corrosion or discoloration of the components.*

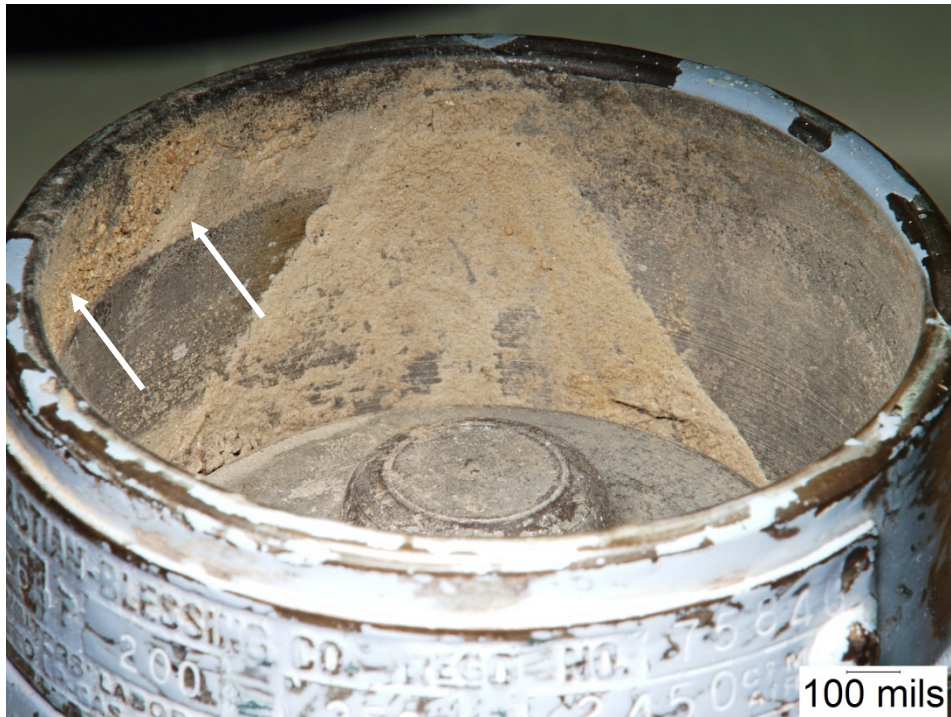
Figure A-29. Blue Paint on the External Surface and Dried Mud on the Internal Surface of PRV 102. A faint internal rain cap line was present (arrows)

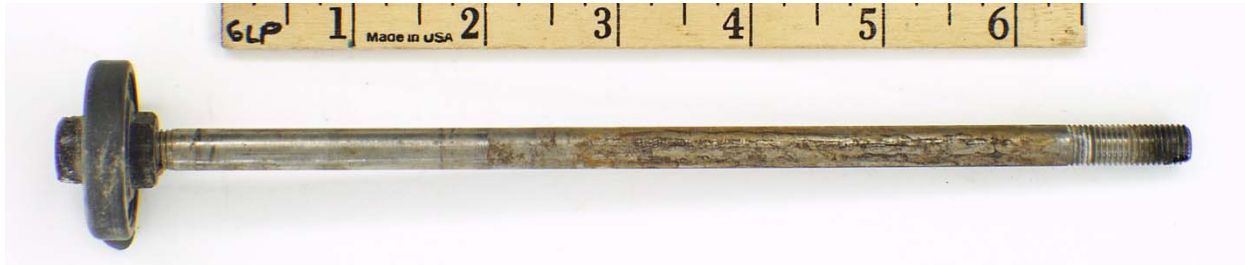
When PRV 102 was disassembled, the valve stem and poppet popped free from the valve body. There was considerable corrosion on the surface of the valve stem and a distinct interaction mark where the surface of the valve stem contacted the inner surface of the brass guide spacer. Those features are illustrated in Figures A-31 through A-34.

Figure A-31. Corrosion on the Surface of the Valve Stem from PRV 102

Based on the results of these examinations, it appears that corrosion and possible misalignment contributed to the behavior of PRV 102 during pressure testing.

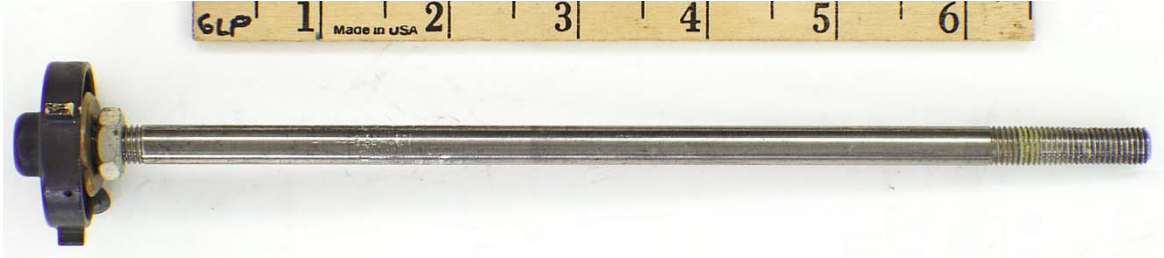
It was reported that when PRV 279 was disassembled, the seat disc (gasket) was stuck to the valve body. The application of torque to the valve stem loosened the gasket. The valve stem contained no regions of corrosion and there was only a faint interaction line where the stem contacted the spacer, as is shown in Figure A-35. The compression set rings in the gasket from

Figure A-35. Appearance of the Valve Stem from PRV 279 Showing the Absence of Corrosion and a Faint Interaction Line from Contact with the Guide Washer (Arrow)

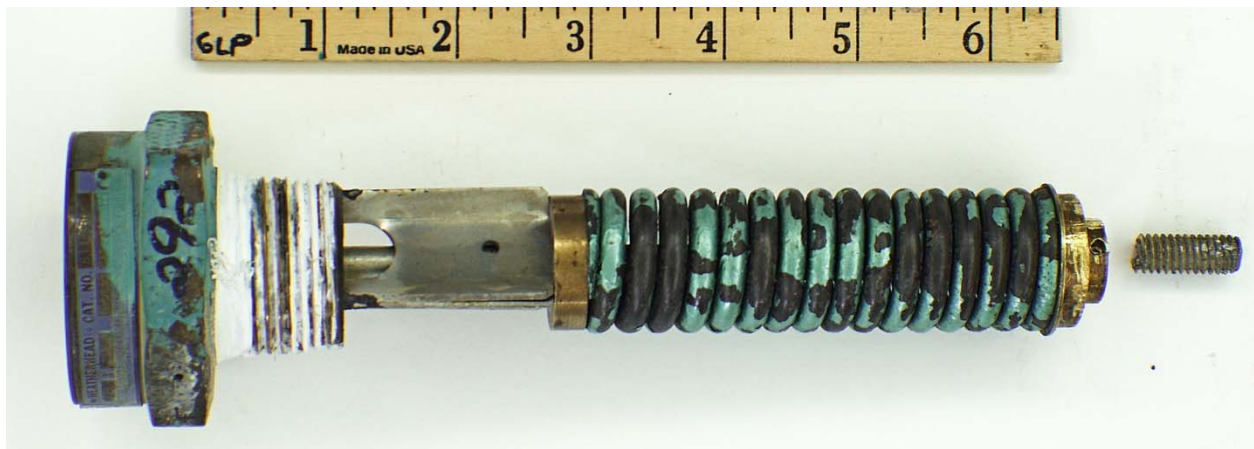
During the present study, PRV 292 was visually examined and then disassembled. The appearance of PRV 292 is shown in Figure A-38. Visual examination revealed an external rain cap line and there was some dirt and debris in the valve body. The spring had a green coating and most of the coating was flaked off. Figure A-38 shows the portion of the valve stem that broke off during the initial study. This PRV had an unusual spacer between the valve body and the guide washer at the top of the spring. It was fabricated from three pieces of sheet metal that were not joined together. When the valve was disassembled those pieces fell out. There also was a screw through the top of the seat disc and that screw had been corroded, as shown in Figure A-39. The valve stem had a distinct interaction line similar to those shown previously where it contacted the upper guide washer. There was no evidence of transfer of the gasket material to the sealing surface of the valve body.

Figure A-38. Appearance of PRV 292

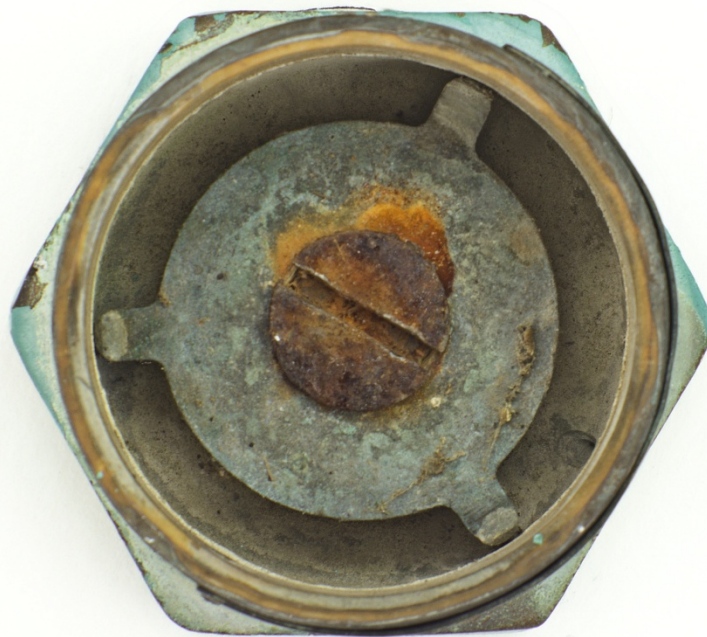
Figure A-39. Rusty Screw through the Gasket Holder and a Small Amount of Debris in the Valve Body of PRV 292

This examination has not shown conclusive evidence why PRV 292 stuck when pressure tested to 375 psig. The interaction line on the valve stem may indicate alignment issues but it does not appear to be sufficient enough to cause sticking at pressures 1.5 times the set pressure.

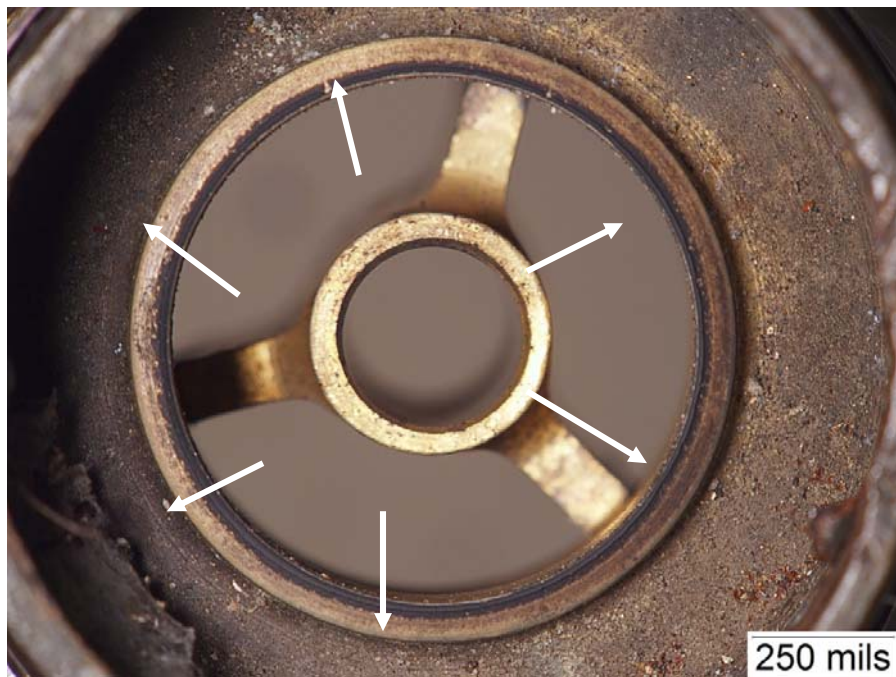
Examination of the valve body after the gasket was released showed that there was gasket material transferred to the entire inner circumference of the sealing surface as is shown in Figure A-42. As is shown in Figure A-43, there was evidence of pull out of material from the sealing region of the gasket.

Figure A-42. Gasket Material on the Entire Inner Circumference of the Sealing Surface of the Valve Body from PRV 250

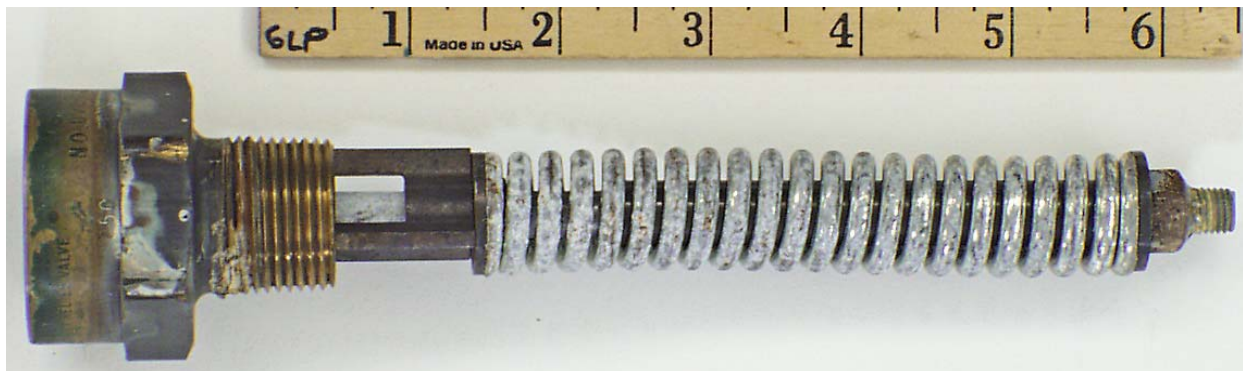
During the present study, PRV 398 was visually inspected and then disassembled for more detailed analysis. PRV 398 is shown in Figure A-45. Examination revealed white, powdery corrosion products on the surface of the spring and on the surface of the valve stem but no evidence of red rust on either component. There were no corrosion products or debris in the valve body. The appearance of the external surface of the valve body indicated that a rain cap had been present. The adjustment/locking mechanism consisted of a single nut welded to the valve stem. Some rust was present on the locking nut. There was no evidence of tampering with the adjustment nut.

Figure A-45. Appearance of PRV 398
