ADDENDUM TO THE FINAL REPORT ON:

TESTING AND ANALYSIS OF THE PERFORMANCE OF PRESSURE RELIEF VALVES FOR CUSTOMER TANKS

Battelle Project N007245
PERC Docket 15203

April 2011

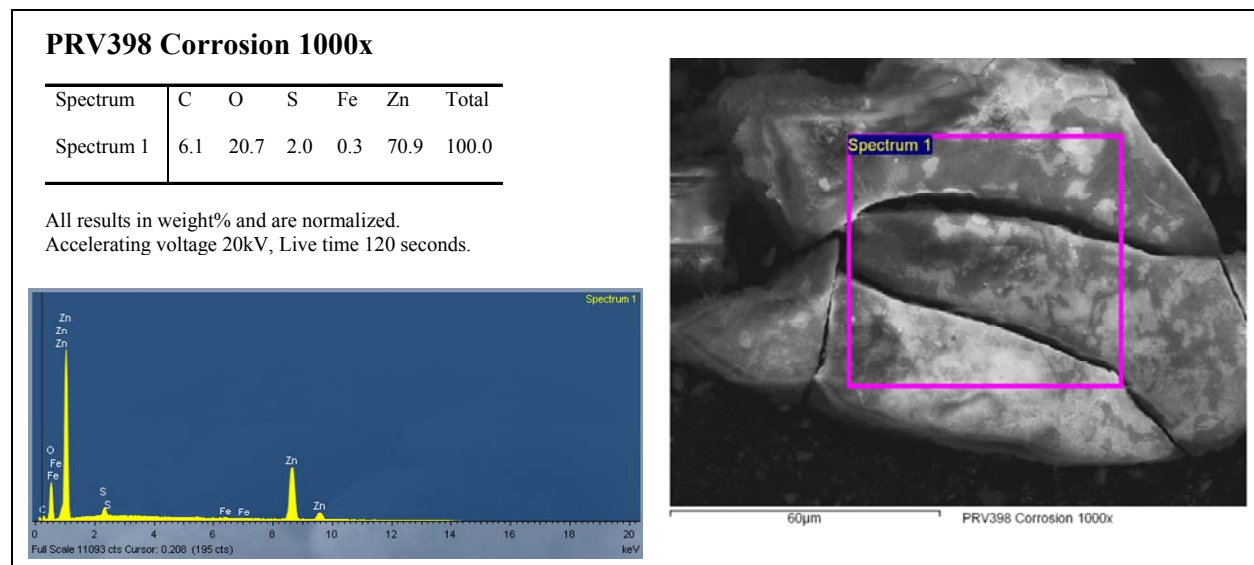
To identify the white corrosion products, some of those deposits were gently scrapped from the valve stem surface and analyzed using energy dispersive spectroscopy (EDS) in the scanning electron microscope (SEM) and by x-ray diffraction. The results of the EDS analysis are shown in Figure A-49. They show the corrosion products contained primarily zinc (Zn) and oxygen (O) with smaller amounts of sulfur (S) and iron (Fe). The carbon came from the carbon tape that was used to pull the corrosion products from the valve stem. The EDS results indicate that these corrosion products were zinc oxide.

Figure A-49. Results of EDS Analysis of the White Corrosion Products from PRV 398

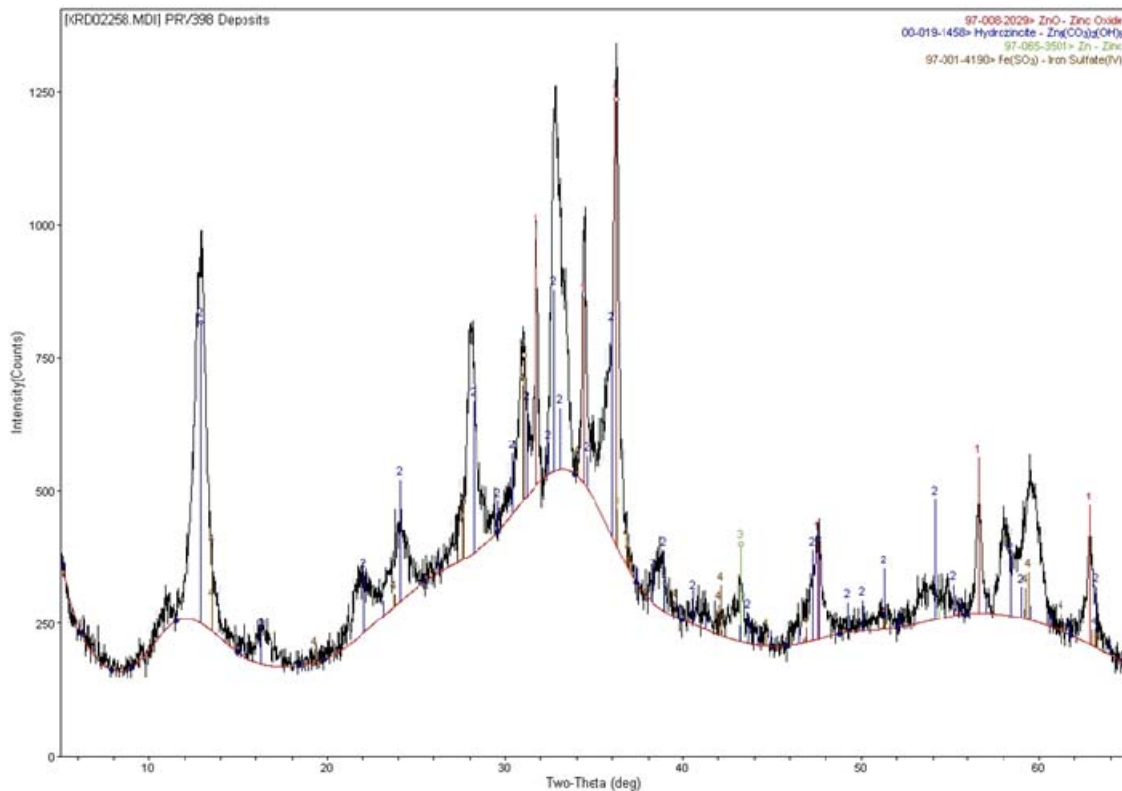
Another sample of the white corrosion products were analyzed by x-ray diffraction using copper k-alpha x-ray source. The results of that analysis are shown in Figure A-50. The pattern was analyzed using the Powder Diffraction File-4+ Release 2009 and the Inorganic Crystal Structure Database/NIST version 2009-2. Three zinc bearing phases were identified in this pattern. Those phases were zinc oxide (ZnO), hydrozincite, and zinc metal. The zinc metal came from the zinc coating on the valve stem. In addition, a small amount of iron sulfate was tentatively indexed in this pattern. That phase clears up several non-indexed peaks and accounted for all of the elements detected by the EDS analyses.

Figure A-50. X-ray Diffraction Pattern from the Corrosion Products from PRV 398

The results of the examination of PRV 398, which exhibited high-start-to-discharge pressure during pressure testing, show significant amounts of zinc corrosion products on the spring, the valve stem, and the inside surface of the guide spacer. The spring and valve stem had been coated, most likely electroplated with zinc. Those corrosion products most likely bonded the valve stem to the guide spacer which resulted in the high-start-to-discharge pressure behavior.

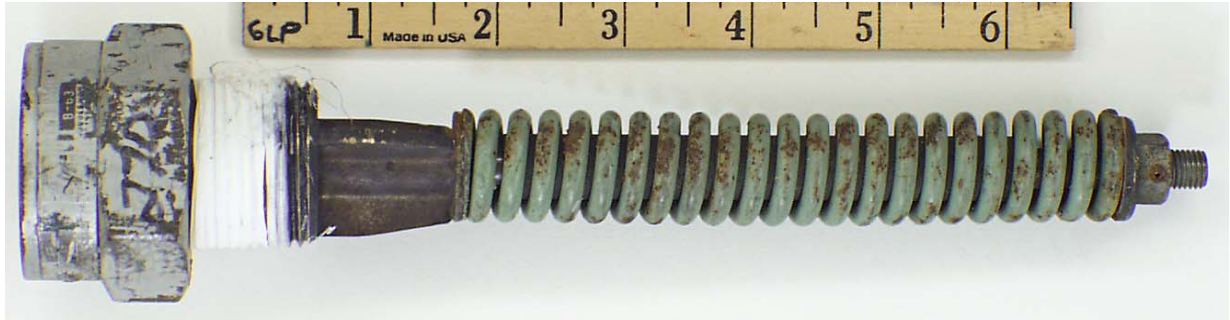
PRV 270 is shown in Figure A-51. The valve body had been painted silver and there did not appear to be a rain cap line on either the external or internal surfaces. However, there was very

little debris in the valve body. The spring had a green coating, some of which had been chipped off and there was corrosion on the spring coil surfaces in those regions. A sleeve was inside the spring. The brass guide spacer also was discolored. The adjustment nut locking mechanism was a drive pin through the nut and valve stem. There was rust on the nut and locking pin but there was no evidence of tampering.

Figure A-51. Appearance of PRV 270

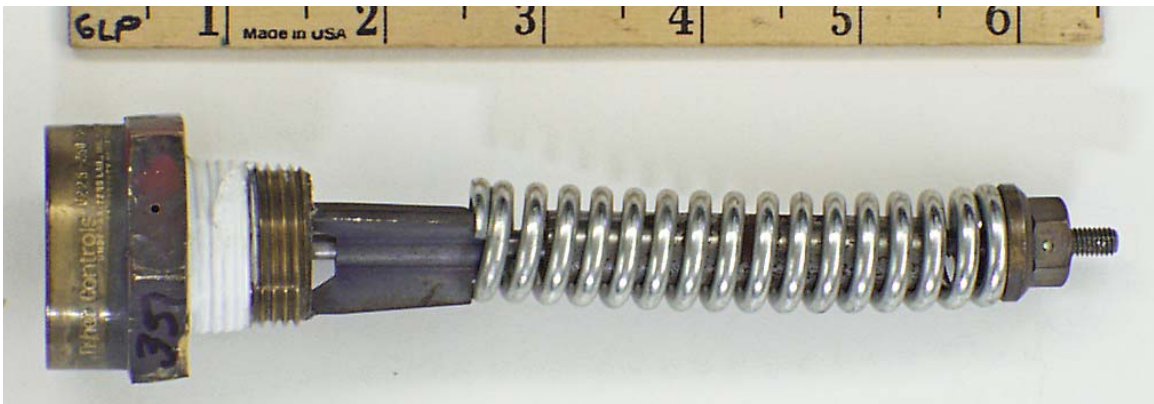
When PRV 351 was disassembled, the valve stem/poppet was stuck to the valve body. However, it broke loose when the rod was wiggled. There was no corrosion on the surface of the valve

stem and only a light interaction line from contact between the guide spacer and the valve stem. In addition, there was no evidence of gasket material being stuck to the sealing surface of the valve body.

The examination of PRV 351 did not reveal any conclusive evidence to explain the high start-to-discharge pressure behavior.

Figure A-52. Appearance of PRV 351

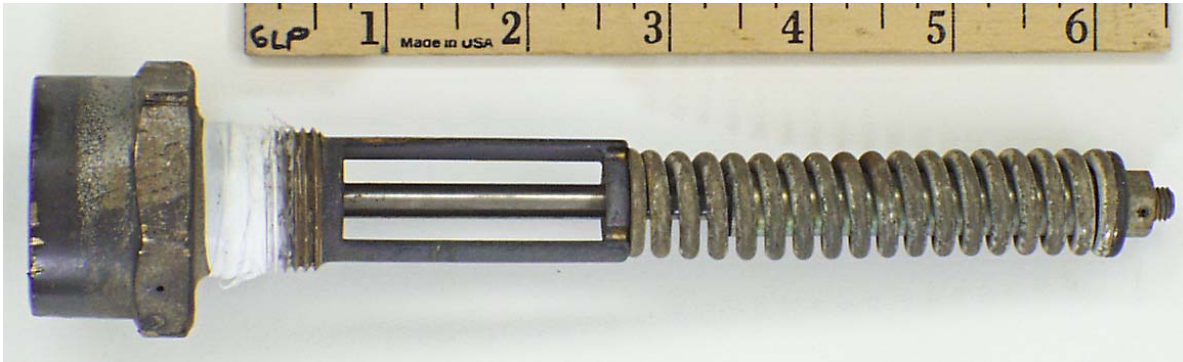
PRV 343 is shown in Figure A-53. The black band at the top of the valve body indicates that a rain cap had been present. The internal surfaces of the valve body were discolored but there were no loose corrosion products or debris in the valve body. The valve body had three vertical tapered ribs protruding from the valve body. These ribs most likely aided in alignment of the poppet. The guide spacer had two legs and appeared to have been machined from bar stock. This is the only PRV examined that had that type of spacer. The surfaces of the spacer were discolored. The surfaces of the spring coils had a dull finish, but they were not corroded. The adjustment nut locking mechanism was a drive pin through the nut and valve stem. There was some corrosion on the nut and the threads of the valve stem extending beyond the nut, but there was no evidence of tampering.

When PRV 343 was disassembled, the valve stem/poppet was stuck to the valve body, but broke loose when the valve stem was wiggled. There was no corrosion or interaction line on the valve stem and no gasket material transferred to the sealing surface of the valve body.

Figure A-53. Appearance of PRV 343

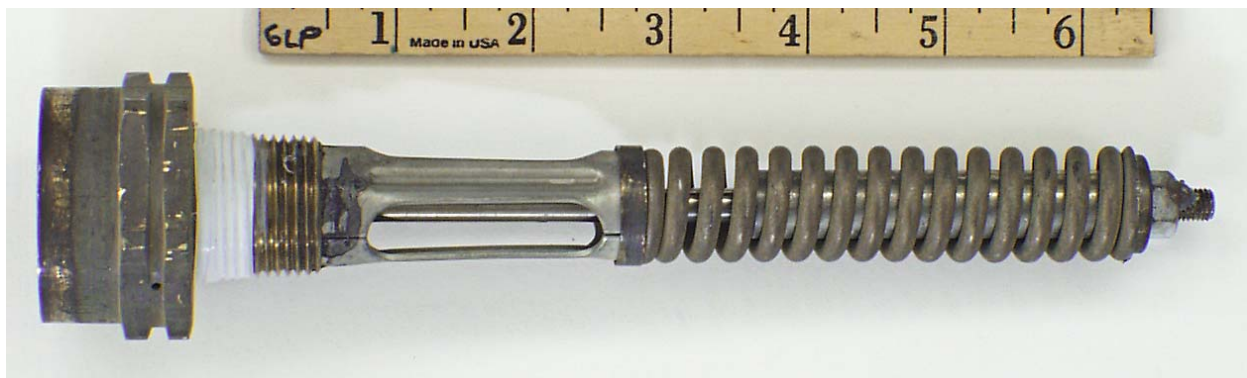
PRV 132 is shown in Figure A-54. There was a distinct rain cap line on the external surface of the valve body. There was some discoloration on the internal surfaces of the body and the gasket holder, no loose corrosion products or debris in the valve body, and the weep hole was open. This PRV had a spacer fabricated from sheet steel into a slotted tube. Guide spacers were located at the top and bottom of the spring. The spring had a darkened, dull finish but there was no evidence of corrosion on the spring. A sleeve was present inside the spring. The adjustment/locking mechanism was a single nut with a single tack weld between the nut and the valve stem. There was some corrosion on the adjustment nut and the threads on the valve stem that extended beyond the nut. There was no evidence of tampering with the adjustment nut.

Figure A-54. Appearance of PRV 132

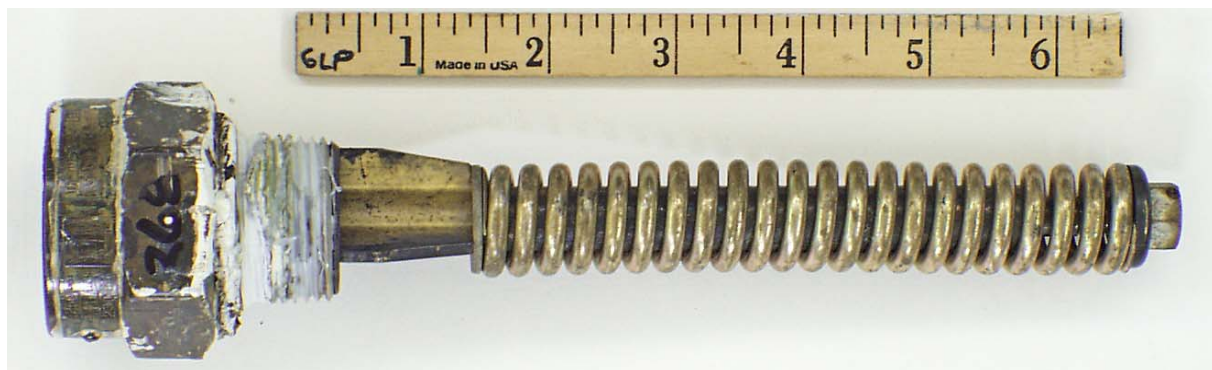
PRV 268 is shown in Figure A-55. Examination of the valve body revealed no obvious external or internal rain cap line. The inside surfaces of the valve body and the surface of the gasket holder was discolored but there were no loose corrosion products or debris in the valve body. The weep hole was plugged with paint. There was an o-ring under the hex-shaped portion of the body that was covered with silver paint but it was not compressed. The spring was gold colored, bright and shiny. There was no evidence of corrosion on the spring. There was only a small amount of discoloration on the spacer. The components look very good for having been in service for 52 years. The adjustment nut locking mechanism was a single nut with a drive pin through the nut and valve stem. The hole on one side of the nut had been mis-drilled. There was some corrosion on the nut but there was no evidence of tampering.

Figure A-55. Appearance of PRV 268

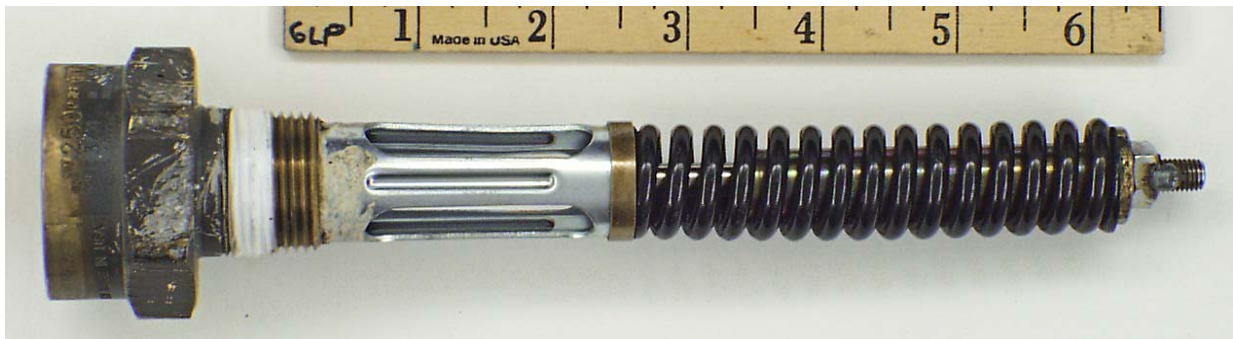
PRV 202 is shown in Figure A-56. It had a distinct rain cap line on the external surface of the valve body. The remainder of that surface was discolored. The inner surfaces of the valve were not discolored and there was no debris in the valve body. There was another material, perhaps adhesive, on the external surface at the top of the spacer. Other than that, the components of the valve contained within the tank looked new. The spring had a shiny black coating and there was a sleeve inside the spring. The adjustment nut locking mechanism was a single tack weld between the nut and the valve stem.

Figure A-56. Appearance of PRV 202

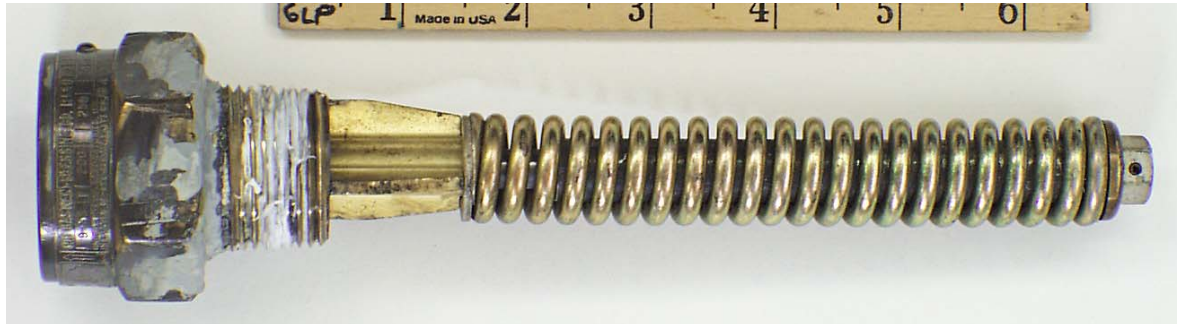
PRV 251 is shown in Figure A-57. Even though the external surface of the valve body was discolored, it appeared that a rain cap had been present. The internal surfaces of the valve body were discolored and there was debris in the valve body. The weep hole was plugged with paint.

The surfaces of the guide spacer showed a slight discoloration and the surfaces of the spring were gold colored, bright, and shiny; it looked new. There was a sleeve inside the spring. The adjustment nut locking mechanism was a drive pin through the nut and the valve stem. There was no rust present on the nut or the drive pin and there was no evidence of tampering.

Figure A-57. Appearance of PRV 251

When PRV 251 was disassembled, the valve stem/poppet was stuck to the valve body, but it loosened when lightly wiggled. The valve stem had a dull metallic finish but there was no corrosion or an interaction from contact with the inner surfaces of the guide spacer. Also, there was no evidence of gasket material being stuck to the valve body. Again, no evidence was uncovered to explain the high start-to-discharge behavior of PRV 251.

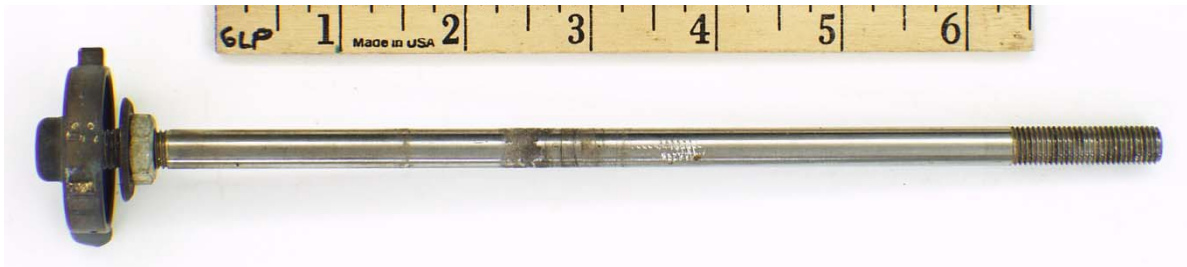
The valve stem from PRV 41 is shown in Figure A-60. As is shown, there was not a lot of general corrosion on the surface but there was an extensive interaction region where the valve stem contacted the guide washer internal surface. This region is shown at higher magnification in Figure A-61. The amount of corrosion could have contributed significantly to the initial high start-to-discharge pressure behavior. The gasket from this PRV was identified as Buna N and exhibited a Shore D hardness of about 45. However, it is not known with certainty whether the material hardened during service.

Figure A-60. Corrosion and an Interaction Region on the Surface of the Valve Stem from PRV 41

Based upon the examination of PRV 41, it is likely that the high start-to-discharge behavior during initial pressure testing was caused by the valve stem being stuck to the guide spacer by the oxidation of the contacting surfaces. That condition can occur because of the condensation of moisture on the components inside the tank.

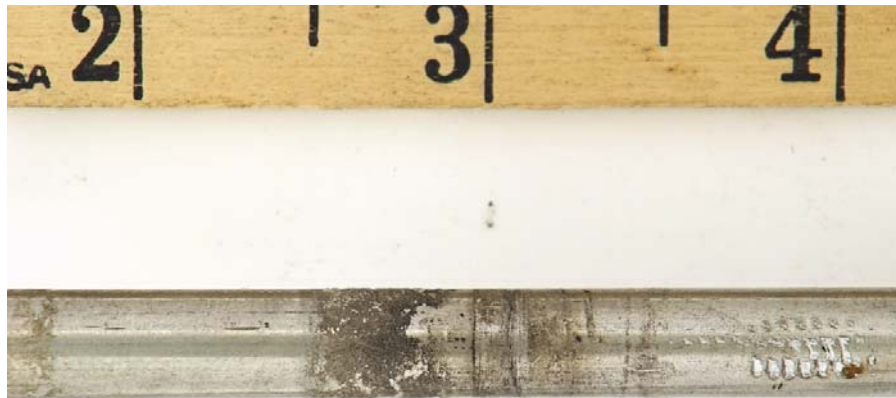
Figure A-61. Higher Magnification View of the Corrosion and the Interaction Region between the Valve Stem and the Guide Washer from PRV 41
